# Wetland Repair and Renovation Project Cane Ridge Wildlife Management Area Patoka River National Wildlife Refuge

Thomas R. Biebighauser  
May 11, 2015

## Cane Ridge Wetland Repair and Renovation Project

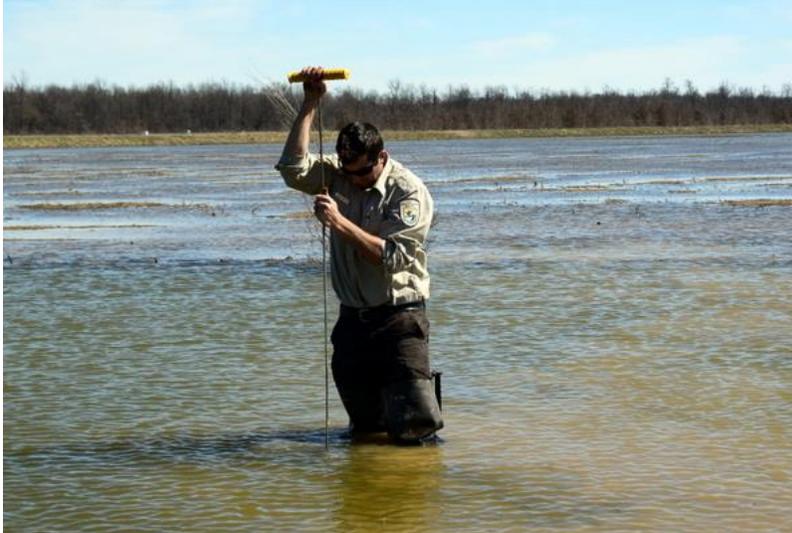
An eight-foot long tile probe was used to hand test for the presence of sand and gravel.

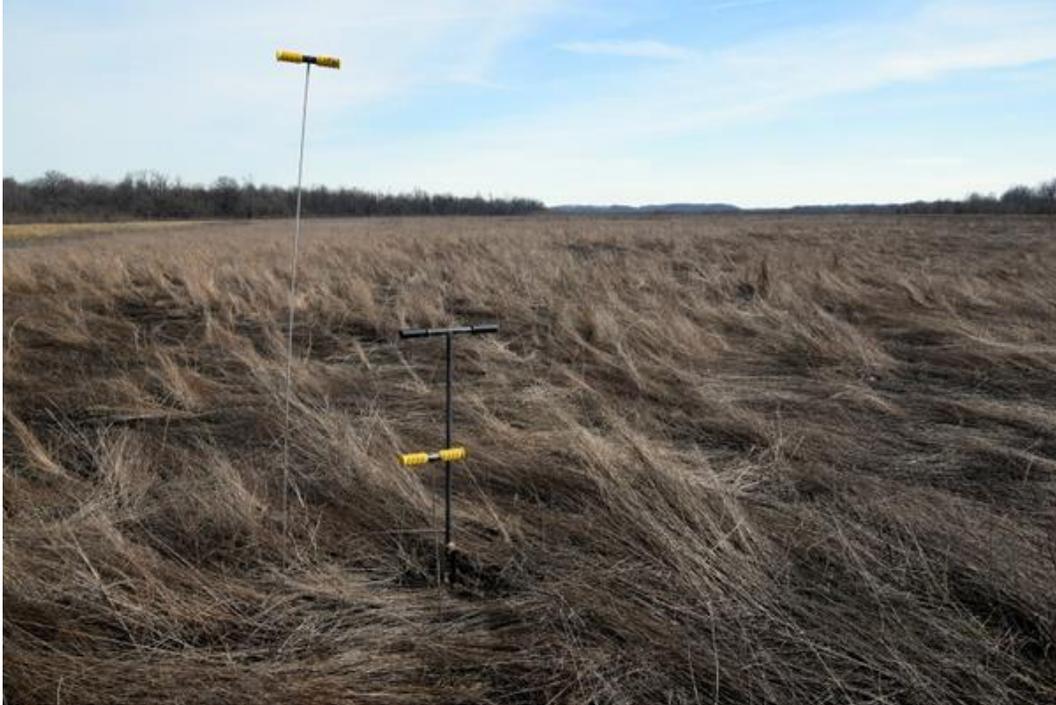
This photo shows the hand tools used to measure soil texture and the elevation of groundwater in the Cane Ridge Wetland Units. The photo also shows how the vegetation in the units is typical of well-drained fields.

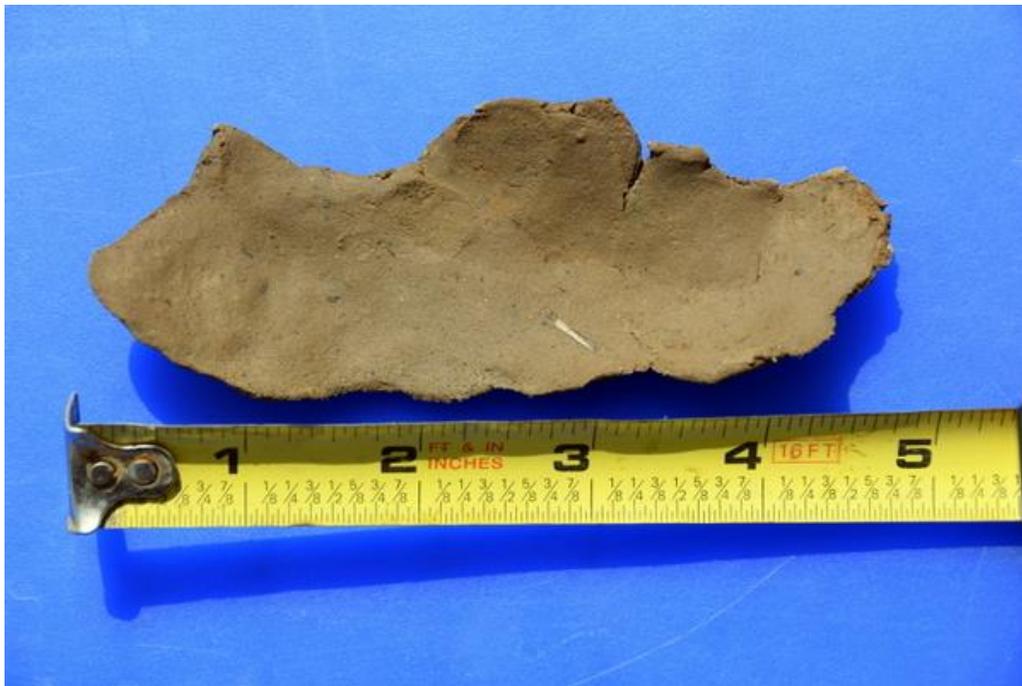
This long and thin ribbon shows a soil texture that is high in clay. The ribbon is typical of soil textures found within the Cane Ridge Wetland Units.

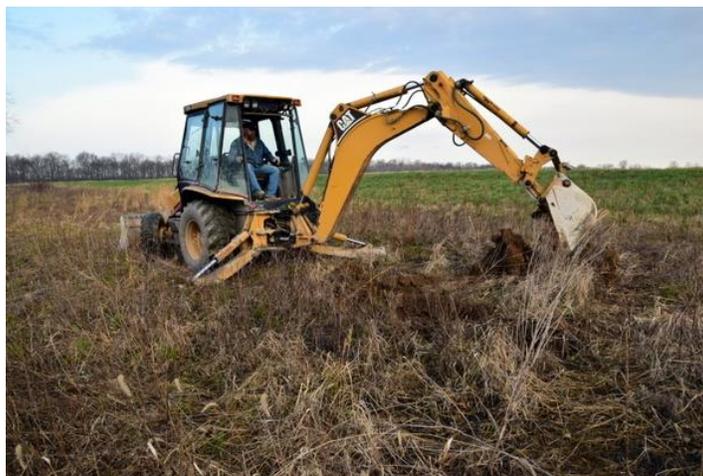
A backhoe was used to dig deep test holes in the Cane Ridge Units to determine soil texture and the elevation of groundwater.

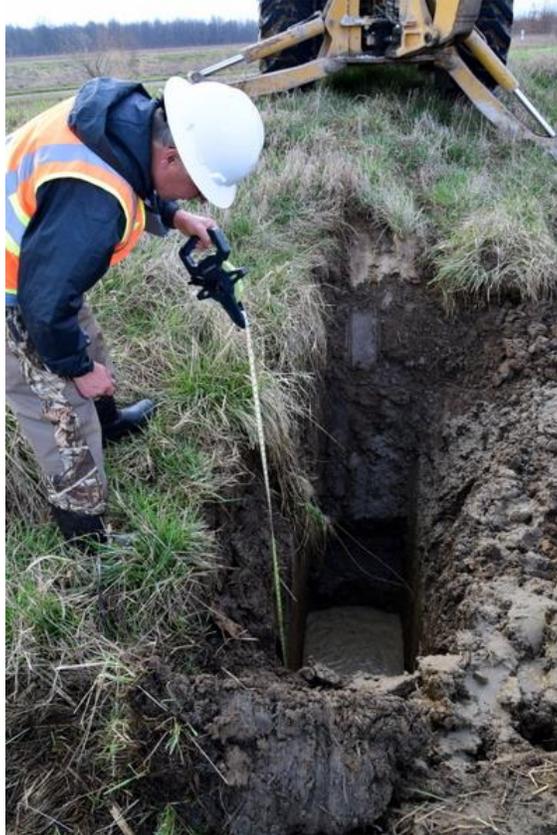
The type and texture of soil layers and the elevation of groundwater was measured in each test hole.

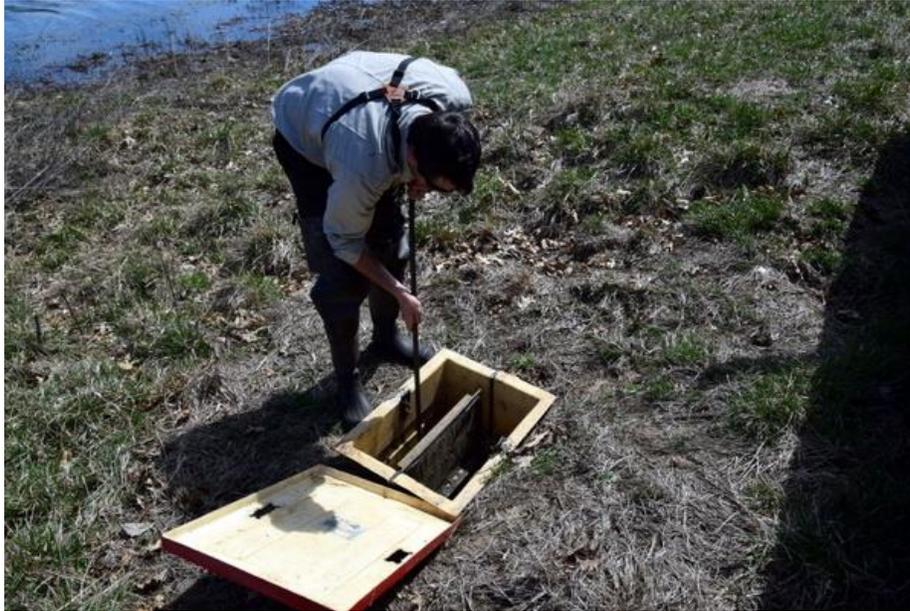
The water control structures placed in Units A-D were manufactured by Fiberglass Utility Supplies, Inc. They contain plates for adjusting water levels in the wetlands.

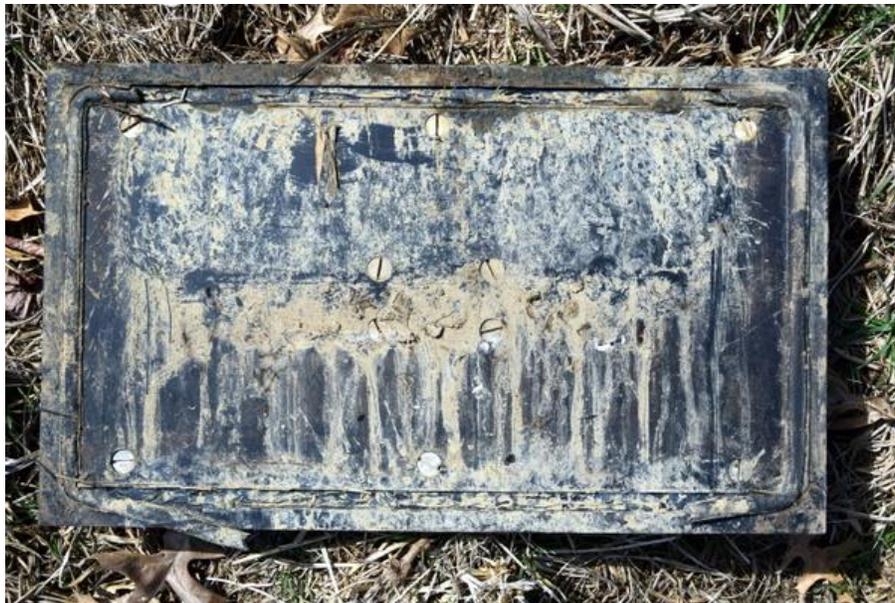
Factory- installed rubber gaskets were used to seal the moveable plates in the water control structures. These gaskets should be replaced. The gaskets are compressed and torn, causing water to leak from the Units. The amount of water leaving the Units can be expected to be much greater when water levels are higher in the wetlands.

The gaskets on the plates are torn and flattened, causing the wetlands to leak.
