**RESTORATION OF WETLANDS AND STREAMS FROM CONSTRUCTED  
IMPOUNDMENTS**  
Thomas R. Biebighauser

This presentation focuses on how wetlands, streams, and rivers are being restored from constructed impoundments on the Yaqan Nukiy Hunting Grounds near Creston, British Columbia, Canada. The project is receiving major funding from the Columbia Basin Trust, Fish and Wildlife Compensation Program, and the Aboriginal Fund for Species at Risk. The project is a partnership program involving the Yaqan Nukiy First Nations and the British Columbia Wildlife Federation. You'll see why after constructing over 1,400 dams, Tom Biebighauser now works to remove them.

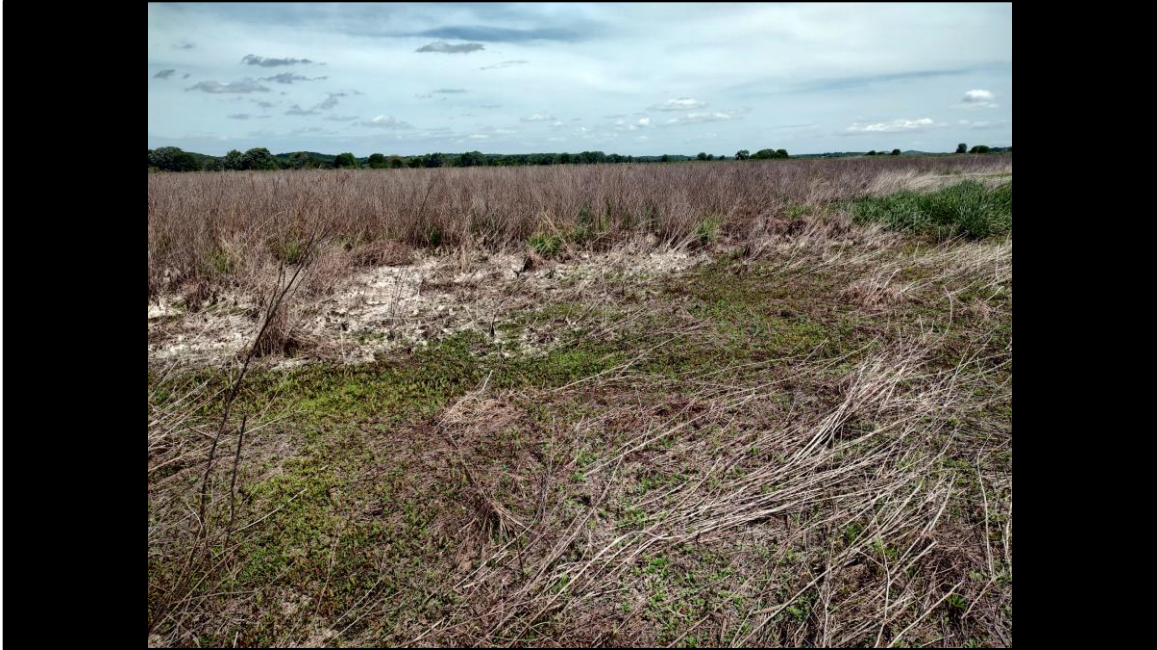
This impoundment like most others is dry most of the year. Water is pumped into the impoundment in the fall when budgets permit. Once filled, the impoundment dries quickly because the impoundment basin intercepts sand-texture soils.

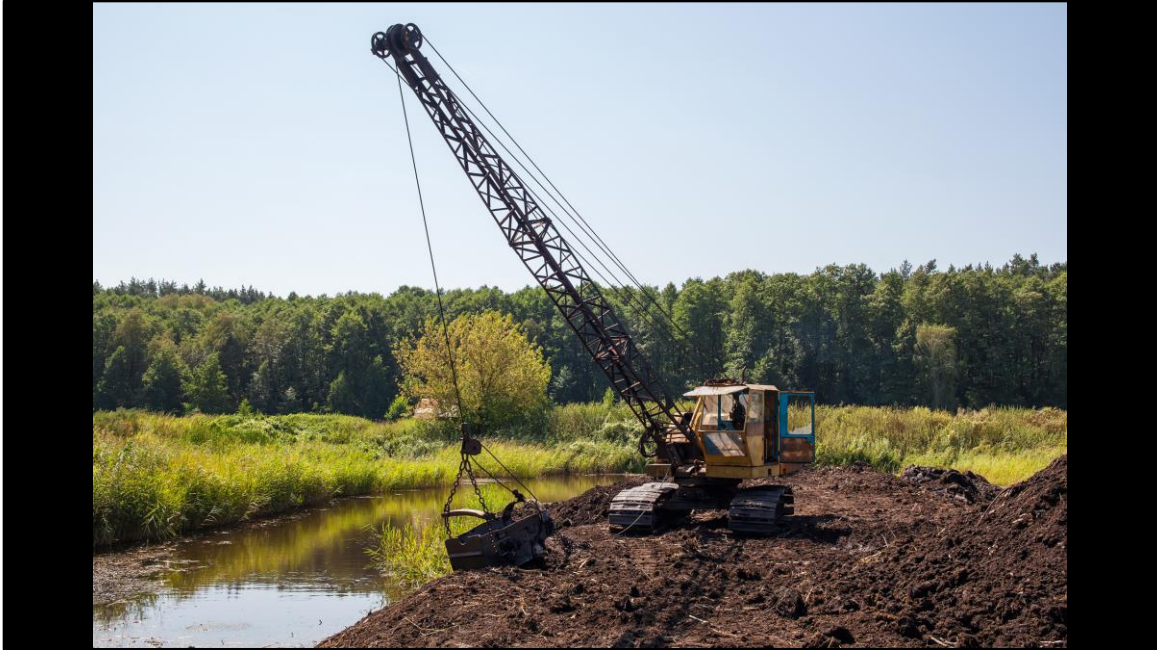
Many of the dams built for impoundments were constructed using a dragline like the one shown here. The use of draglines explains why one often finds a deep borrow pits that look like ditches paralleling impoundment dams. The dragline has been replaced by the excavator for building impoundments today.

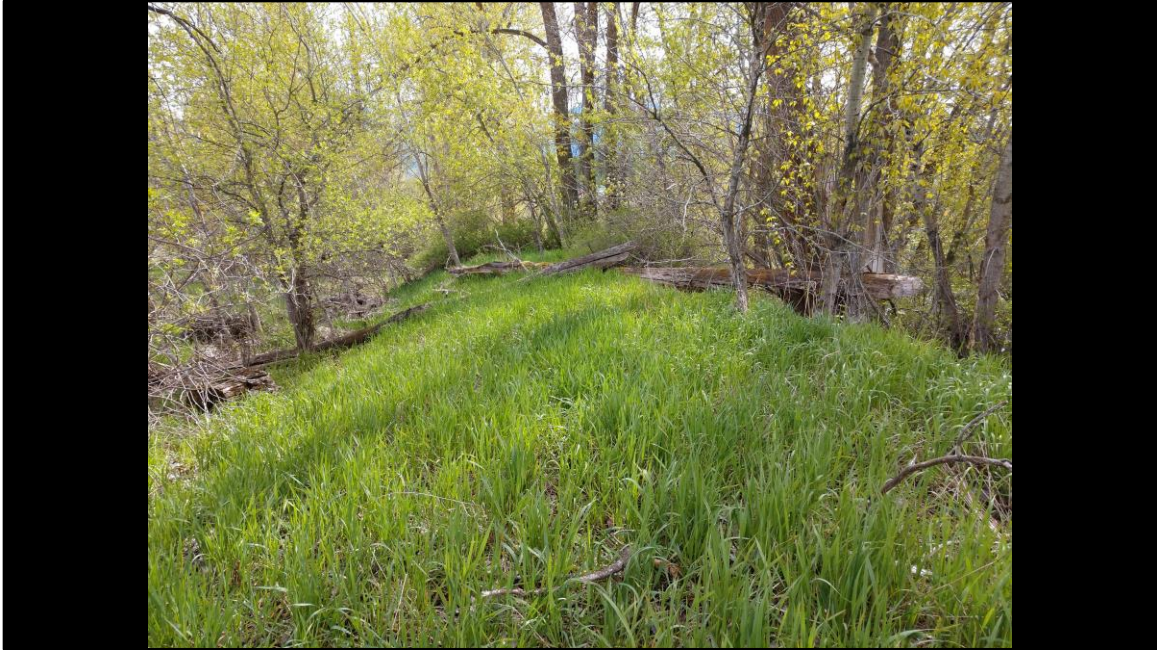
This photo shows a dam built for an impoundment. The dam is located along the banks of a river. The dam prevents floodwaters from entering the impoundment and is designed to maintain water pumped into the impoundment. These dams may also be called a berm, dike, or levee.

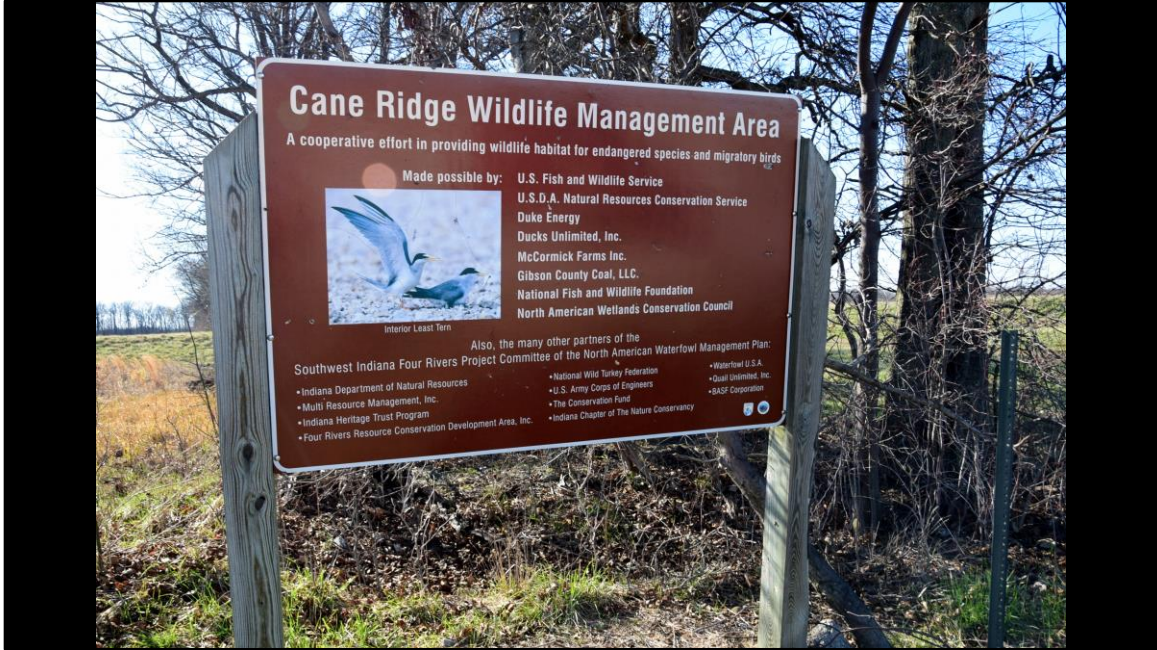
The Cane Creek Wildlife Management Area is part of the Patoka River National Wildlife Refuge near the Wabash River in Indiana. Like almost every other National Wildlife Refuge it contains large impoundments that don't hold water.

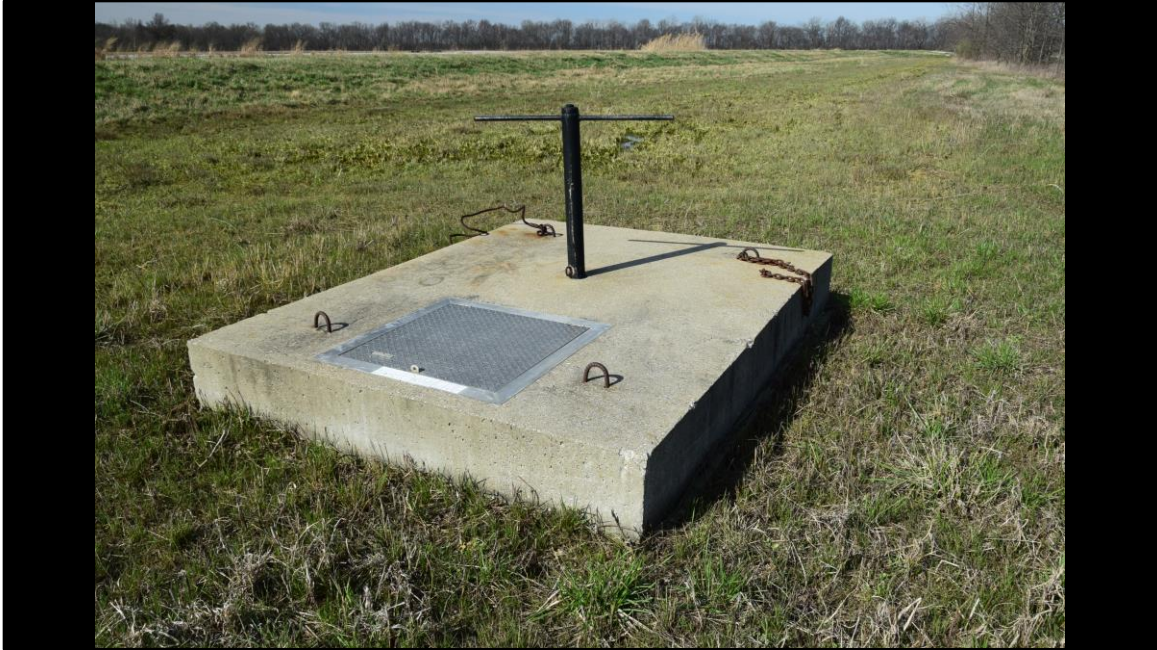
Wells with large pumps were installed at the Cane Ridge Wildlife Management Area in an effort to fill the impoundments with water.

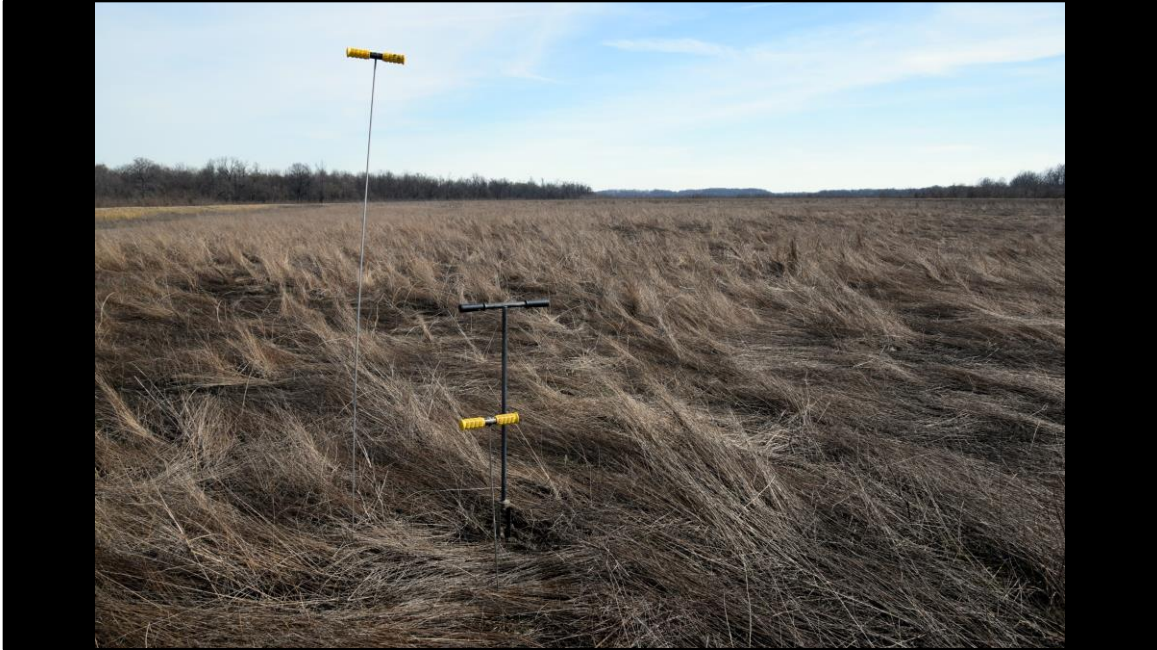
The impoundments cannot be filled with water even the when large pumps are operated day and night

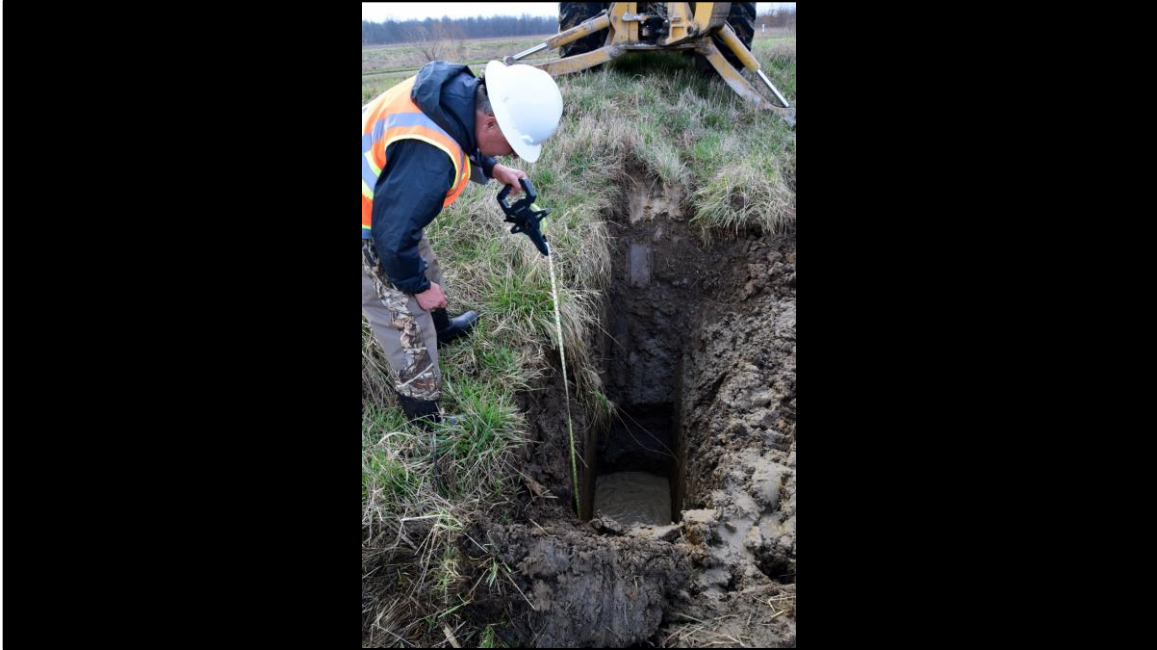
I carefully examined the impoundments and found that the dams were built on a foundation of sand, and that a layer of sand extended under the impoundment basins. The drainage ditches adjoining the impoundments intercepted the same layer of sand, and were draining the impoundments no matter how much water was pumped into them.

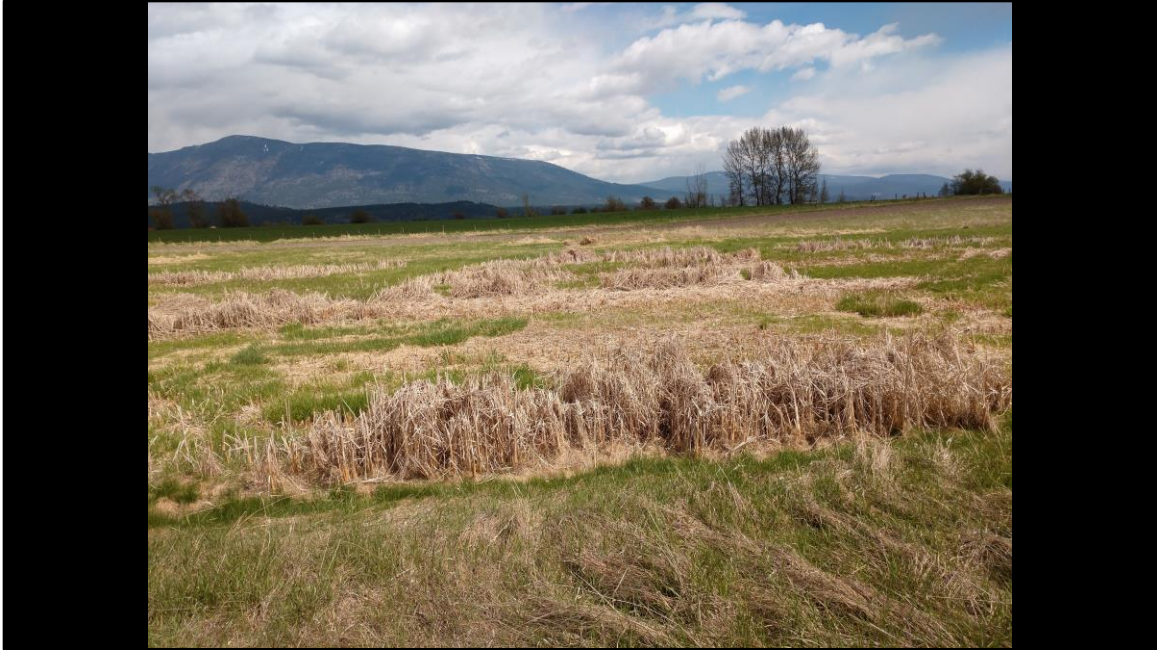
The cattails shown in this photo are growing in a natural wetland that was drained with ditches to create an impoundment on the Boundary Smith Creek Wildlife Management Area in Northern Idaho. The impoundment and drained natural wetlands now only contain water for short periods of time, only as long as water is pumped into the impoundment.

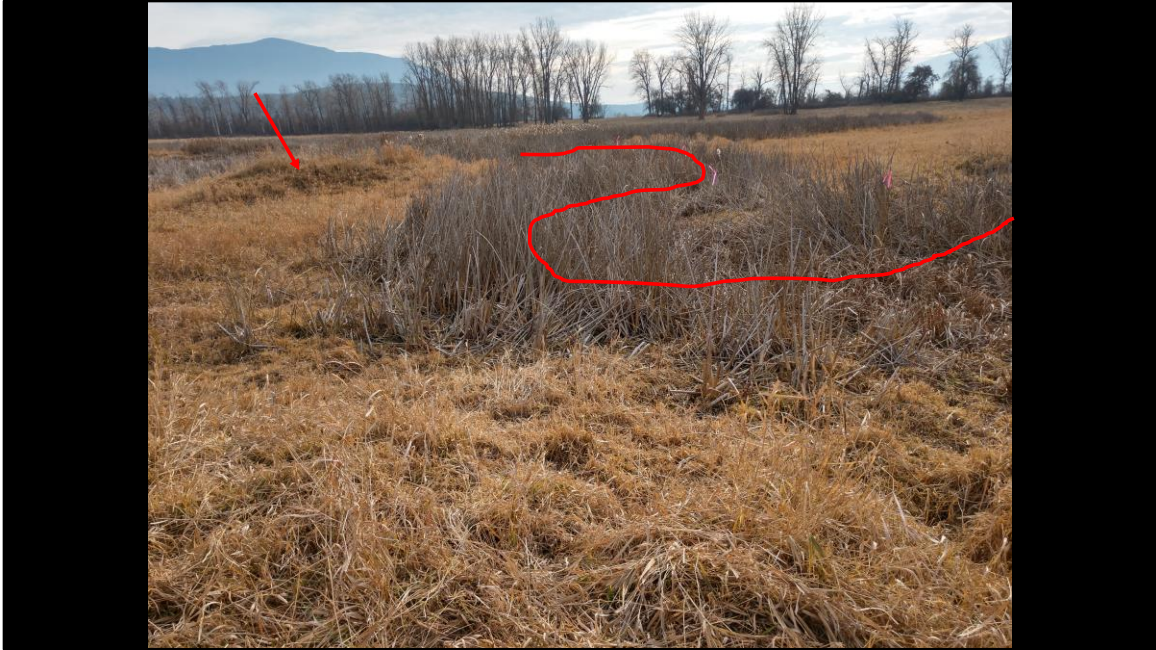
The redline shows the center of a ditch dug between two natural wetlands that were drained for the construction of an impoundment on the Lower Kootenay Band Reserve near Creston, British Columbia. The ditch was dug with a sinuous shape so it would appear like a stream. This type of ditch is called a “level ditch.” Level ditches were designed to create narrow areas of open water within an impoundment. They are not supposed to drain water from an impoundment. However, this level ditch was dug on a slope, so it drains water from the natural wetlands it connects. The author has examined hundreds of level ditches that were dug in impoundments and has found that nearly all are draining water both from the natural wetlands that were drained to build the impoundment, and from the impoundment. The arrow points to one of the piles of soil left from digging the ditch.

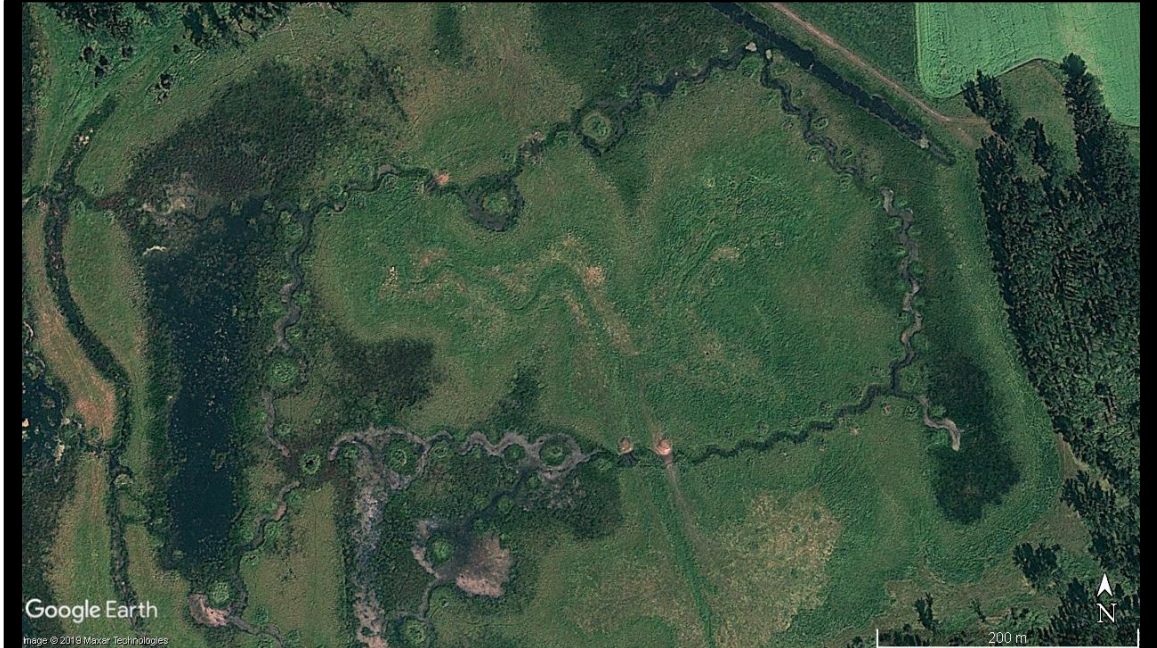
The large dark areas are natural wetlands that were drained to build an impoundment on the Lower Kootenay Band Reserve in British Columbia, Canada. The squiggled lines are ditches dug between the natural wetlands within the impoundment. These so-called “level” ditches drained most of the water from the natural wetlands. The impoundment only contains water while water is being pumped into it from the Kootenay River. This is because the dams and the impoundment basin were built on a layer of sand.

There are three main reasons why the ditches dug within the impoundment have drained the natural wetlands; 1) Each natural wetland is found on a slope, 2) The ditches were dug to cut through the natural rim of each wetland,, 3) The main dam constructed for the impoundment does not hold water.

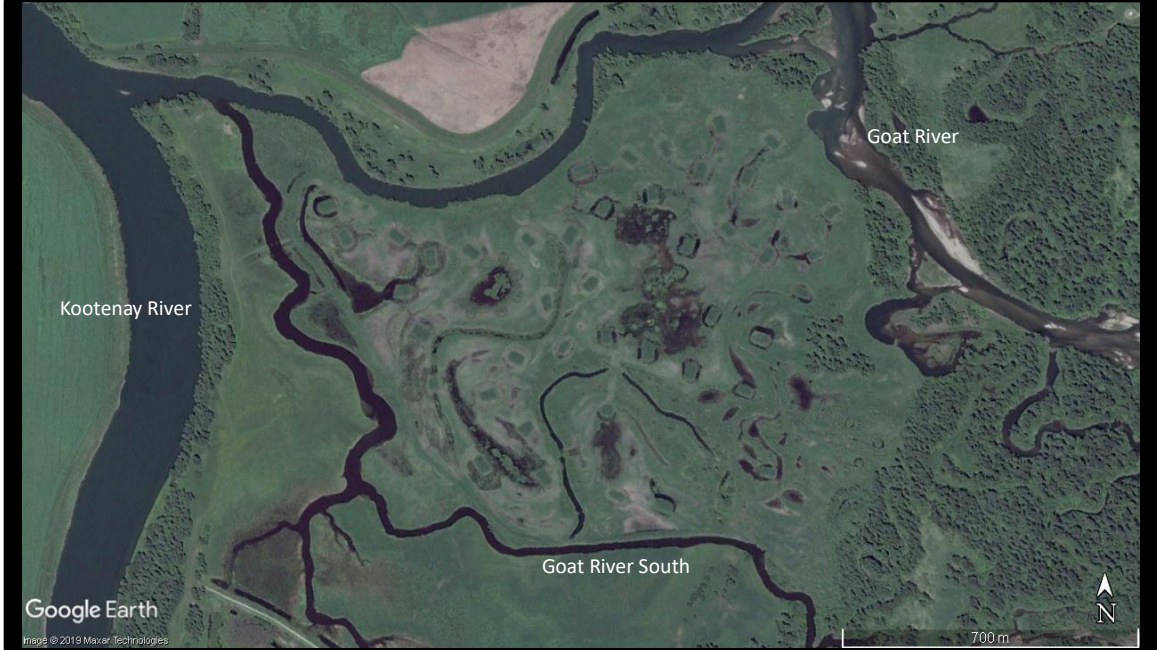
This aerial photo taken in 2016 shows the Yaqan Nukiy Hunting Grounds. The land is part of the Lower Kootenay Band Reserve, located near Creston, British Columbia, Canada. The Hunting Grounds encompasses approximately 210-hectares (519-acres) of floodplain along the Kootenay River, Goat River, and Goat River South. The Hunting Grounds is of great traditional importance to the Yaqan Nukiy. All of the natural wetlands that were historically present on the Hunting Grounds were drained by Ducks Unlimited Canada when one large impoundment was constructed.

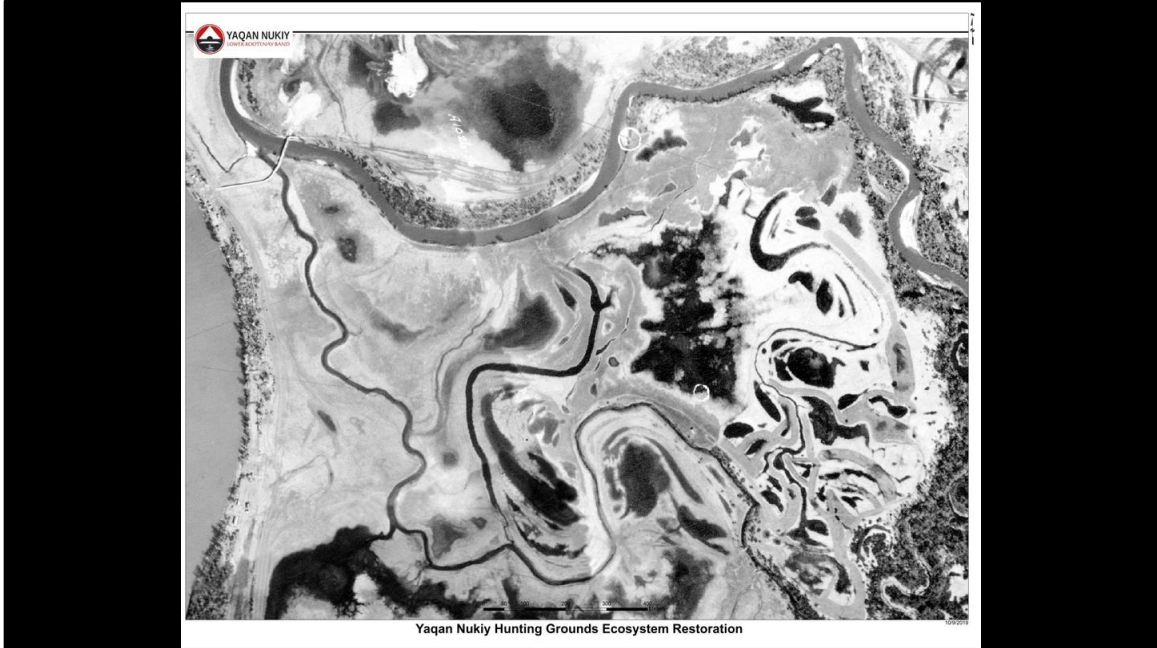
This image shows the Hunting Grounds as it appeared in 1929. Norm Allard, Community Planner for the Yaqan Nukiy, prepared this image by joining 4-separate aerial photos, that he also georeferenced. The black colored areas are deep water, the gray color is shallow water wetlands. The author used the Avenza Maps app to open the image in the field on his cell phone. This image also shows ditches that were dug to drain wetlands prior to 1929. The app and image were of great value in identifying the locations of wetlands, streams, and rivers that had been drained since 1929. The image and Avenza app were used to guide the marking of every wetland area, stream, and river to be restored using heavy equipment. The image was also of critical importance in guiding where soil should be spread, so that soil would not be placed in wetlands that had been historically drained.

Here the dozer is spreading the soil removed from the dam in thin layers. The 1929 aerial photo image prepared by Norm Allard was used to show heavy equipment operators where soil could be spread. The importance of directing where soil is spread cannot be overemphasized. Heavy equipment operators are trained to spread soil in low areas. We found that all of the low areas used to be wetlands.

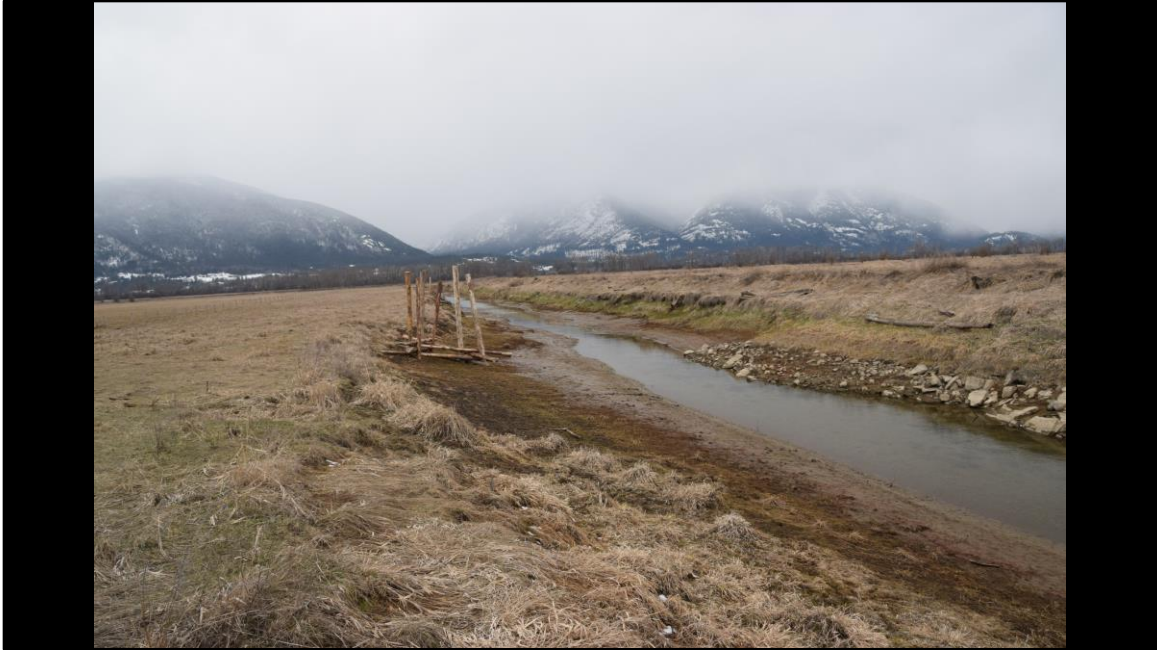
Ducks Unlimited Canada dug this deep ditch to cut off a natural loop in the Goat River South to build the impoundment dam. The ditch intercepted a subsurface permeable layer so it also drained over 200-acres of natural wetlands adjacent to the Hunting Grounds. Broken concrete slabs were placed along the banks of the ditch to control erosion. Prior to the restoration of wetlands and streams within the Hunting Grounds people were not aware that the Goat River South was flowing in a constructed ditch.

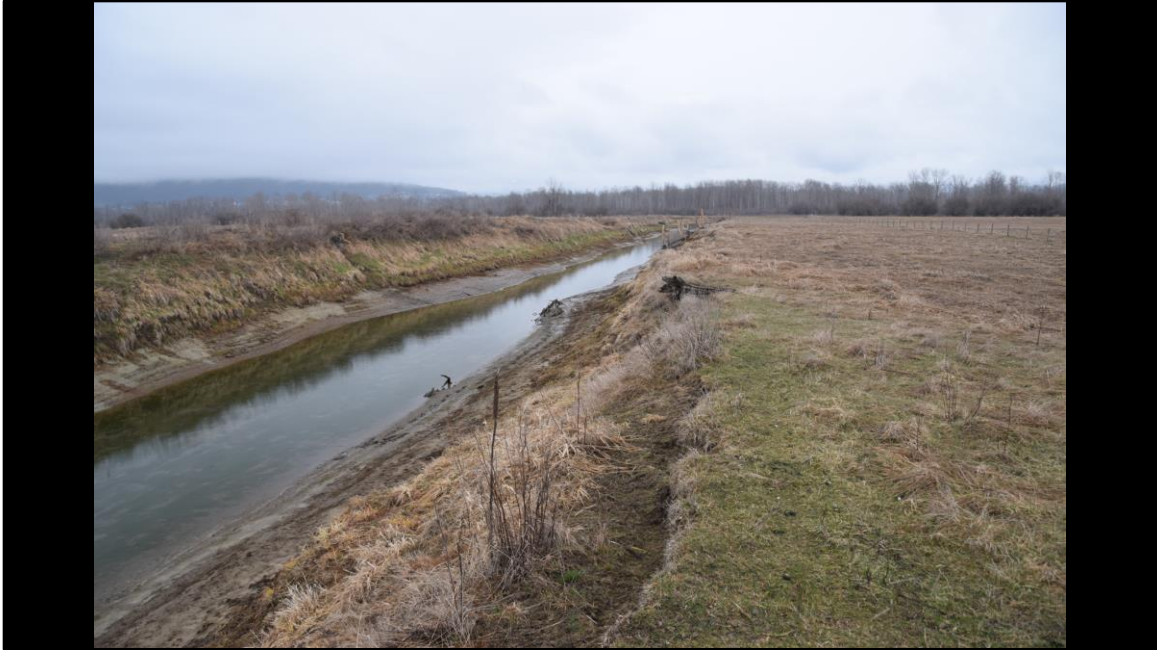
This photo shows a diverted section of the Goat River South that was turned into a deep drainage ditch as part of impoundment construction on the Hunting Grounds. This ditch was dug through the center of major natural wetlands and streams, draining an estimated 200-acres of wetlands. The author has seen where numerous other rivers and streams were diverted to construct similar impoundments across North America. Engineers and Biologists with Ducks Unlimited Canada believed that the constructed impoundments would provide better habitat for ducks than the diversity of natural wetlands on the Hunting Grounds.

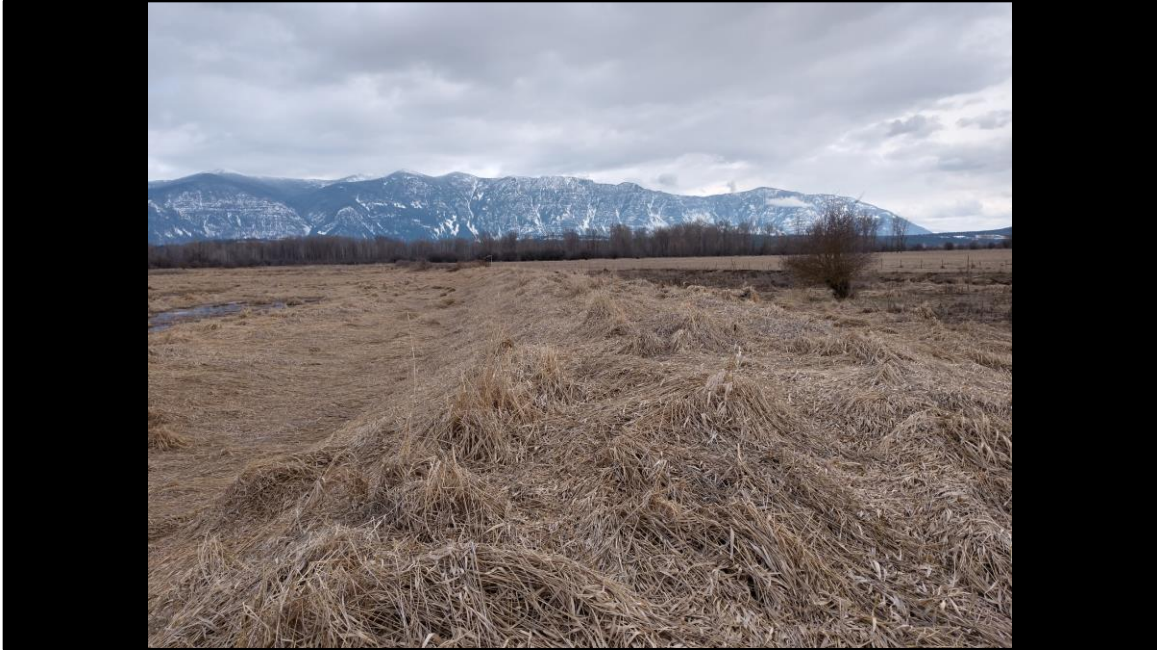
This photo shows the longest dam that was built for the Hunting Grounds impoundment. The dams averaged 1.7-meters high. The dam did not hold water as planned because it was built on a permeable foundation of sand and organic soils. Here are some possible reasons the dam was built:

- Prevent the Goat River and Goat River South from flooding the Hunting Grounds.
- Hold water pumped into the impoundment from the Kootenay River
- Dry large areas for farming.
- Reduce the possibility of duck nests being flooded.

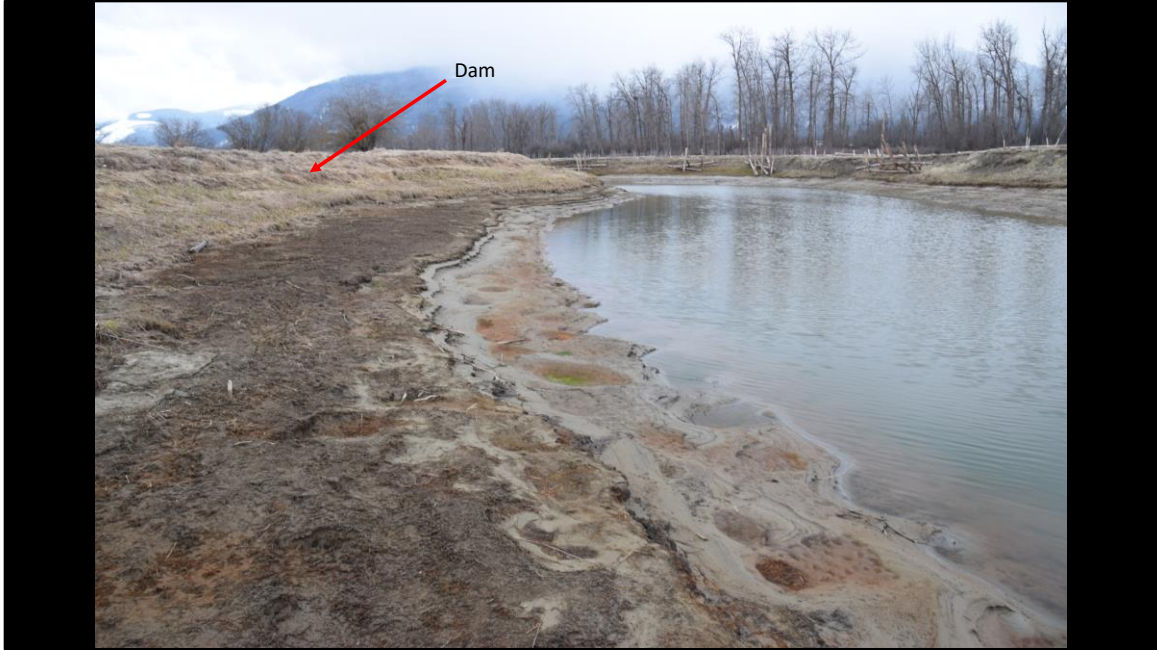
The red arrow points to a section of dam built for the Hunting Grounds Impoundment along the moved and channeled Goat River South. Upon close examination we observed water flowing under the dam and into the ditched Goat River South via a thick layer of sand.

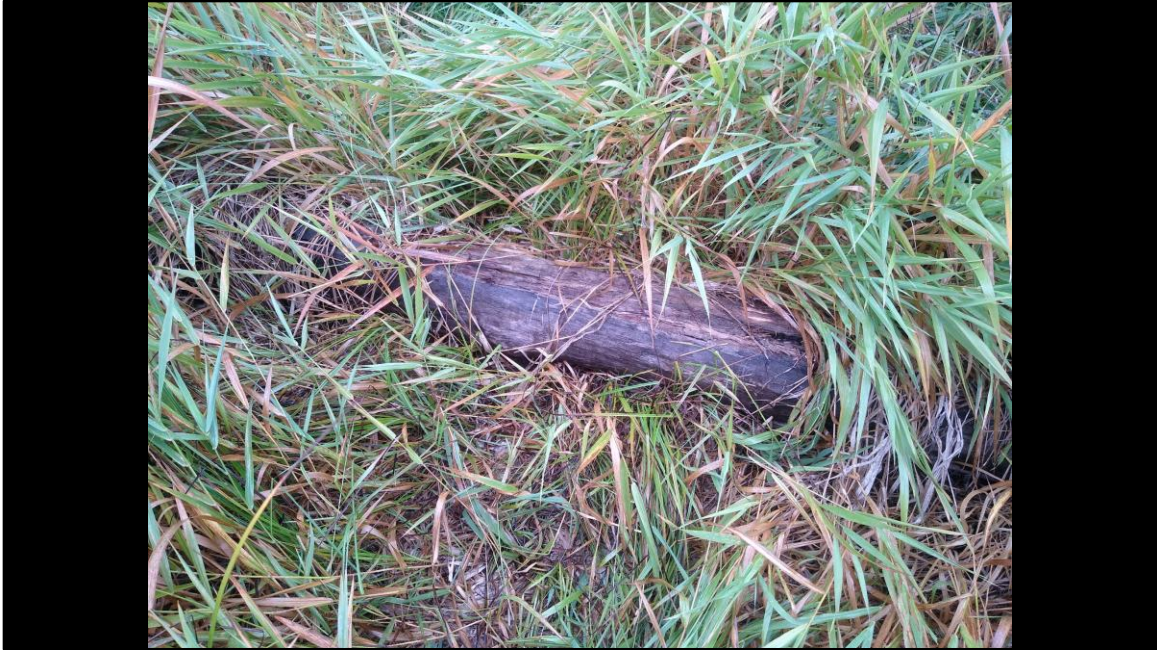
Large woody debris was no longer be deposited on the Hunting Grounds following construction of the large impoundment. This is one of the few logs remaining on the Hunting Grounds after 40-years of artificial flood control caused by the construction of the impoundment dam. The annual addition of wood to natural wetlands on floodplains is of critical importance to turtles for basking, waterfowl for loafing, and fish for hiding.

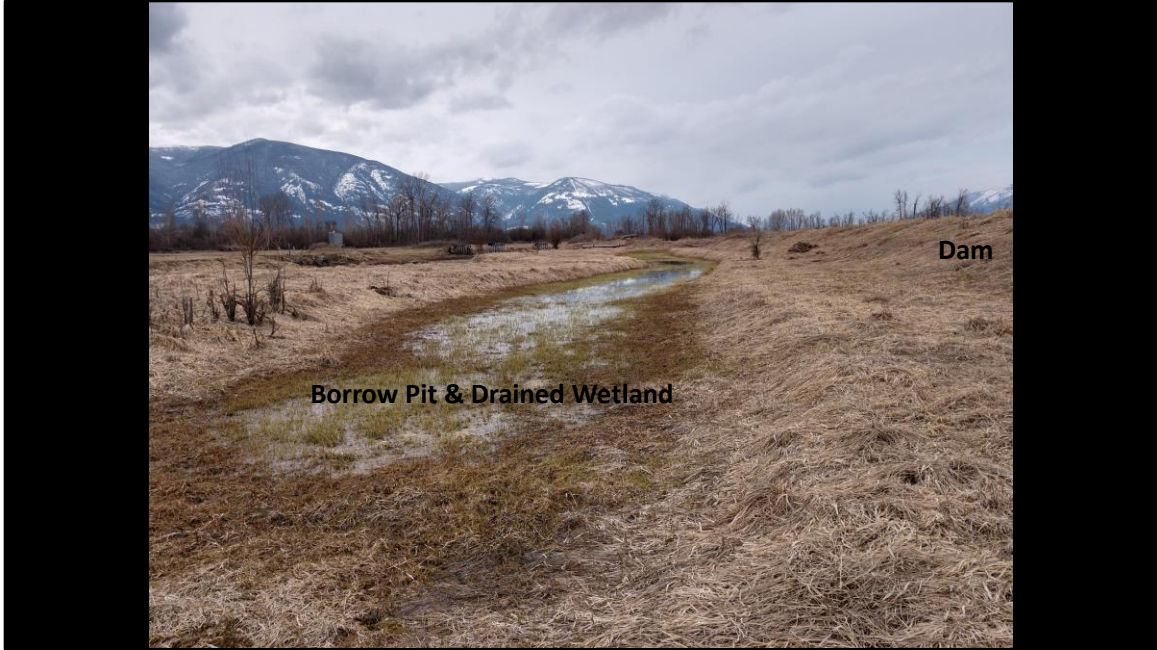
The only places holding water within and near the Hunting Grounds following construction of the impoundment were the deep and narrow borrow pits dug in the natural wetlands that had been drained with ditches. The borrow pits had exposed the groundwater in the drained wetlands.

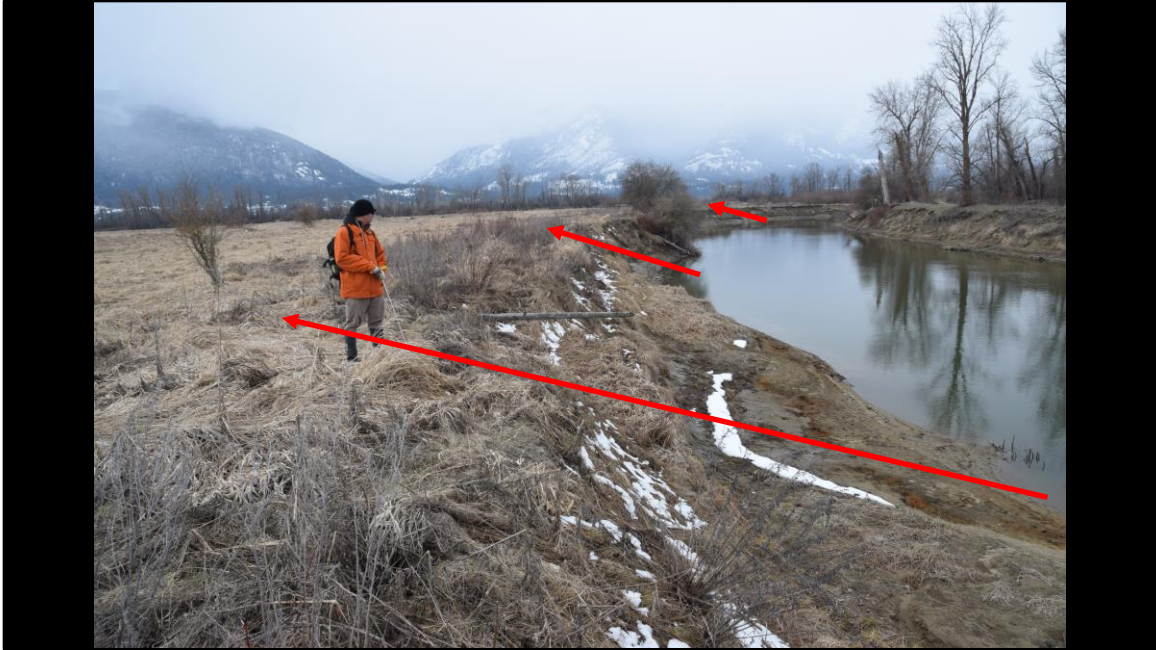
Norman Allard Jr., Community Planner with the Lower Kootenay Band, stands on a section of dam built to prevent floodwaters from the Goat River from entering the Hunting Grounds impoundment. Norm is standing within a historic inlet where floodwaters from the Goat River once flowed naturally onto the Hunting Grounds. Inlets often occur in outside bends of a river. The presence of eroding banks and large woody debris deposited are also signs of an inlet. The red arrows show the location of three inlets along the Goat River, all had been blocked by the construction of the impoundment dam.

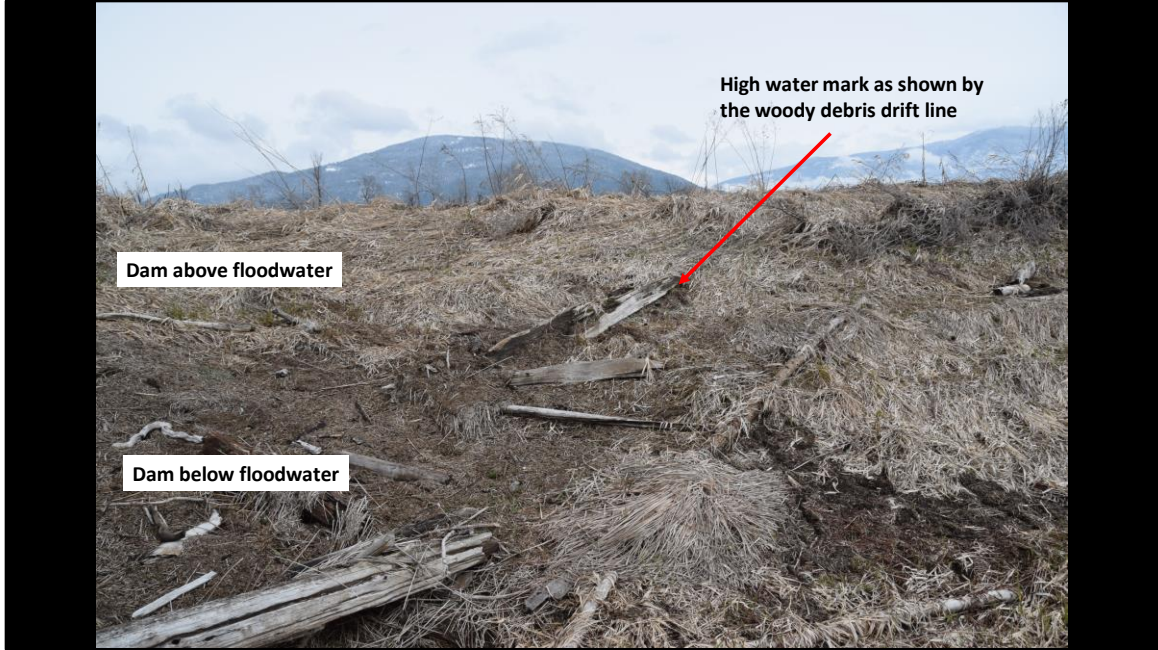
This photo shows the river side of a dam constructed for the impoundment. The photo was taken while standing on the edge of the Goat River South, looking into the Hunting Grounds. The high- water mark from the Goat River South can be seen by the drift line of wood and fine organics (red arrow). The impoundment dam prevented floodwaters woody debris, and fish from entering the Hunting Grounds. The elevation of the drift line served as an important guide in removing the dam. Floodwaters and woody debris may again enter the Hunting Grounds if the dam was lowered to an elevation below the high-water mark as shown by the woody debris.

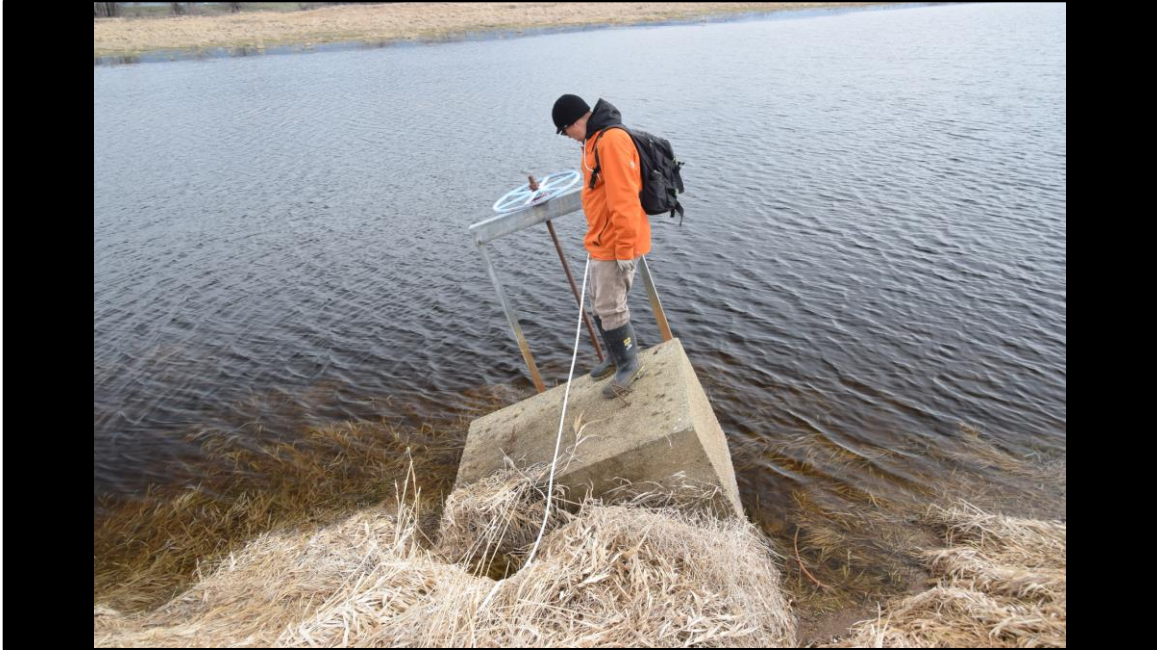
This water control structure installed for the Hunting Grounds Impoundment was no longer functioning, having been damaged by ice. The water control structure was installed so that water could be removed in the Spring for farming and closed to contain water pumped into the impoundment for duck hunting. The structure was installed in an natural outlet for the Hunting Grounds Floodplain that had been deepened into a ditch so that the entire Hunting Grounds could be drained in the spring for moist soil management.

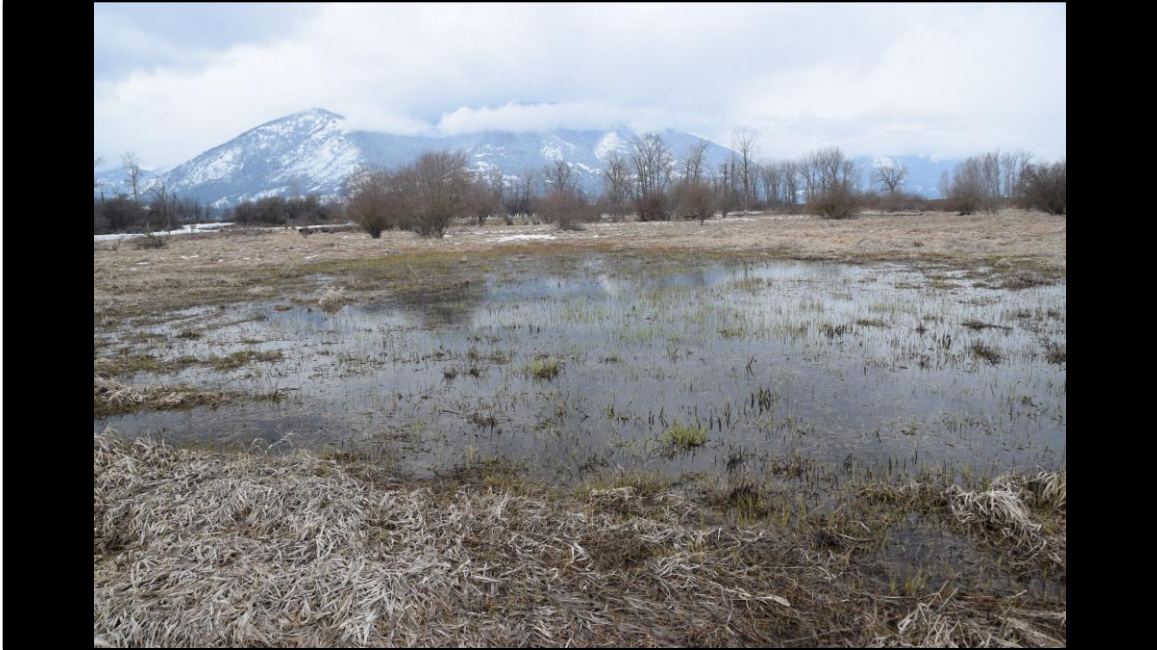
Here's a natural ephemeral wetland near the Hunting Grounds that was not drained. This wetland was located outside of the impoundment. Note the willows growing on higher ground around the edge of the natural wetland. All of the natural wetlands within the Hunting Grounds impoundment were drained using ditches, and then filled with soil.

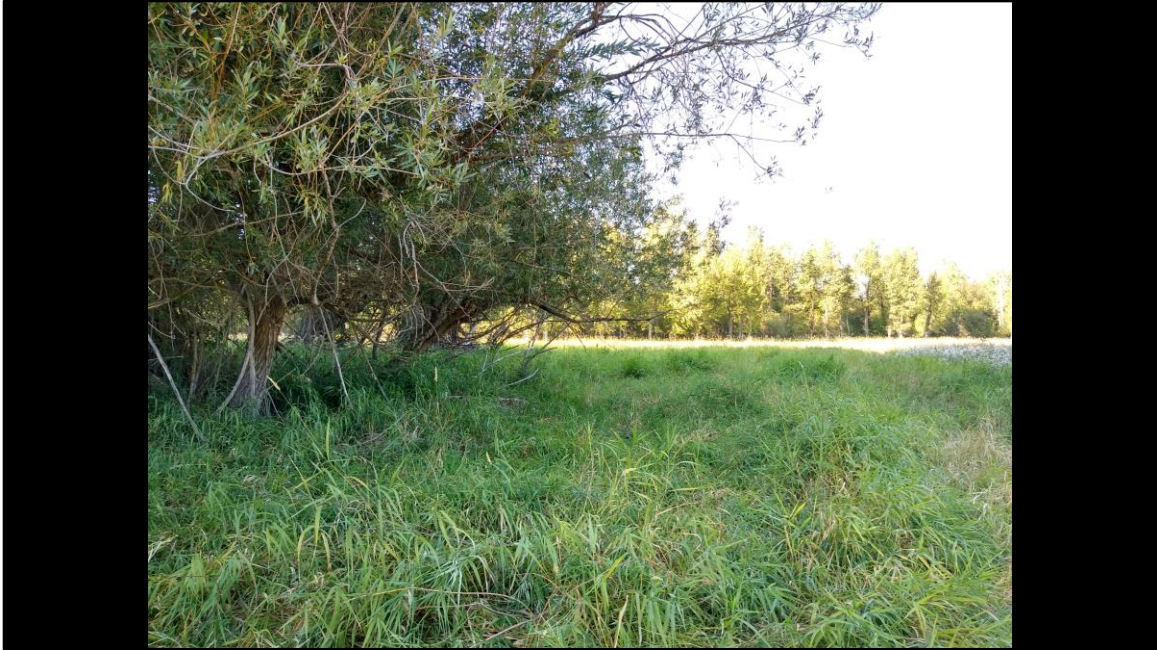
This photo shows one of many natural wetlands drained when the Hunting Grounds impoundment was built. Willows surrounding dry basins that are now dominated by reed canary grass show where natural wetland were drained when the impoundment was built.

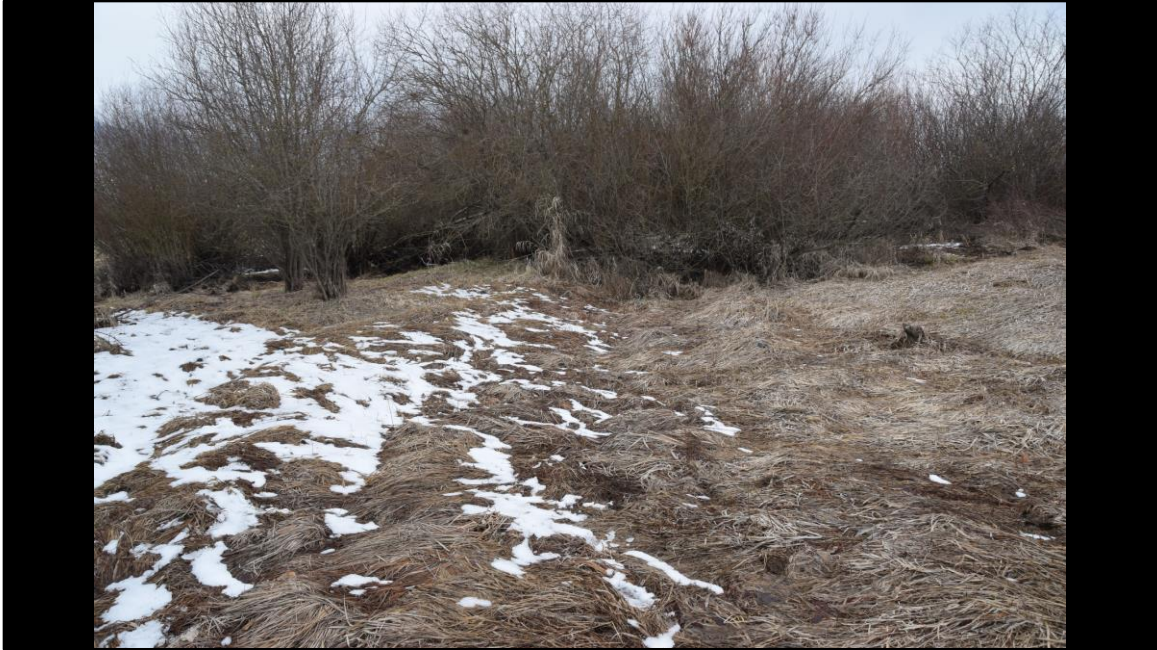
This photo shows a ditch dug to drain a natural wetland within the Hunting Grounds prior to 1929.

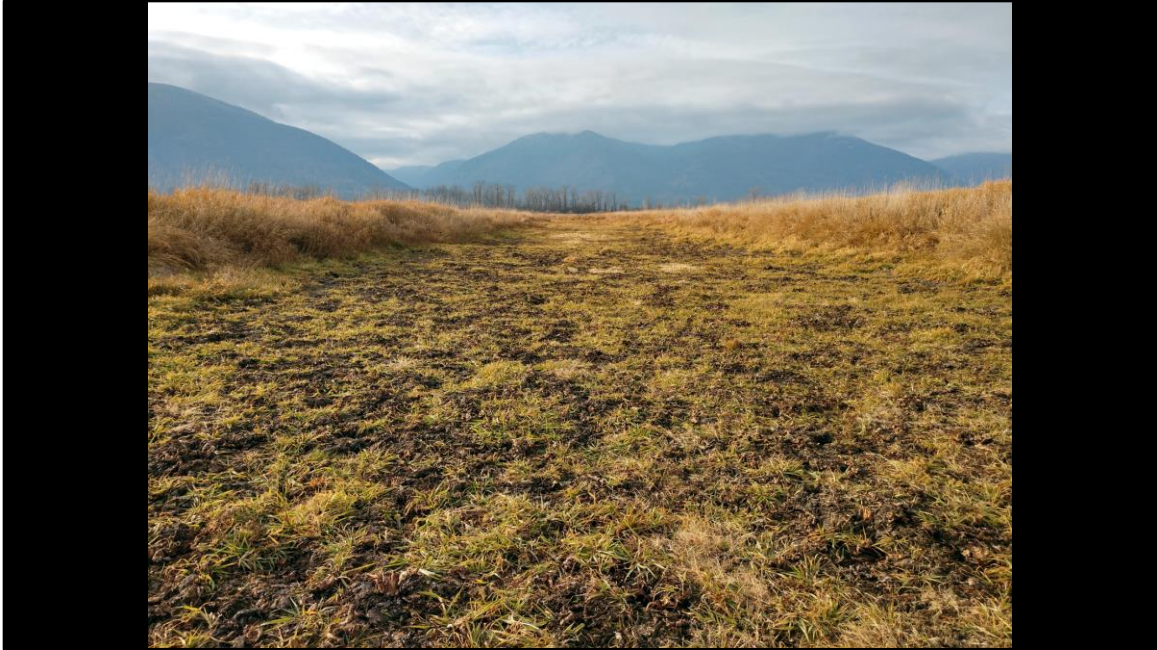
This photo shows a historic river channel on the Hunting Grounds. Note its wide width and low banks. These river channels were dried when the impoundment was built.

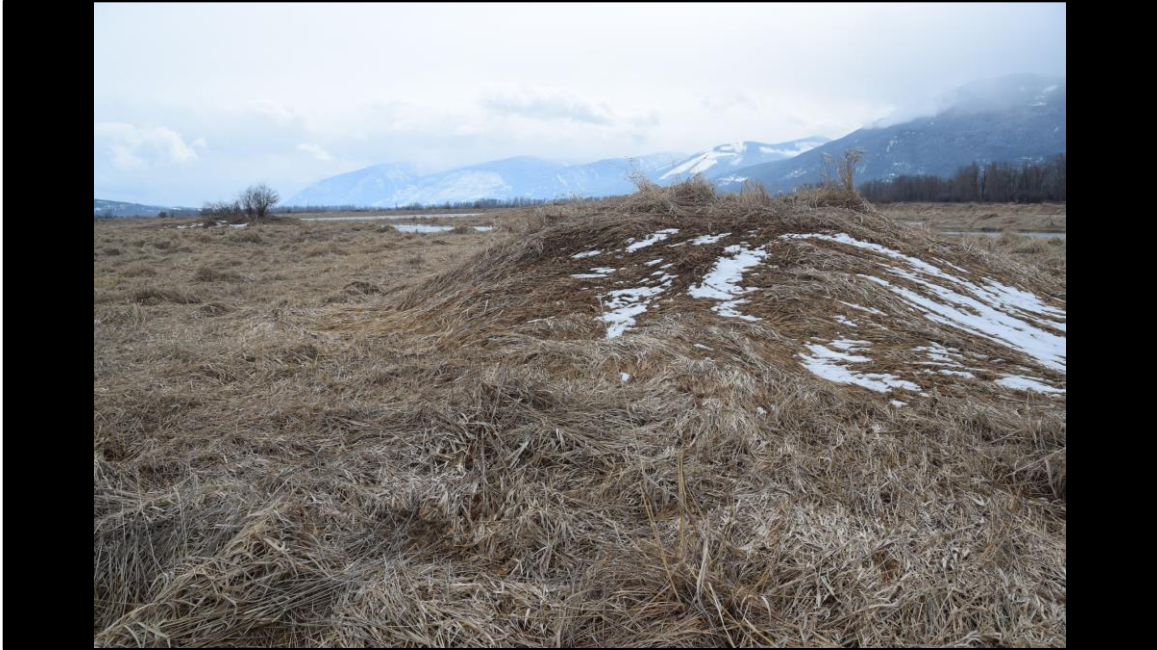
This photo shows one of many piles of soil shaped in the Hunting Grounds impoundment. We've been told these were built to provide waterfowl with islands for nesting. The piles were not used for nesting because the impoundment did not hold water as planned.
