**RESTORATION OF WETLANDS AND STREAMS FROM CONSTRUCTED  
IMPOUNDMENTS**  
Thomas R. Biebighauser

This presentation focuses on how wetlands, streams, and rivers are being restored from constructed impoundments on the Yaqan Nukiy Hunting Grounds near Creston, British Columbia, Canada. The project is receiving major funding from the Columbia Basin Trust, Fish and Wildlife Compensation Program, and the Aboriginal Fund for Species at Risk. The project is a partnership program involving the Yaqan Nukiy First Nations and the British Columbia Wildlife Federation. You'll see why after constructing over 1,400 dams, Tom Biebighauser now works to remove them.

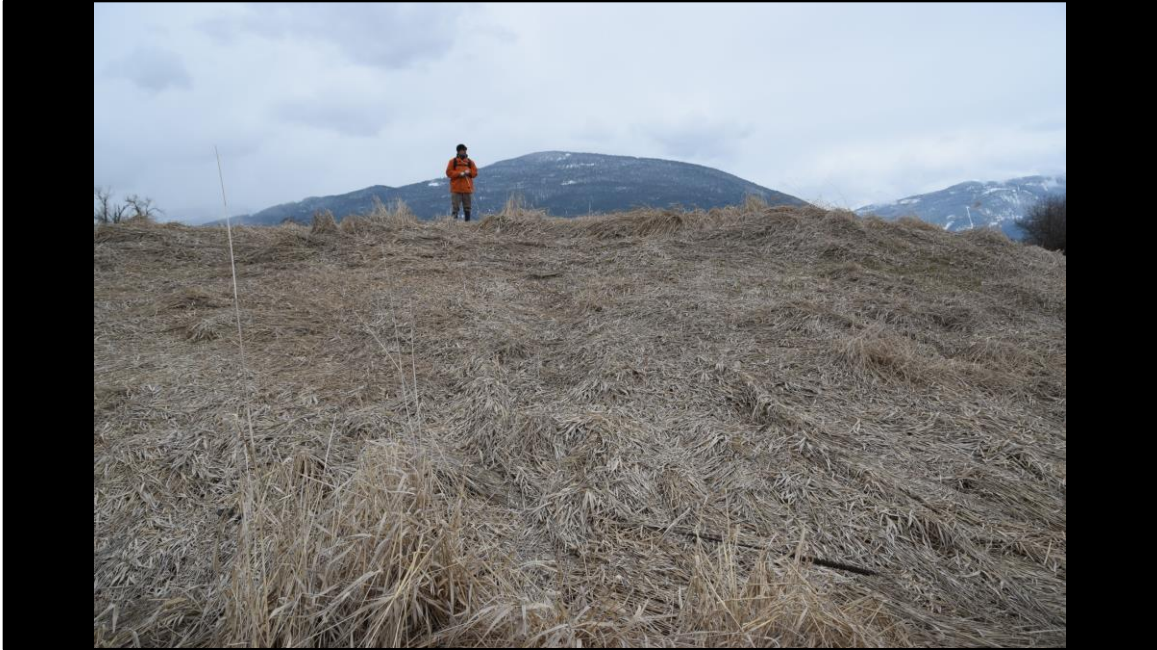
The piles of soil or “nesting islands” were huge. By walking around examining the area we discovered that the majority of the islands were built using the soil removed from digging ditches to drain natural wetlands within the impoundment. Some of the islands were built on the edges of natural wetlands that were drained while others were used to fill natural wetlands. The actions completed on the Hunting Grounds and other impoundments on the Lower Kootenay Band Reserve show there was a systematic and purposeful effort to destroy all natural wetlands and streams within the impoundment.

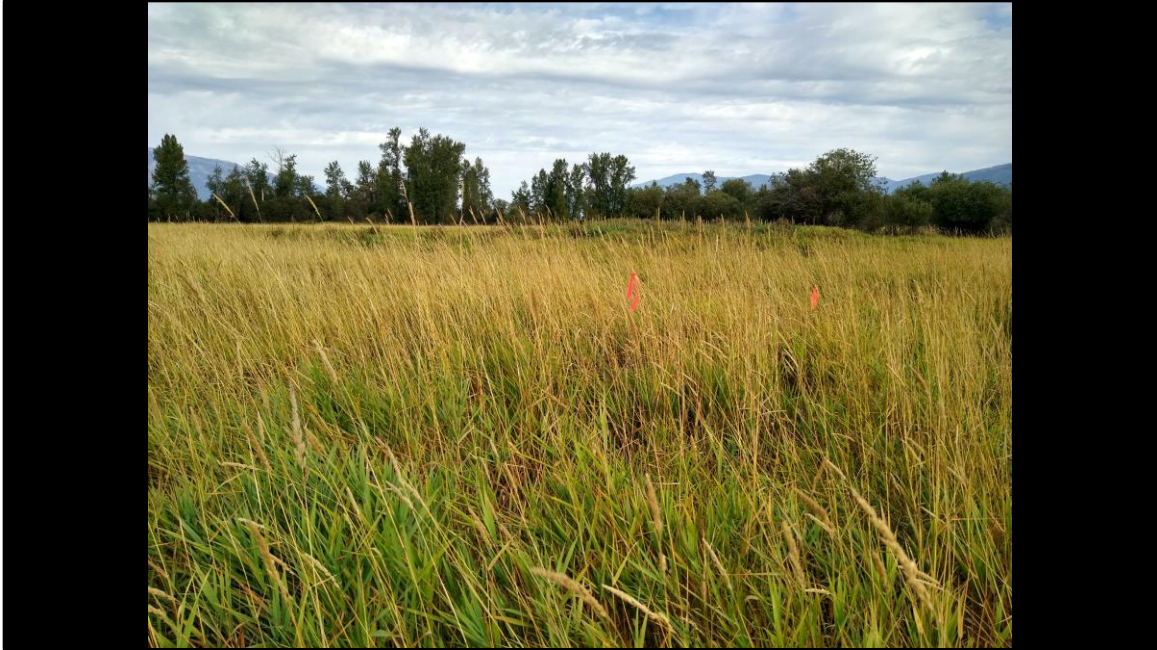
The Hunting Grounds is dominated by reed canary grass. Reed canary grass thrives in drained wetlands. We found a direct correlation between drained wetlands and dense reed canary grass.

Tall and dense growths of reed canary grass were found growing in wetlands that had been drained. Dry, shallow basins containing reed-canary grass provided strong indication of drained wetlands.

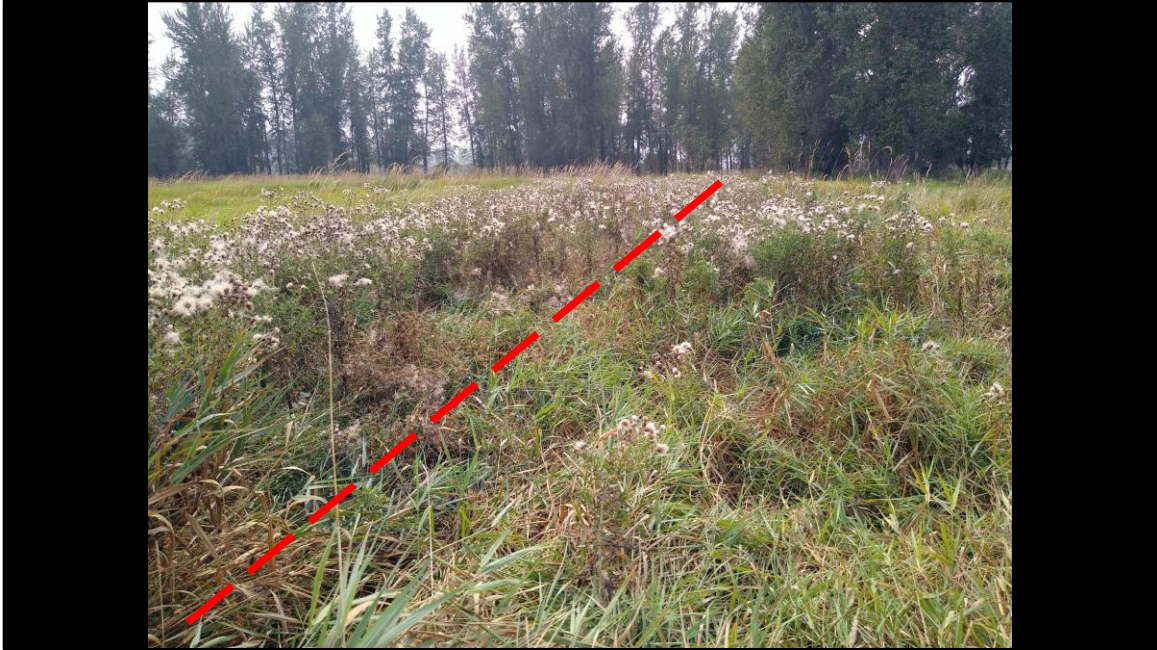
The dashed red line shows a dam that was built by Ducks Unlimited Canada to prevent the Goat River from flooding the Hunting Grounds. The dam was so wide and sloped that it was difficult to determine it had been constructed. The center of the dam is shown by the dashed red line. The Goat River was also diverted so that floodwaters would not flow over the dam constructed for the impoundment.

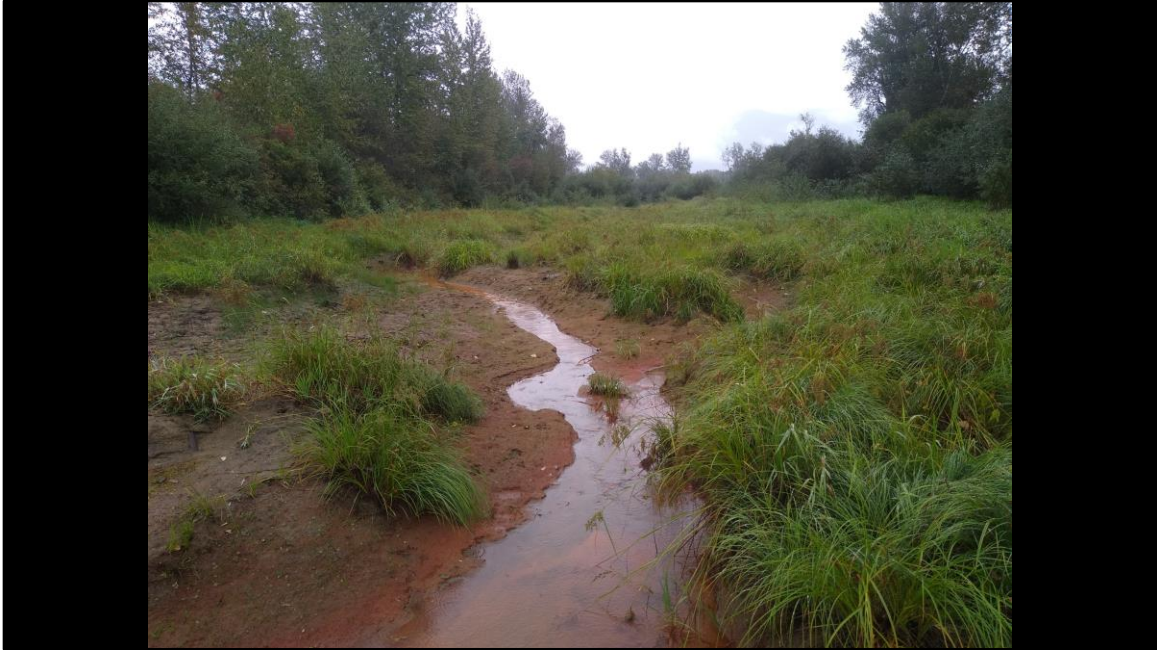
Here is a major bend in the Goat River that was cut-off when the river was diverted. The water in the channel is groundwater that is being drained from the Hunting Grounds. The natural bend in the river was cut-off to prevent the Hunting Grounds Impoundment from flooding. The moving and channeling of rivers and streams to construct impoundments is common practice across North America.

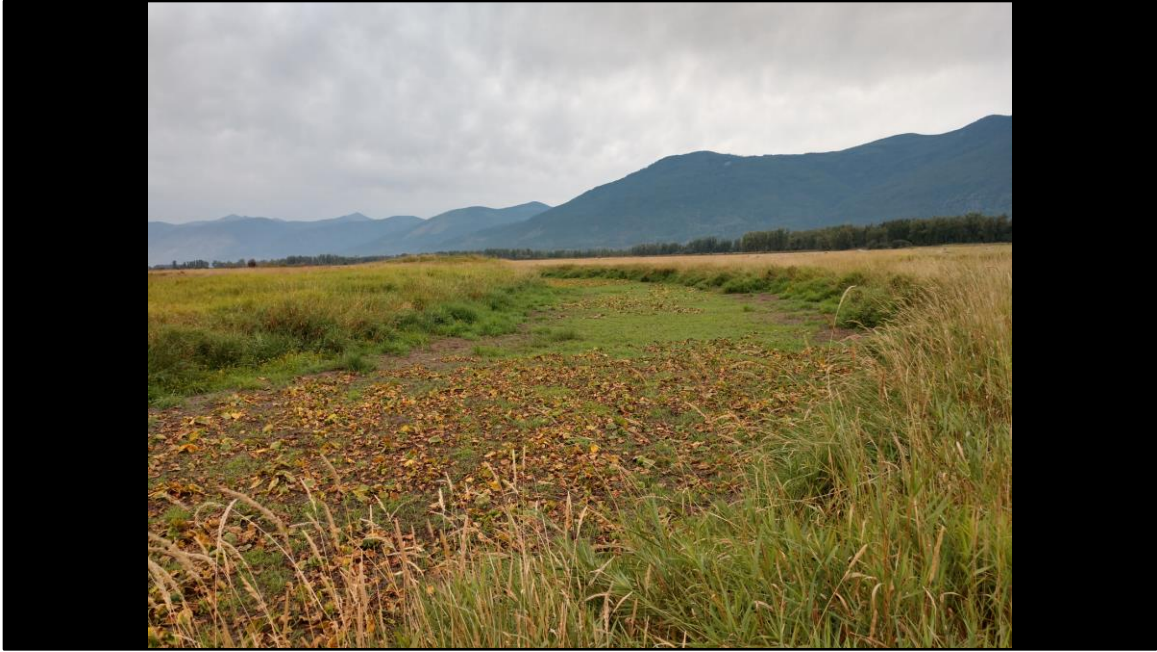
This historic river channel was cut off by the construction of the impoundment dam.

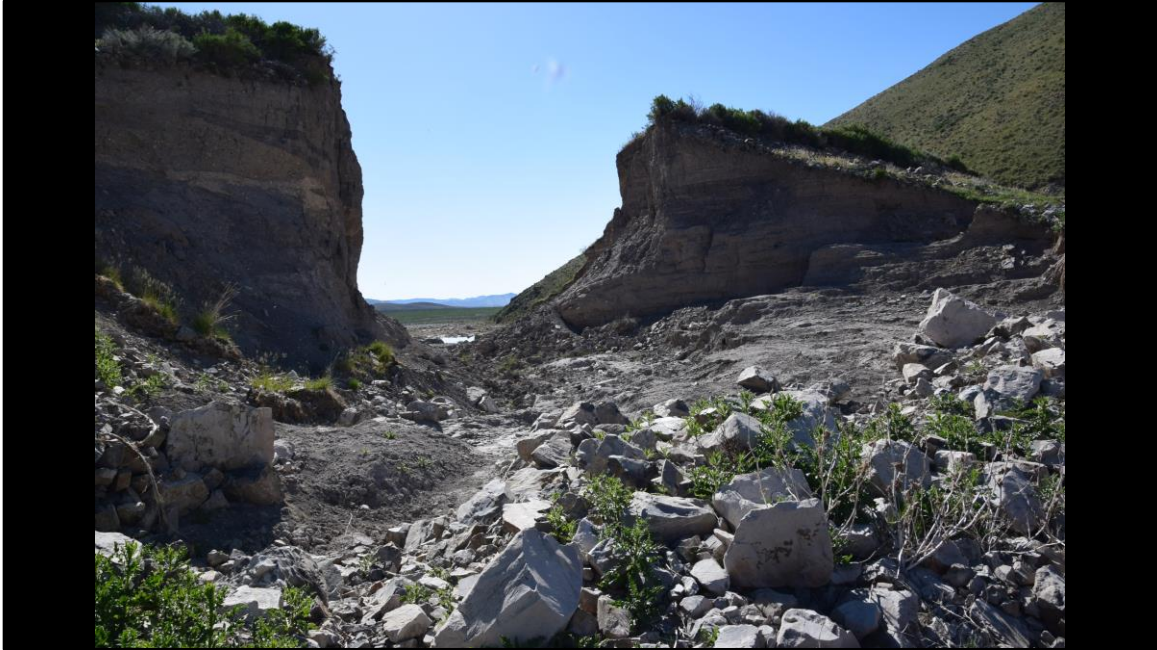
Unfortunately, many people think all you have to do to restore a floodplain is to breach a dam. They are wrong! Breaching a dam and doing nothing else to restore the floodplain triggers catastrophic erosion resulting in the drainage of wetlands and streams in the entire valley.

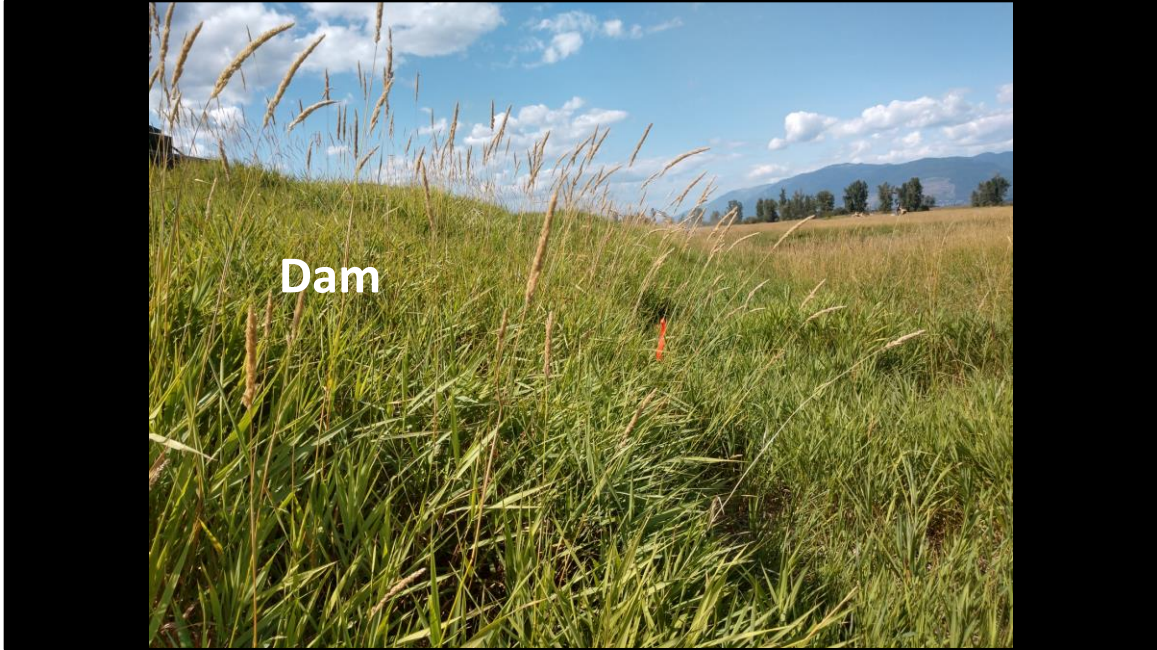
A significant accomplishment of the Hunting Grounds Project involved the removal of 1.9km of constructed dam averaging 1.7 meters high. This photo shows a section of the dam, and the inside slope of the dam. The dam and the impoundment basin were dominated by reed canary grass. Orange colored plastic flagging was used to mark the width and elevation of soil to be removed from the dam for the project. A laser level and survey rod were used to guide the placement of the orange flagging, providing a rapid and low-cost way of guiding the excavator operators in the removal of the dam.

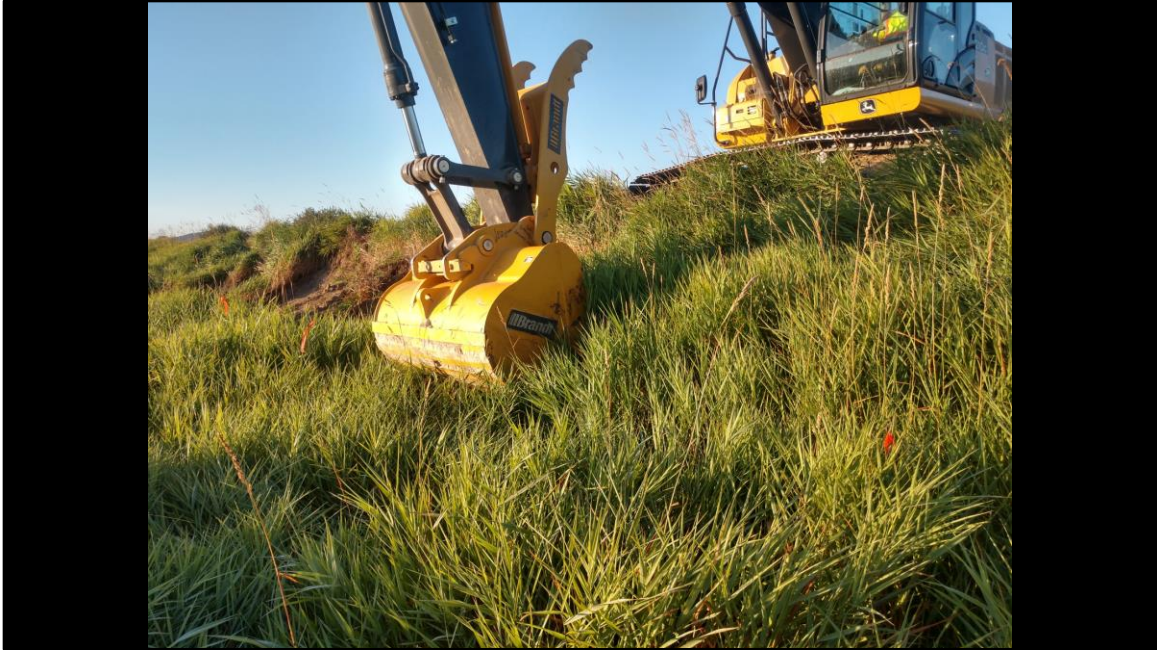
The excavator operator used the orange plastic flags as a guide to create temporary benches along the inside and outside slopes of the dam to be removed. The elevation of each bench equaled the final elevation of the dam to be removed.. The temporary benches served as a visual guide, allowing the operator to rapidly remove sections of the dam approximately 30-meters long before checking elevations using a laser level.

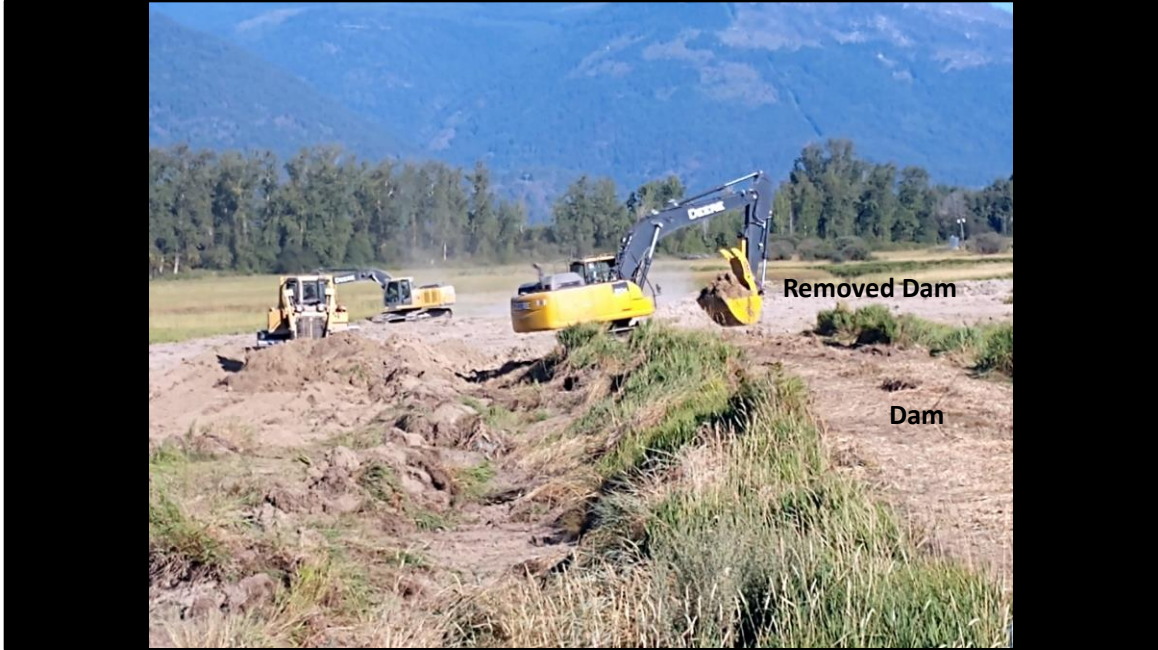
Two excavators and a dozer were used to remove the entire length of the dam to restore floodwater access to the floodplain.

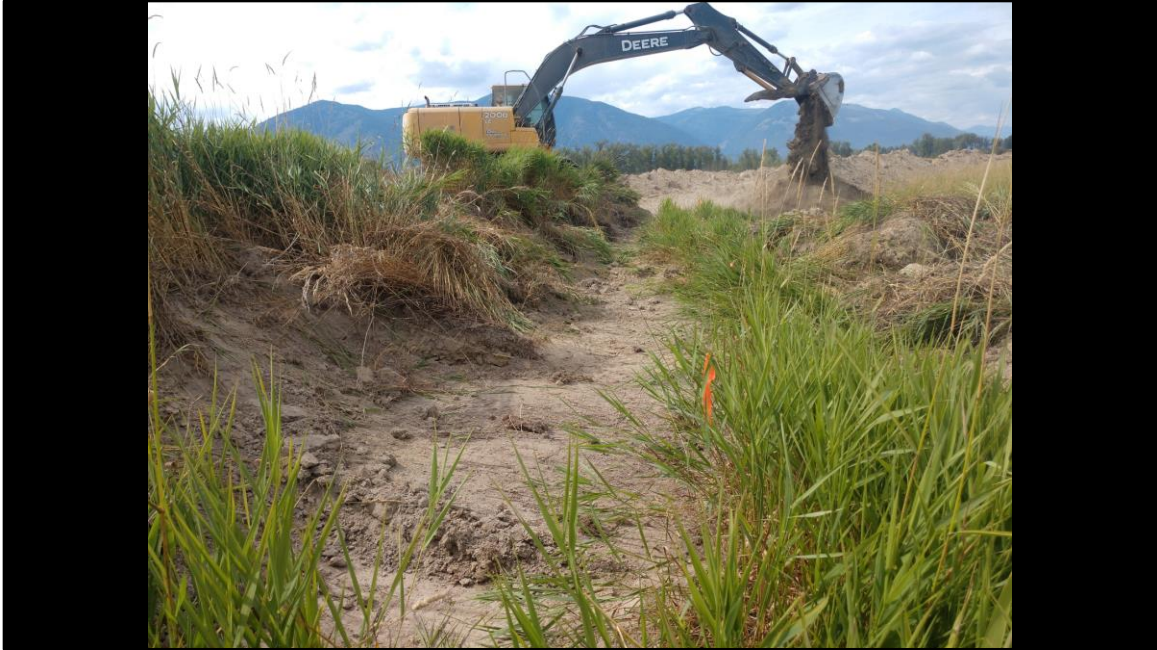
This photo shows where a section of dam is being removed. The bench was created by removing the inside slope of the dam. The orange flags were tied to reed canary grass above the desired final elevation of the dam to be removed.

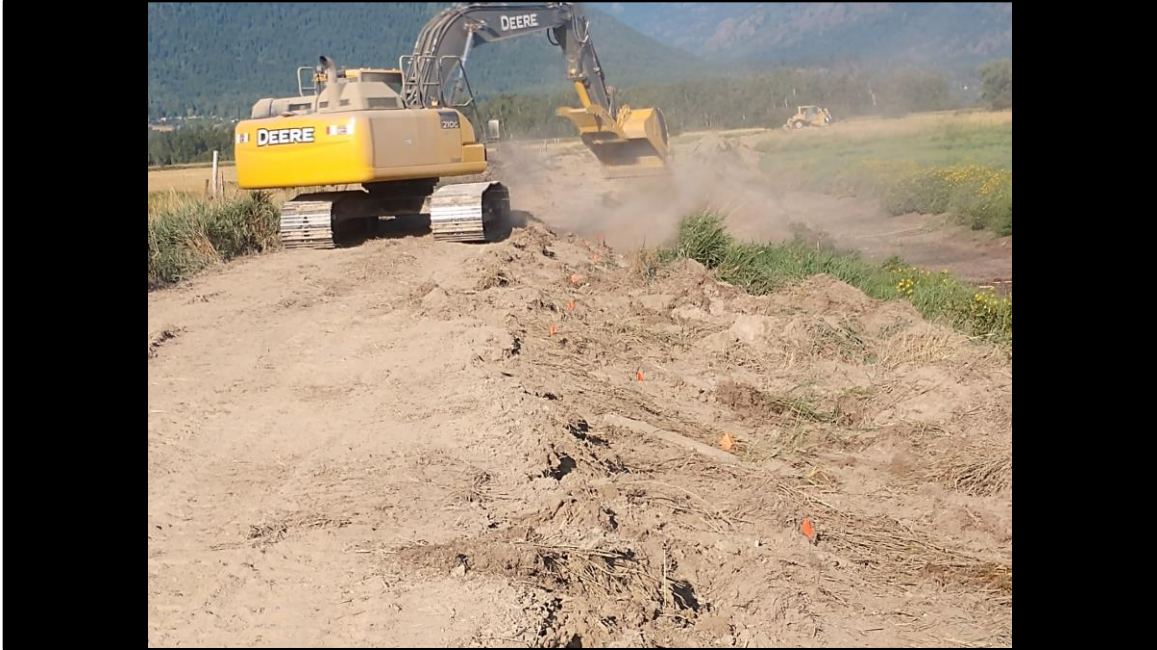
Wire flags were also placed to show the elevation of the dam to be removed.

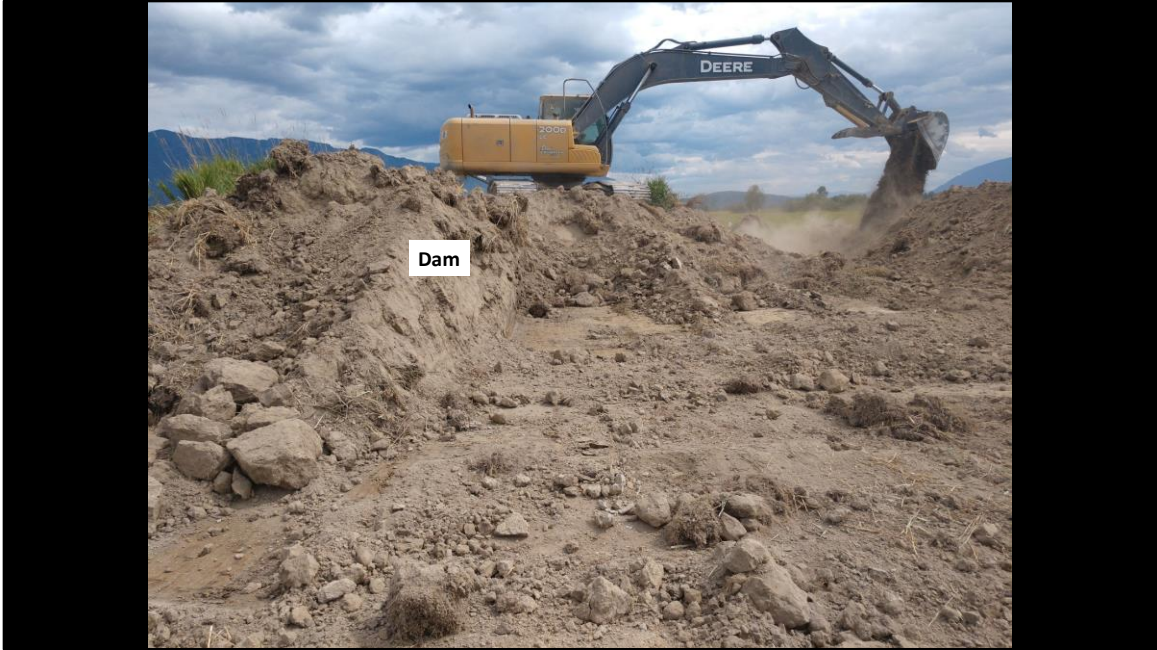
Here the excavator removes a center section of dam.

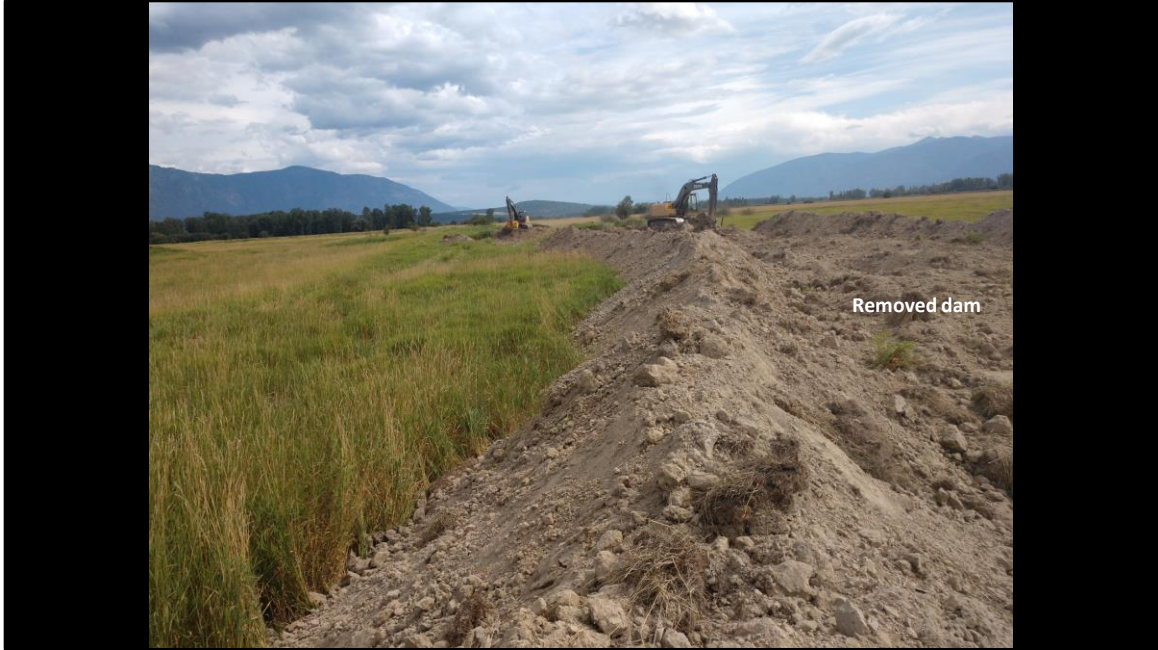
Here the soil that was in the dam has been placed in parallel ridges by the excavators. These ridges of soil will be spread by the dozer..

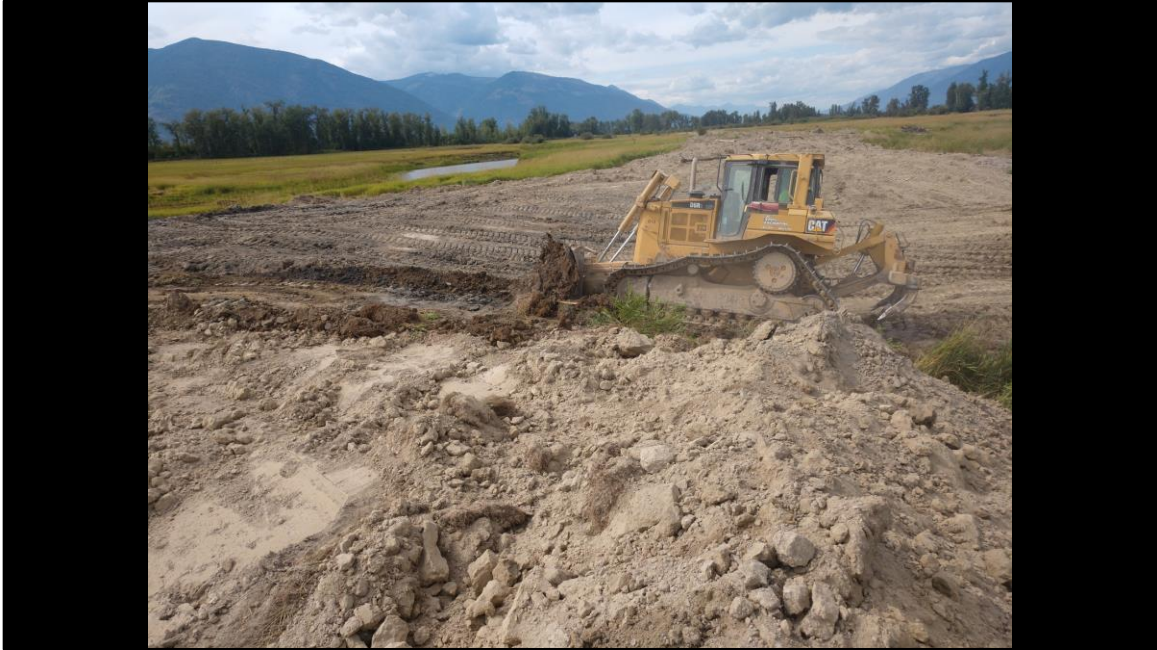
The dozer spreads the soil piled by the excavators. The dozer is doing this faster and at a lower cost compared to using dump trucks or a scraper.

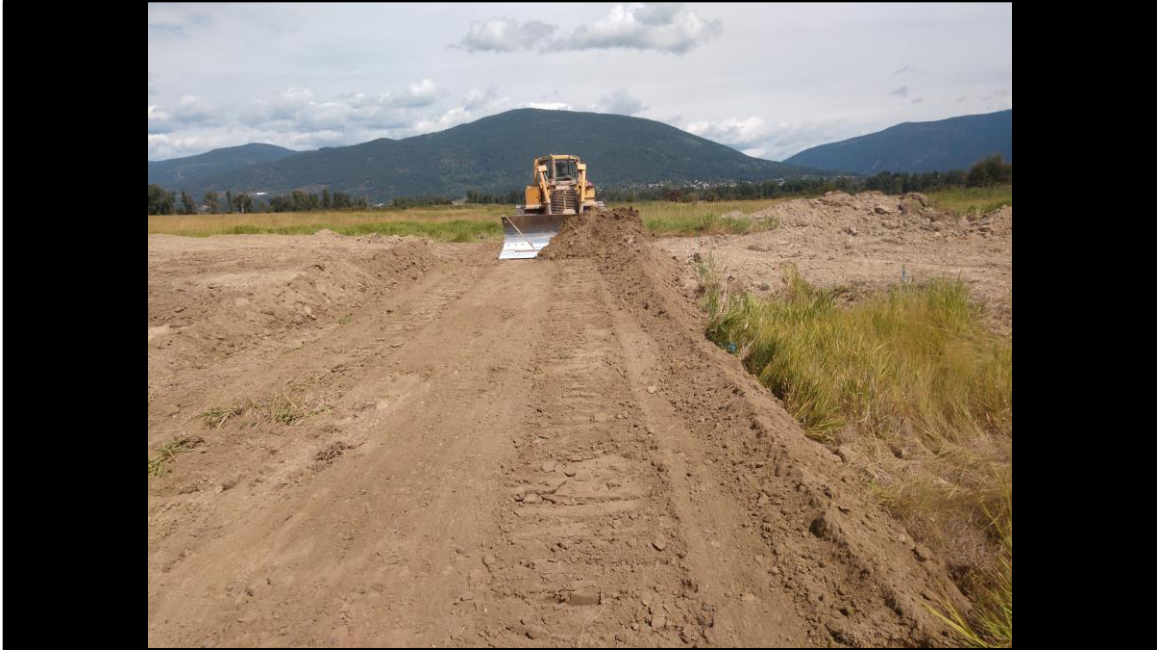
Here the dozer is spreading the soil removed from the dam in thin layers. The 1929 aerial photo image prepared by Norm Allard was used to show heavy equipment operators where soil could be spread. The importance of directing where soil is spread cannot be overemphasized. Heavy equipment operators are trained to spread soil in low areas. We found that all of the low areas used to be wetlands.

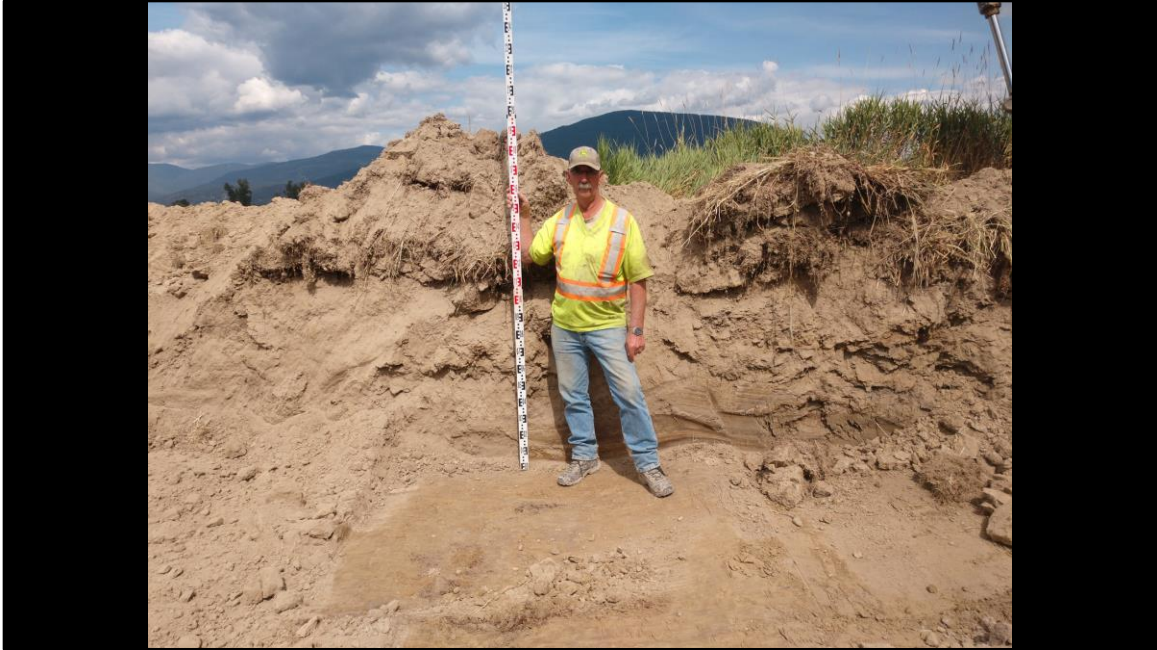
Elevations are taken regularly using a laser level as the dam is removed. This is critical as floodwaters may not enter the restored floodplain if high sections of the dam are left, and the wetlands being restored will be drained if the dam is lowered too much.

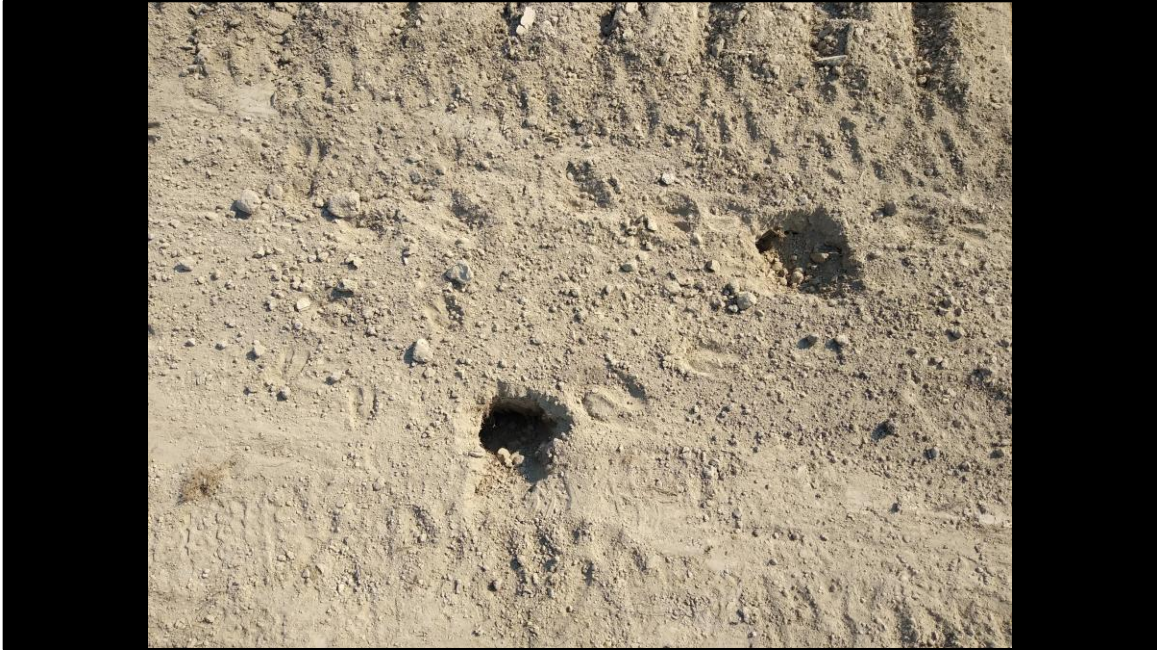
Here is a partially removed dam showing some of the many holes found in the dam.

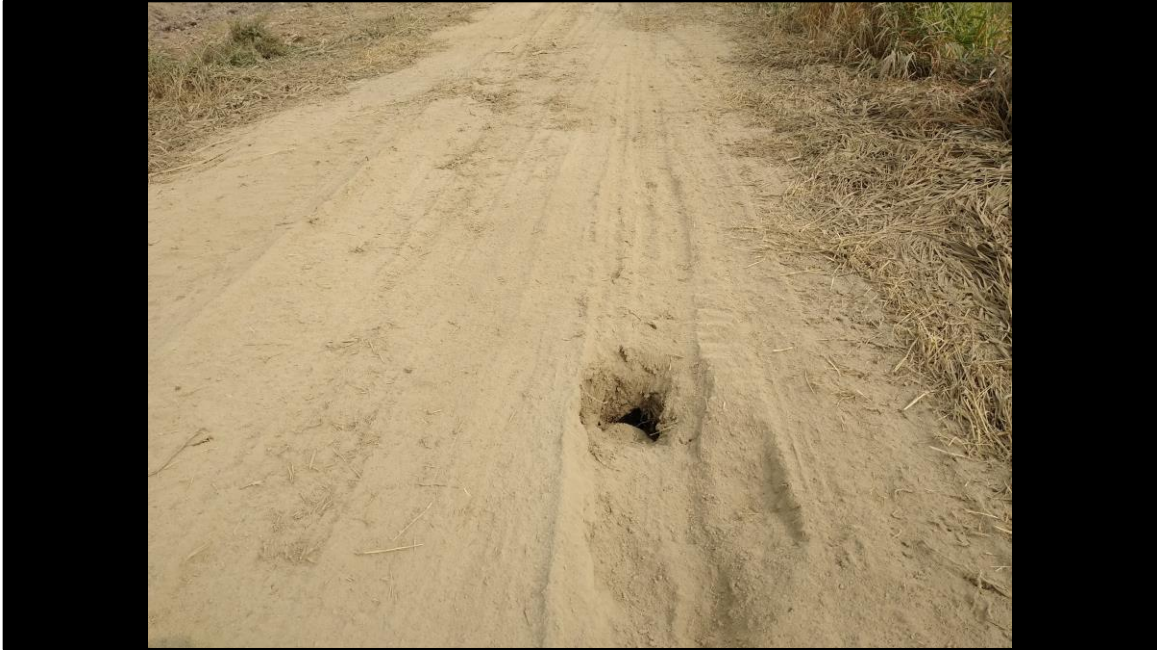
Muskrat burrows were found along the length of the dam that was removed. These burrows were difficult to find and prevented the dams from holding water.

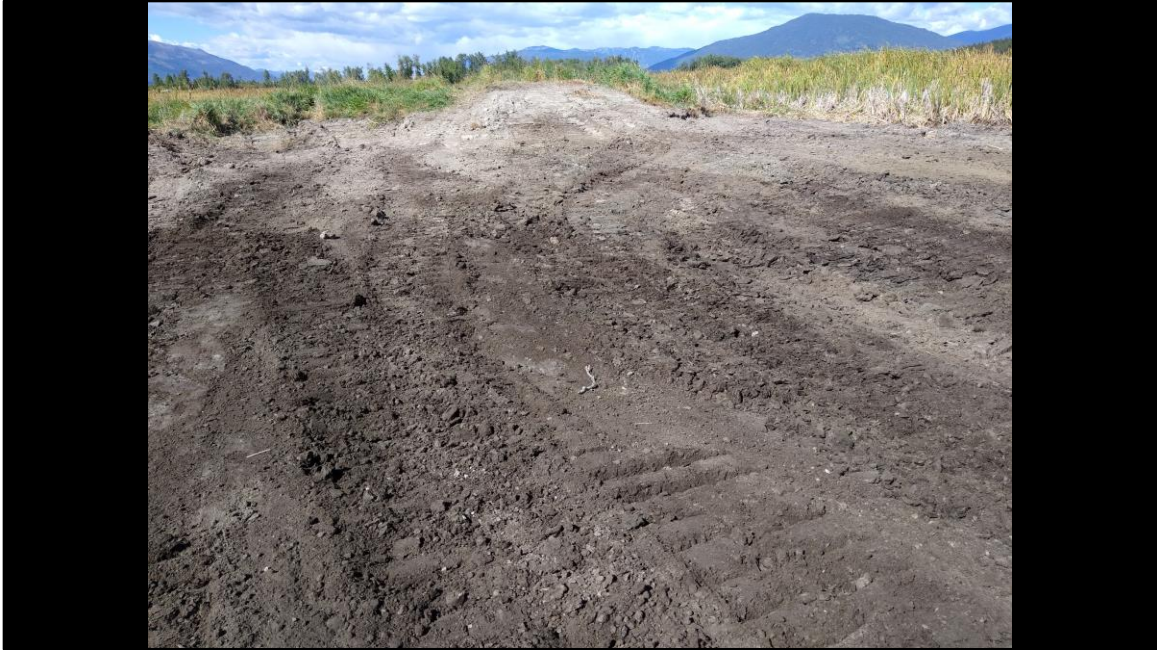
This photo shows the foundation of the dam after a section was removed. The dam was built on a thick layer of organic soil. Water was leaking under the dam through this organic layer. The engineering drawings showed that the dam was to be built on a foundation of clay. Many of the dams removed by the author to date have been built on foundations of permeable sand, and organic soils. It would have been very expensive for the contractor to build the dams as designed by the engineer.

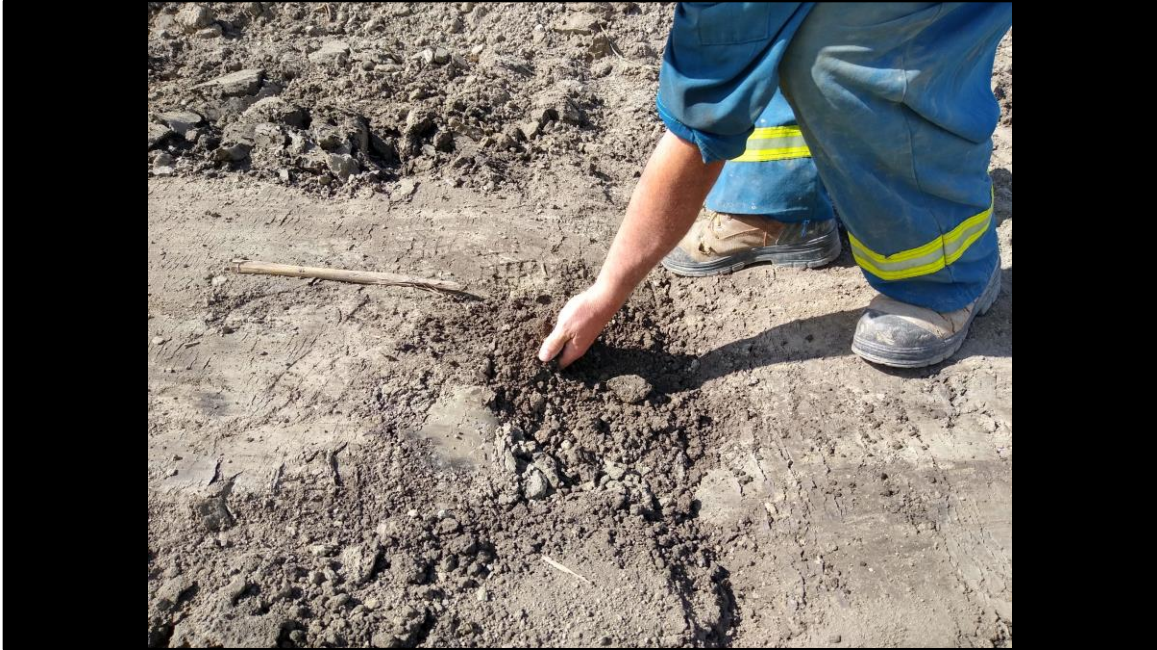
The impoundment dam was built of a mixture of topsoil, silt, silty clay, and sand that was permeable. The hand shows topsoil in the dam being removed. Water leaks through dams unless they are made from soil high in clay that is compacted in layers under suitable moisture content.

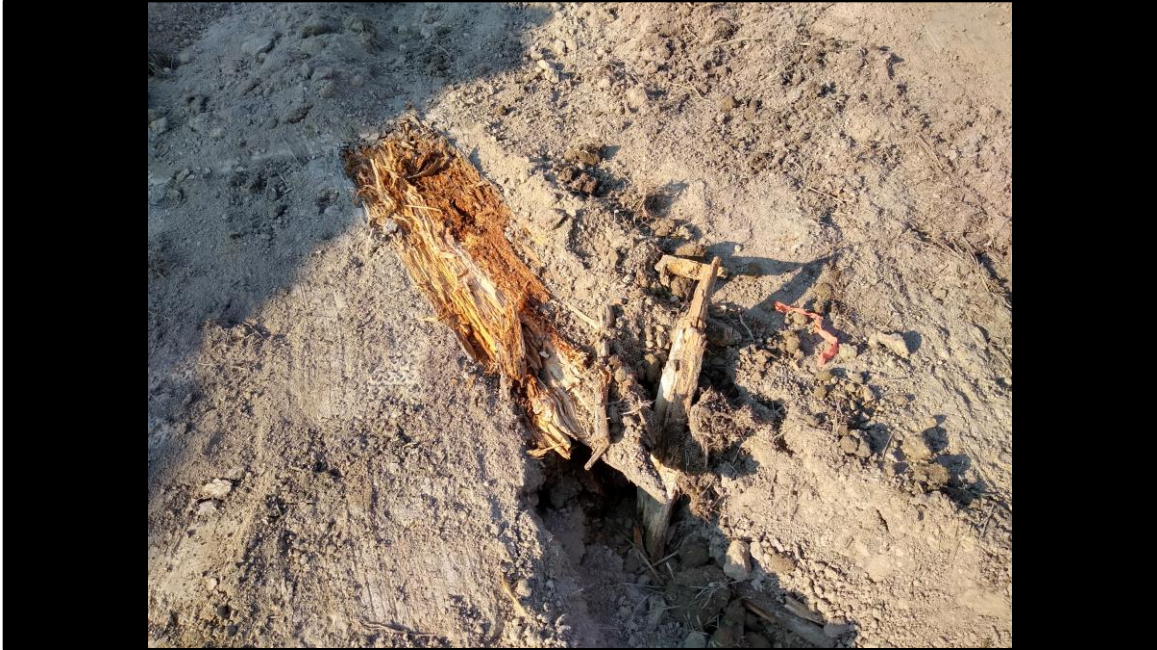
Trees like the one shown were found under the dam, also explaining why the impoundment did not hold water. The author has observed that most dams built for impoundments fail to contain water because they are constructed over permeable substrates.

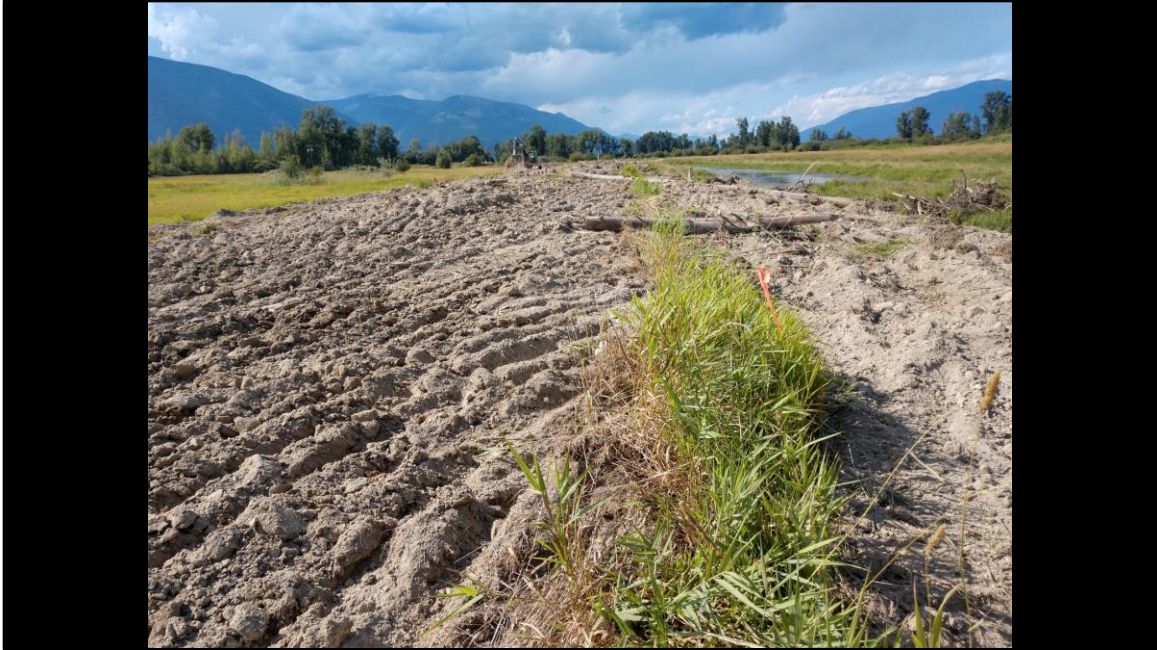
Here's a section of dam that has been removed. The orange flag served as a guide for removing the dam.

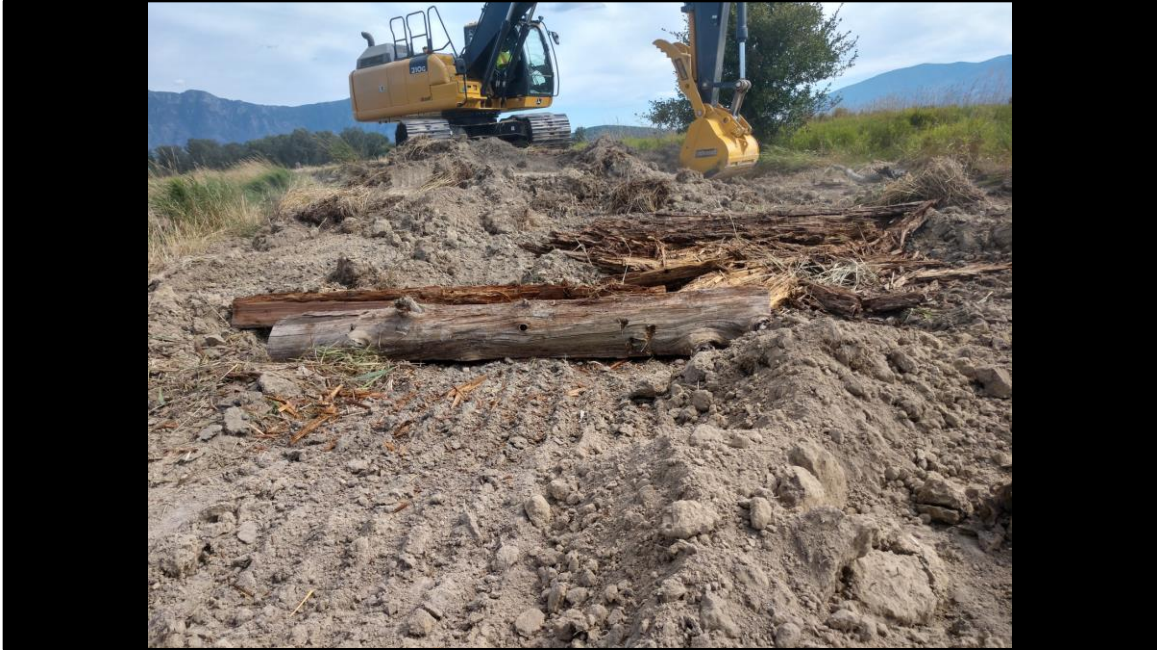
Woody debris uncovered during the removal of the dam was saved and placed by the excavator.

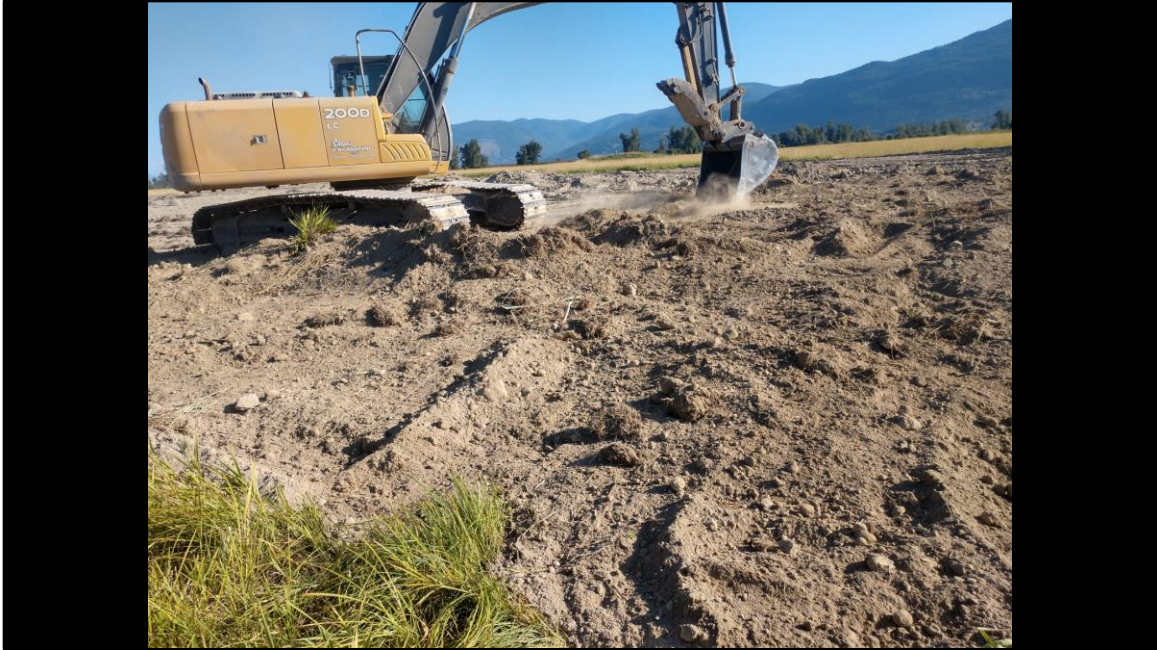
The excavator is used to loosen soils and remove heavy equipment tracks following removal of the dam.

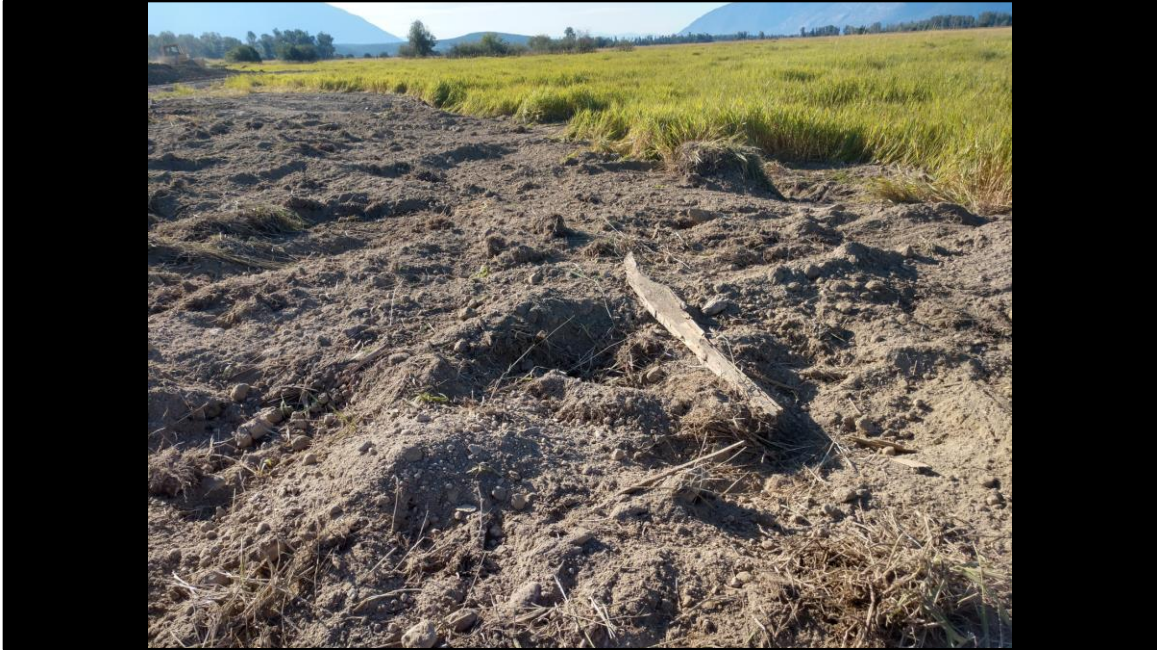
Here's a section of dam that was removed. The rough and loosen technique was used to control erosion and to create a substrate for plant germination and growth.

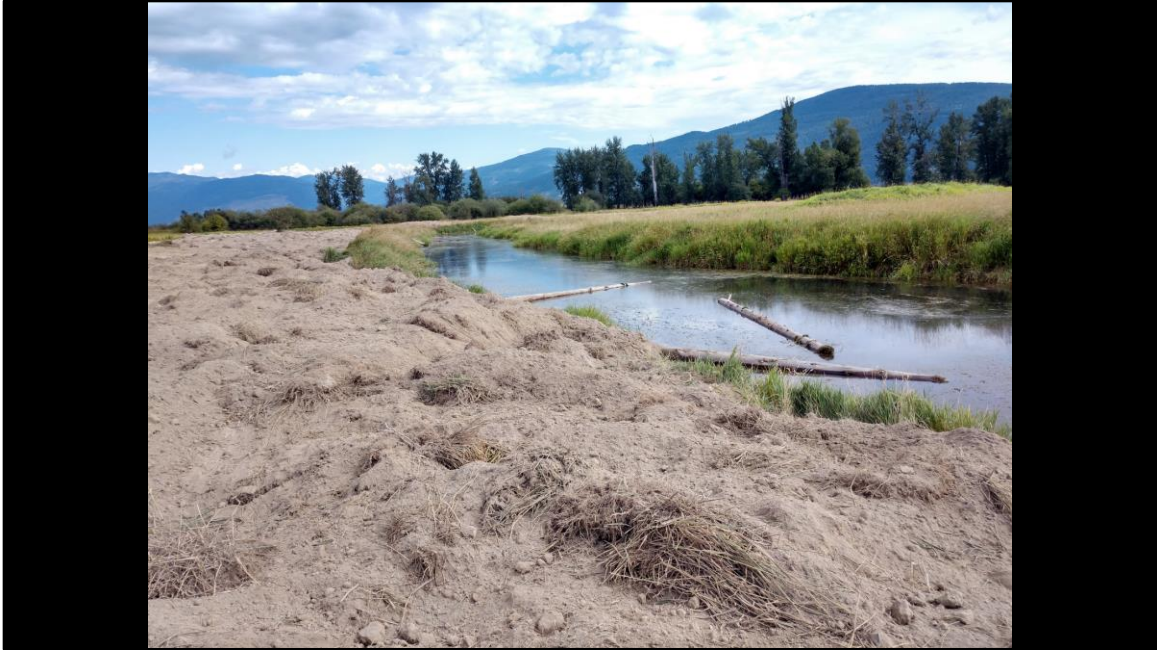
This photo shows a section of dam that was removed near water standing in the borrow pit. Soil was purposely not placed in the water. The water is present where soil was removed years ago to build the dam. Logs were placed in the water to provide the Western painted turtle with basking sites, and waterfowl with loafing sites.

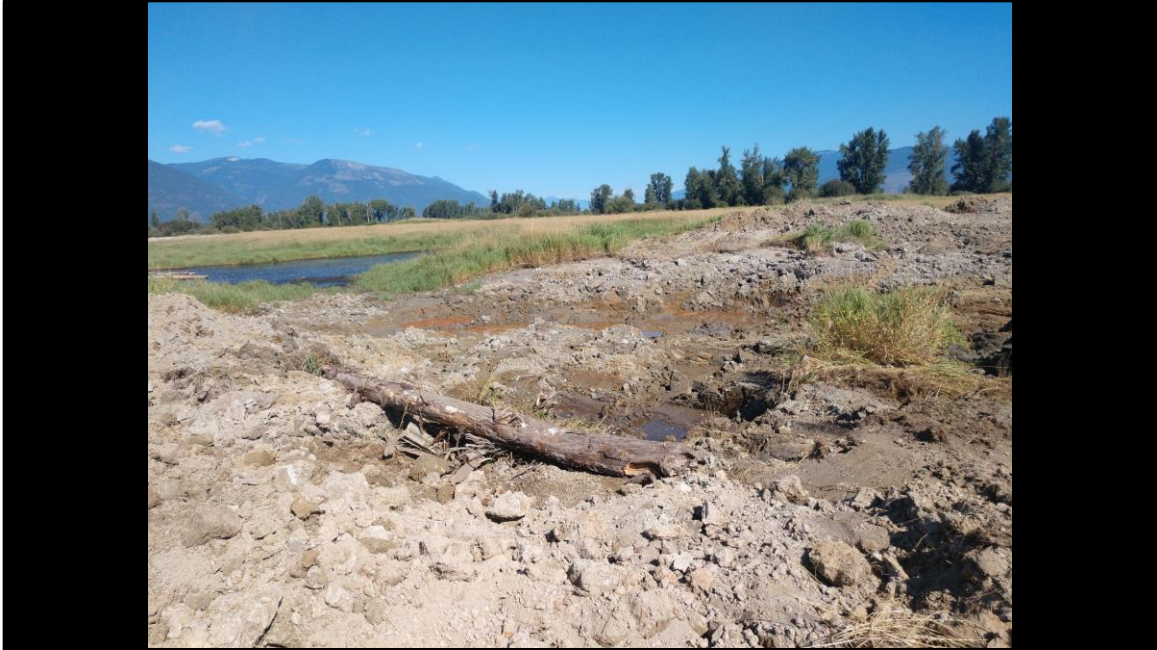
Small ephemeral wetlands were built on the same location where the dam had been removed.
