**RESTORATION OF WETLANDS AND STREAMS FROM CONSTRUCTED  
IMPOUNDMENTS**  
Thomas R. Biebighauser

This presentation focuses on how wetlands, streams, and rivers are being restored from constructed impoundments on the Yaqan Nukiy Hunting Grounds near Creston, British Columbia, Canada. The project is receiving major funding from the Columbia Basin Trust, Fish and Wildlife Compensation Program, and the Aboriginal Fund for Species at Risk. The project is a partnership program involving the Yaqan Nukiy First Nations and the British Columbia Wildlife Federation. You'll see why after constructing over 1,400 dams, Tom Biebighauser now works to remove them.

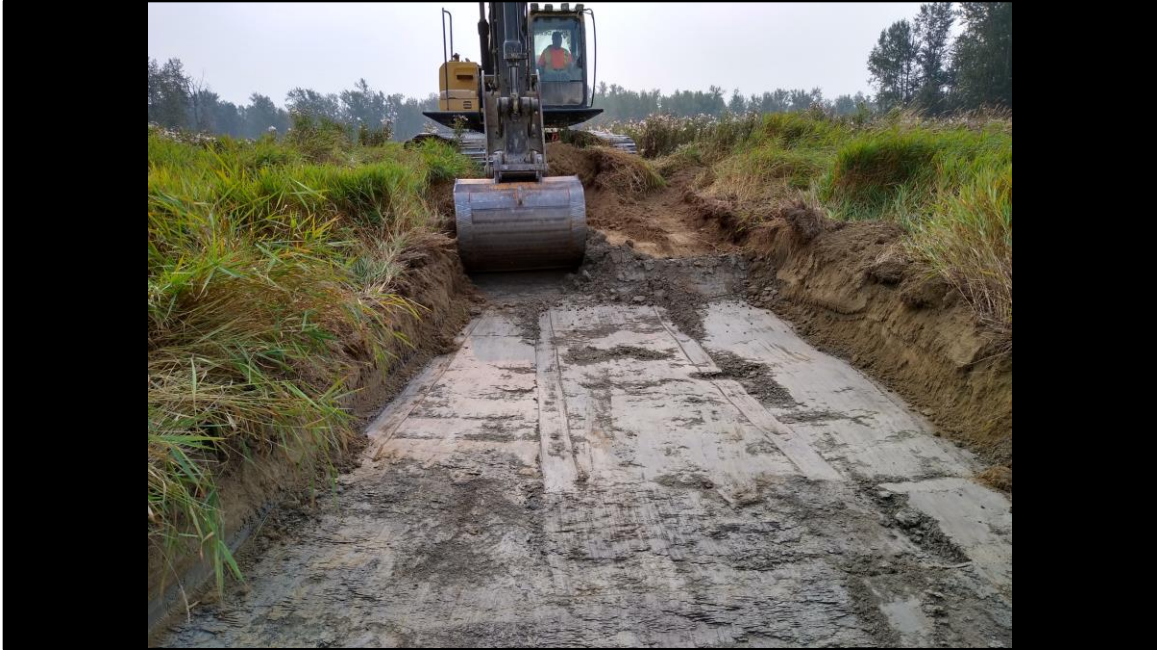
Here the excavator is being used to restore a natural inlet that will carry floodwaters from the Goat River into the Hunting Grounds. The inlet is being restored at the upper edge of the Hunting Grounds so that floodwaters may flow downhill and inundate the restored wetlands and streams. Note the soil that was used to build the dam is brown in color, the gray-colored soil is from a wetland that was filled when the dam was built. Tom Biebighauser was onsite 100-percent of the time supervising construction. Norm Allard was onsite daily working with Tom to design and direct the project.

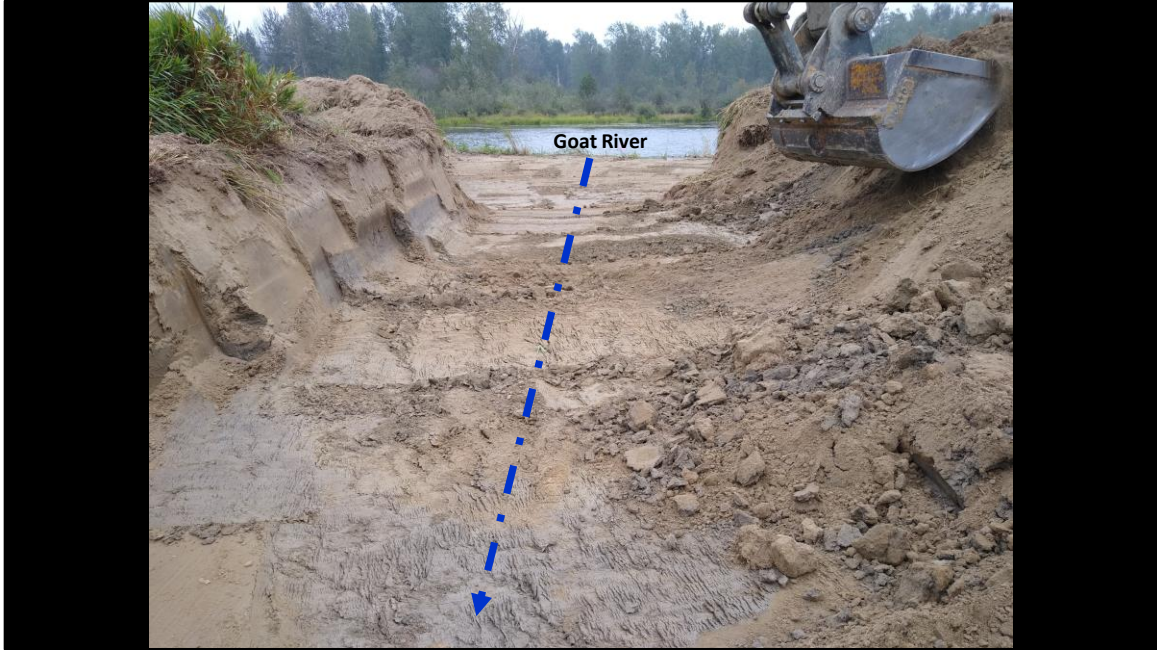
The width of the inlet was made to match the width of natural stream channels that had been cutoff by the dam surrounding the Hunting Grounds. The elevation of the restored inlet was set so that floodwaters from the Goat River would flow into the Hunting Grounds every year. The elevation of outlets was set so that floodwaters would fill restored wetlands and streams, and remain in these features when floodwaters receded.

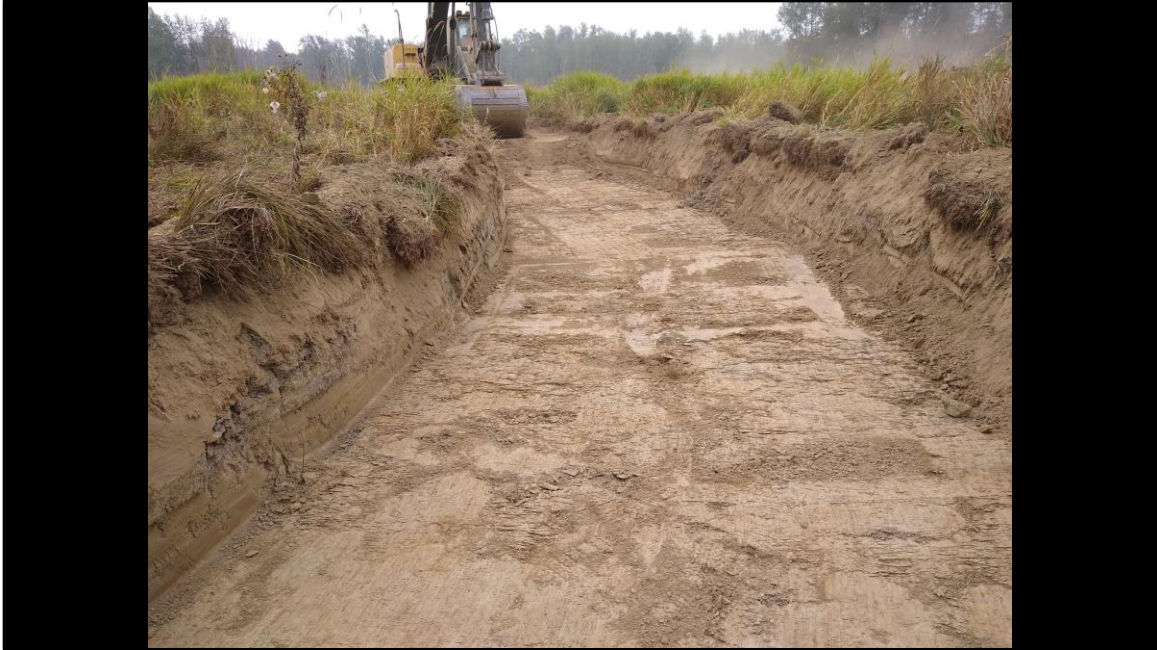
The restored inlet was shaped to be level in cross-section, and along its length. This was done so there would be a sheet-pattern flow of water over the inlet, and no erosion.

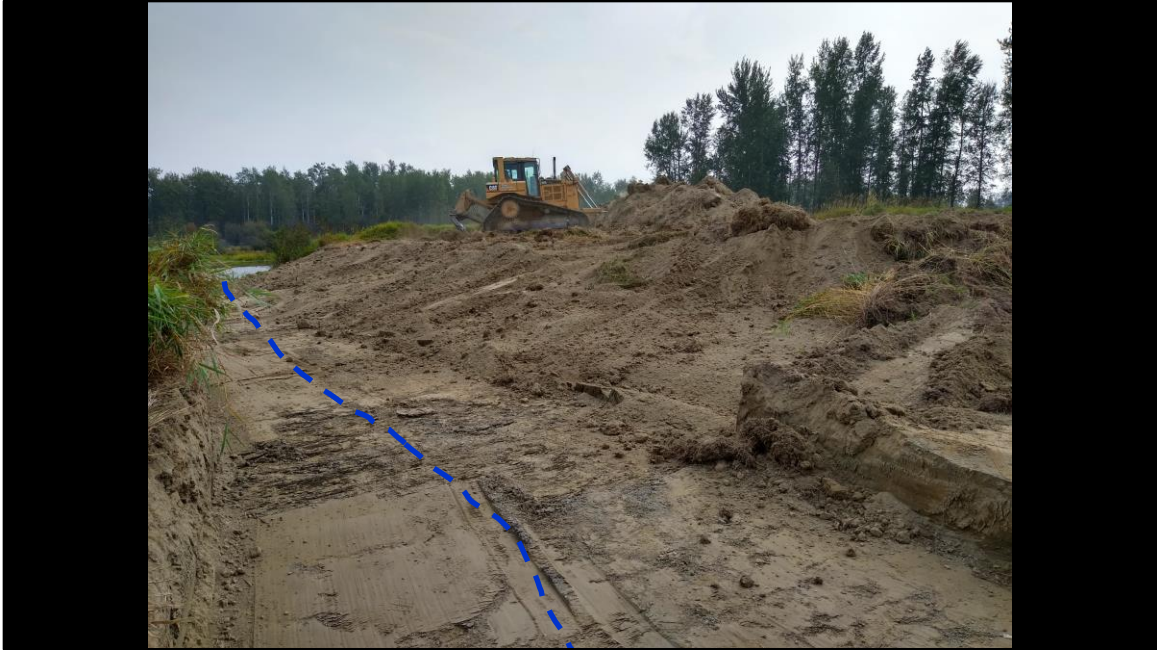
A dozer was used to spread the soil removed from building the inlet. The center of the inlet being restored is shown by the dashed blue line.

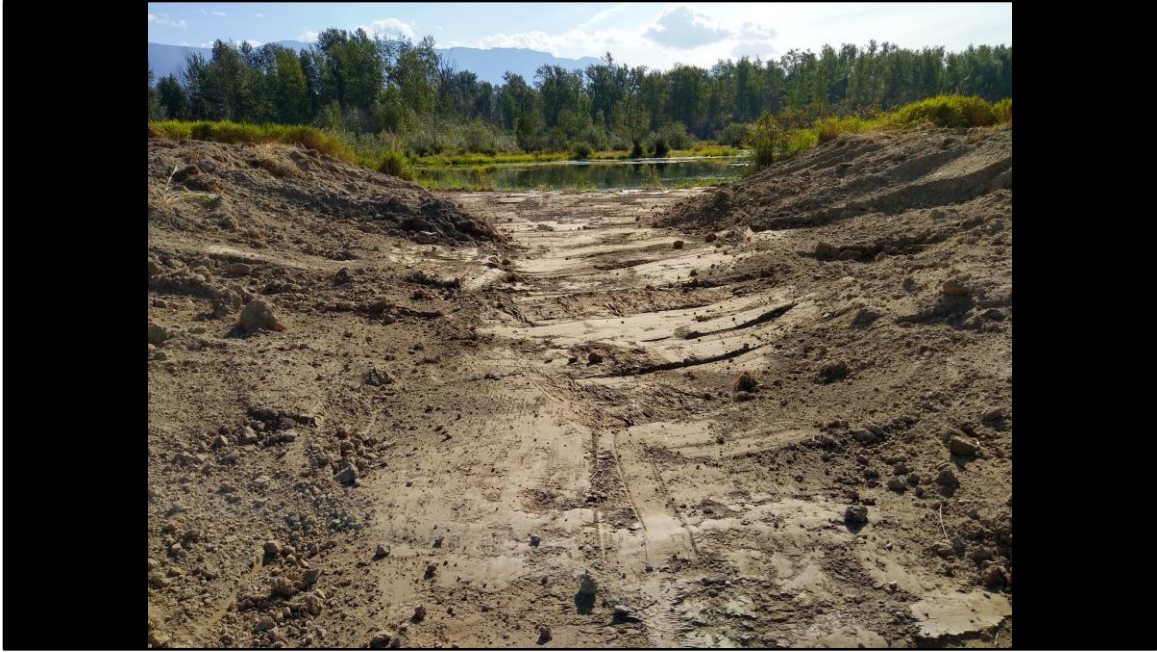
The banks of the restored inlet are sloped after the channel is dug.

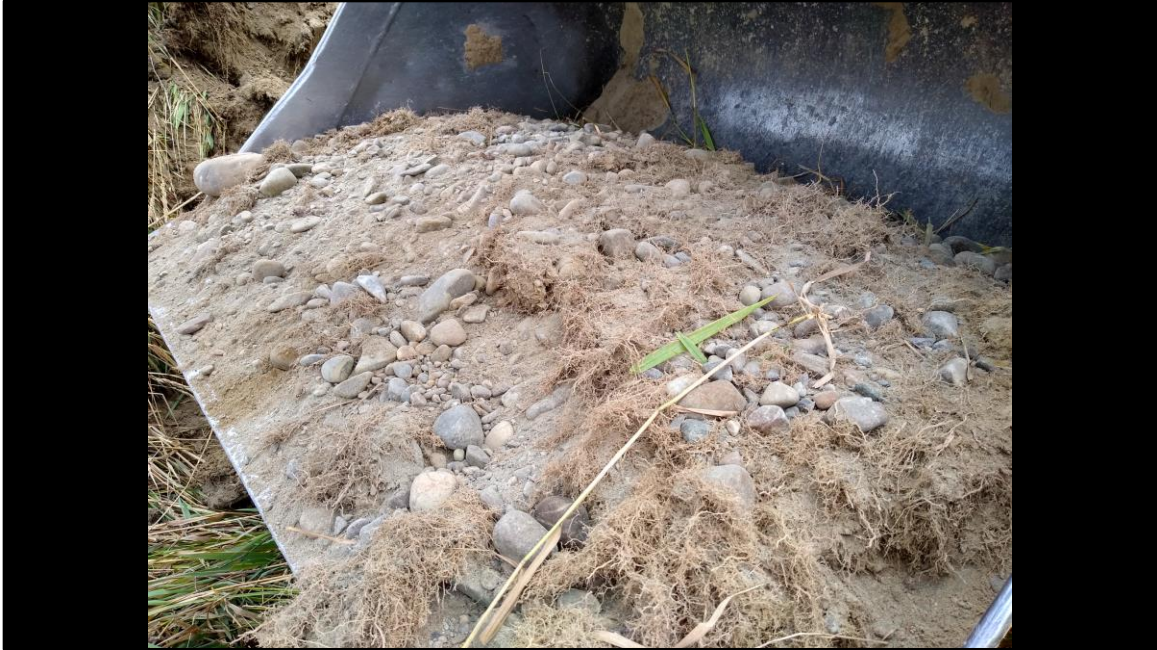
Gravel was uncovered during construction of the inlet. This gravel was brought in years ago so that trucks transporting soil to build the impoundment dam would not get stuck driving across the drained and filled wetlands.

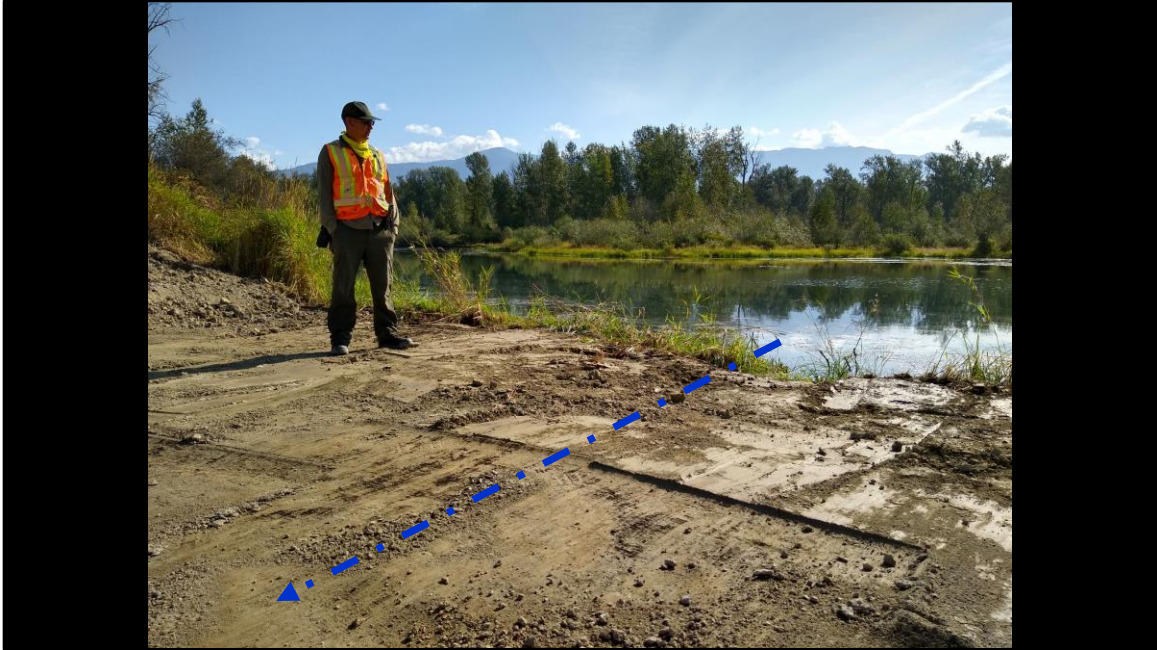
This photo shows the finished entrance to the inlet. The Goat River will now inundate the Hunting Grounds when the elevation of the river rises only 25cm. The elevation of the inlet is critical to the success of the project. If set too high floodwater will not enter the floodplain. If set too low the inlet can also act like a drain to remove water from the restored floodplain.

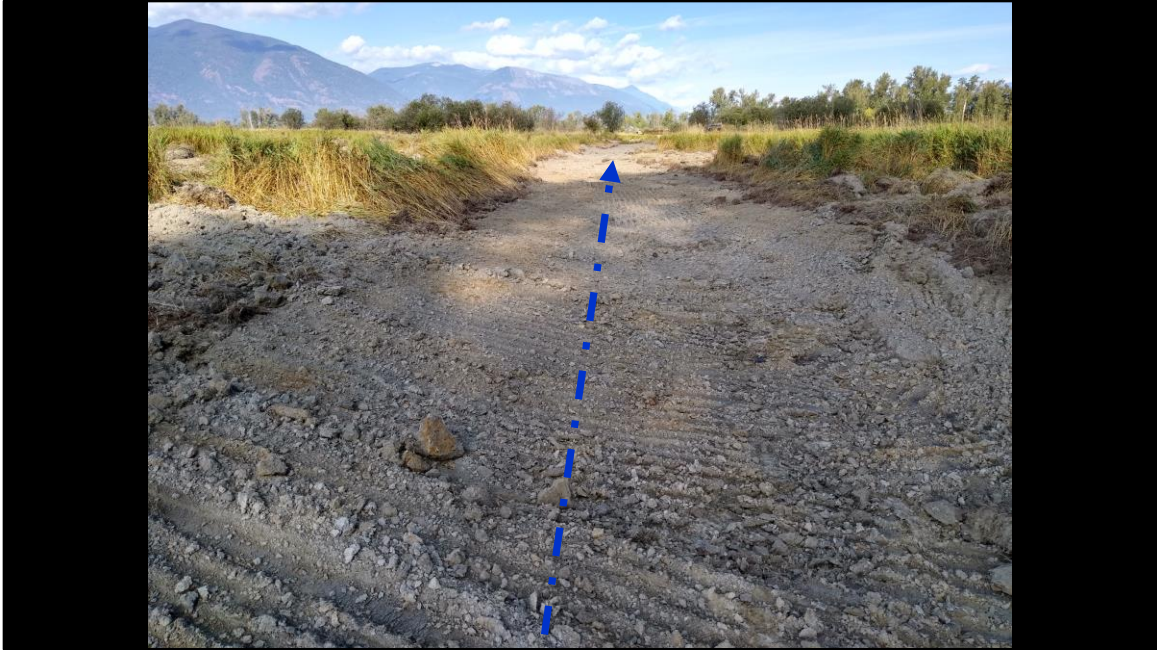
Here is where another inlet was restored to provide a way for floodwaters to enter the Hunting Grounds. The inlets were shaped to resemble wide stream channels with low banks that were dry most of the year.

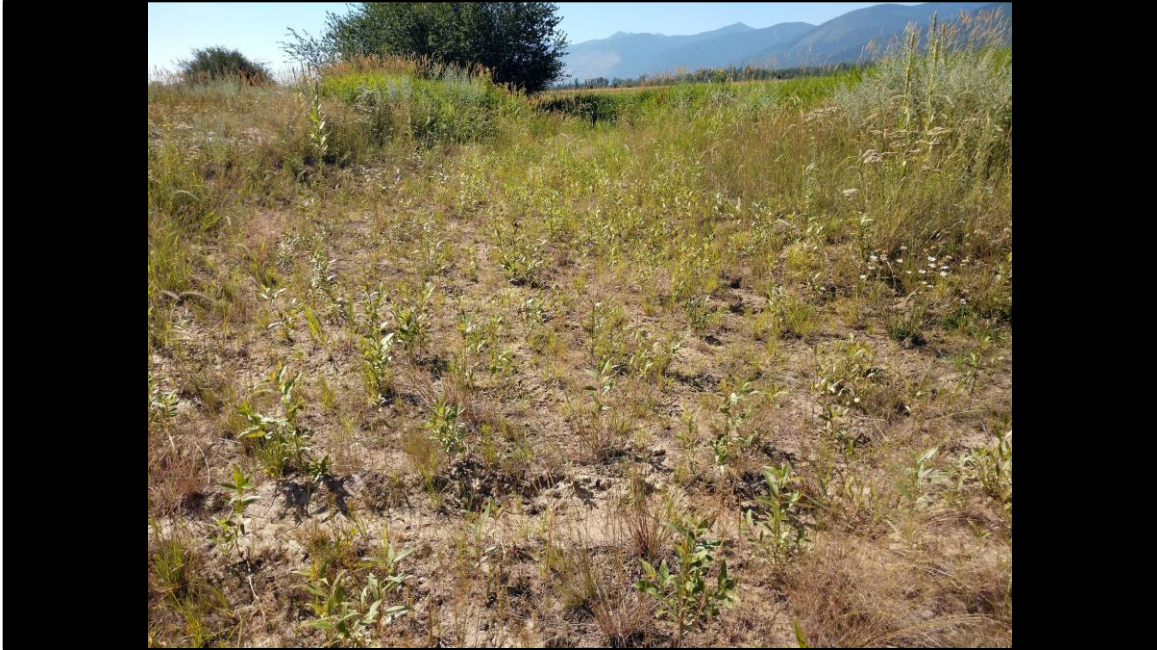
Sedges and cottonwood trees are growing in this restored inlet one-year following construction. There is no erosion because the stream channel was built wide and level with low sloping banks.

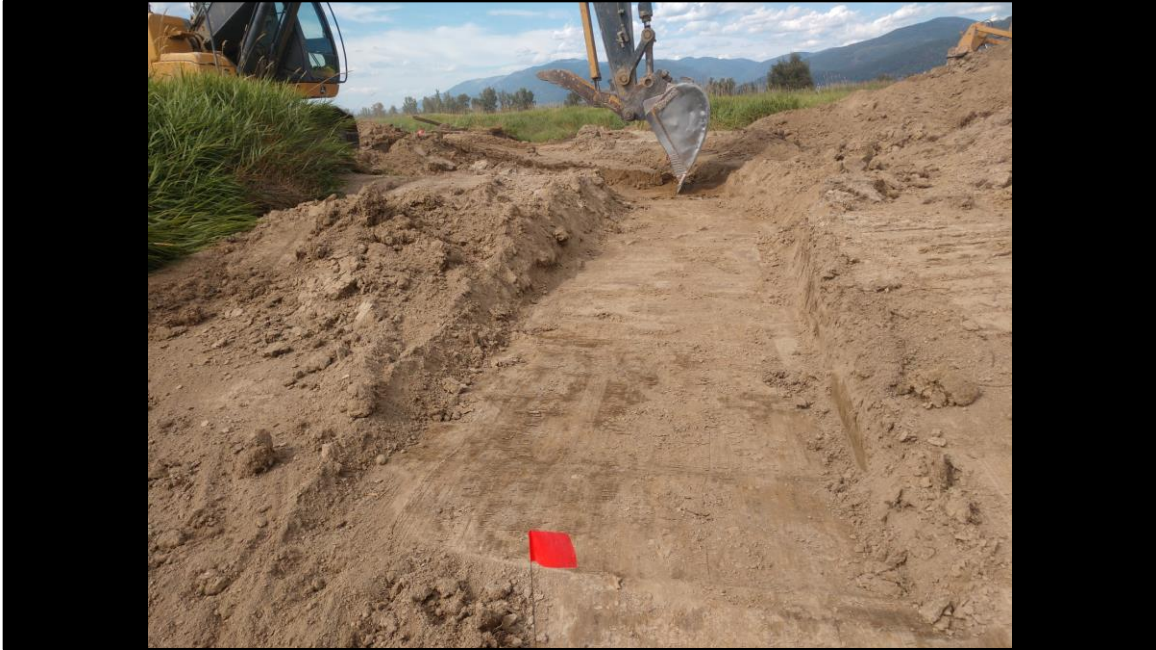
The narrow trench is widened so that water may flow over the outlet in a sheet-like pattern. **The elevation of the outlet is set to be approximately 20cm lower than the elevation of the restored inlets. The outlet was not placed where the drainpipe had been removed.** This is because a deep ditch had been dug to drain the impoundment when the drainpipe was installed, and building an outlet at this location would have been too low and on too steep a slope, causing major erosion and further drainage of the Hunting Grounds.

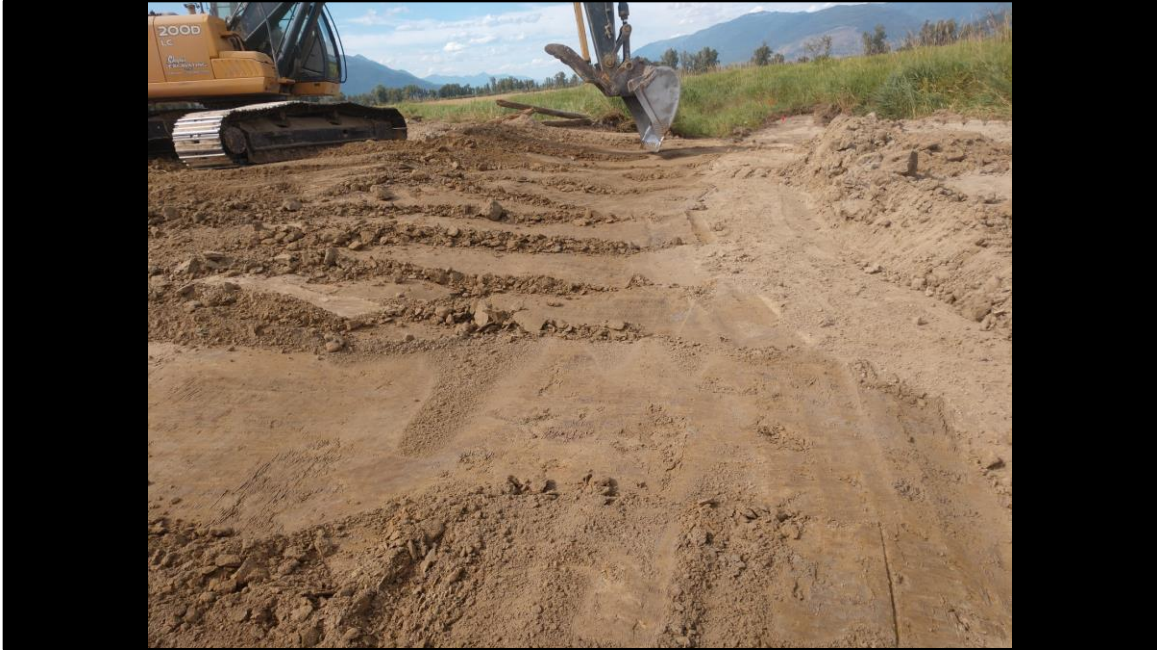
The outlet is widened and made with gradual sloping banks. The location of this outlet is the same as where an outlet was visible on the 1929 aerial photo.

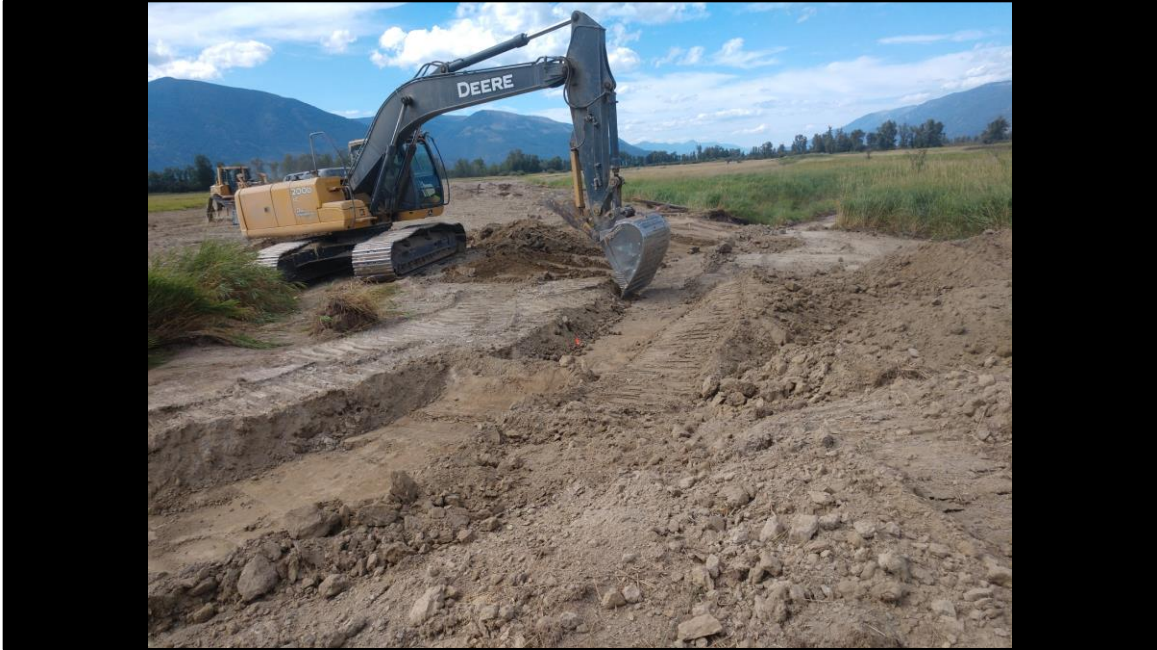
Gradual slopes are placed on the banks of the outlet.

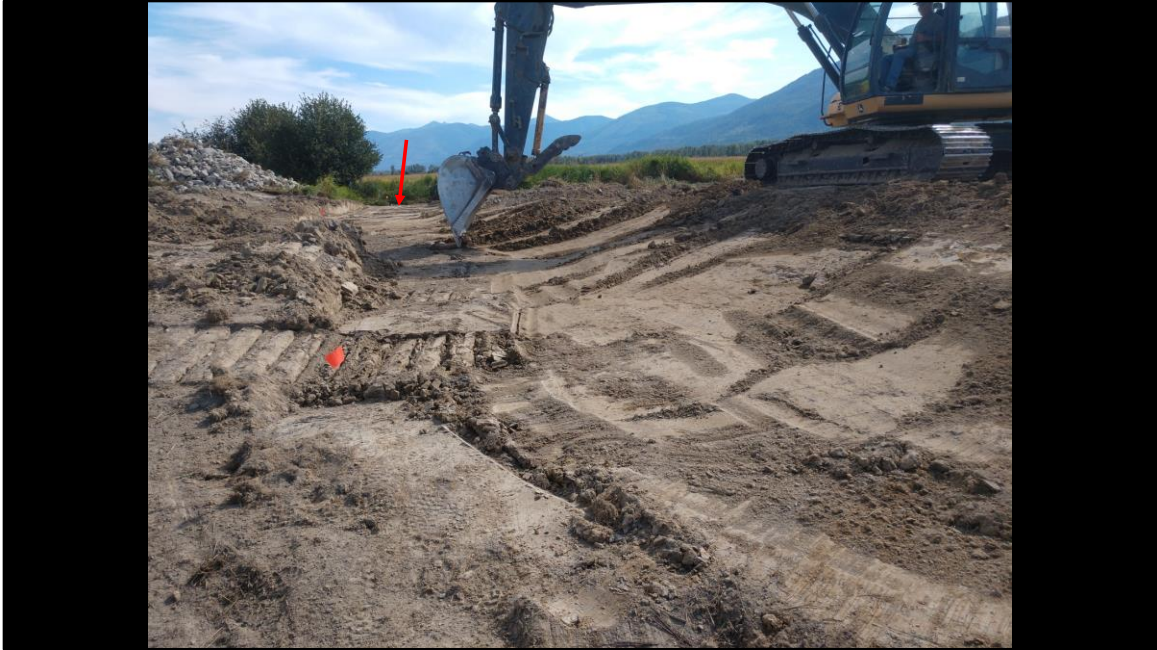
Water will leave the Hunting Grounds by flowing out this restored outlet into the Goat River South. The historic connection was visible as a narrow valley along the Goat River South (red arrow). The construction of the impoundment dam had obliterated the stream that had been the historic outlet.

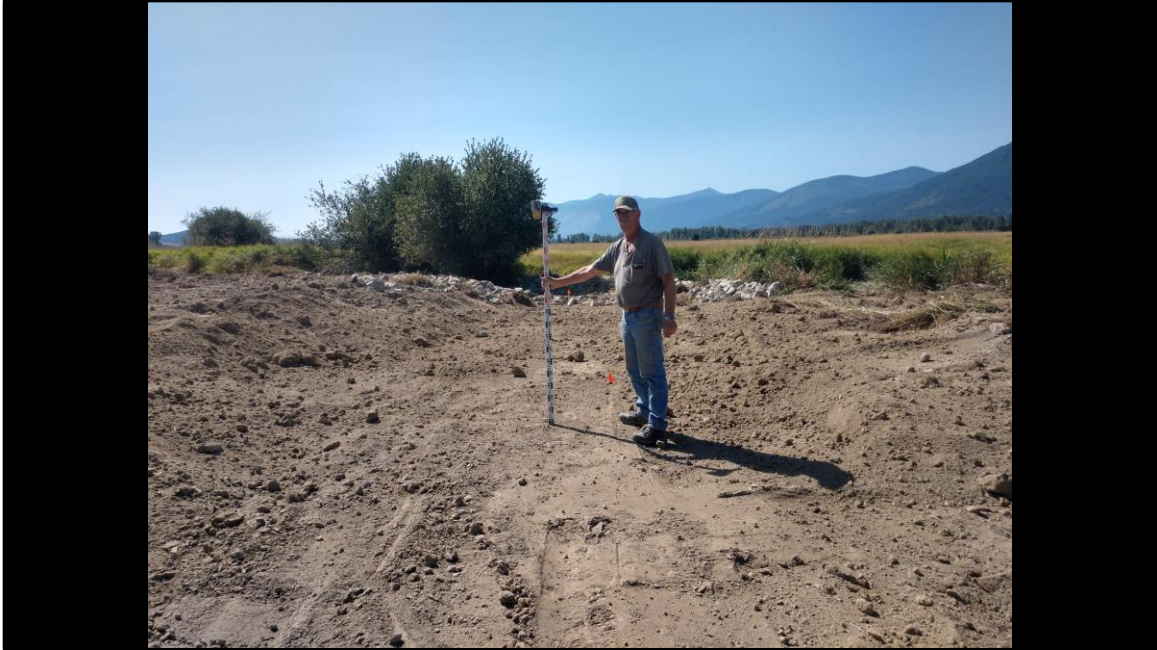
Measures were taken to prevent head-cuts from forming in the outlet, as these could drain the restored floodplain. To prevent head-cuts from forming in the outlet the channel was built wide and was placed on a gradual slope. Frequent elevations were taken, and rock was embedded in the ground to armor steeper slopes.

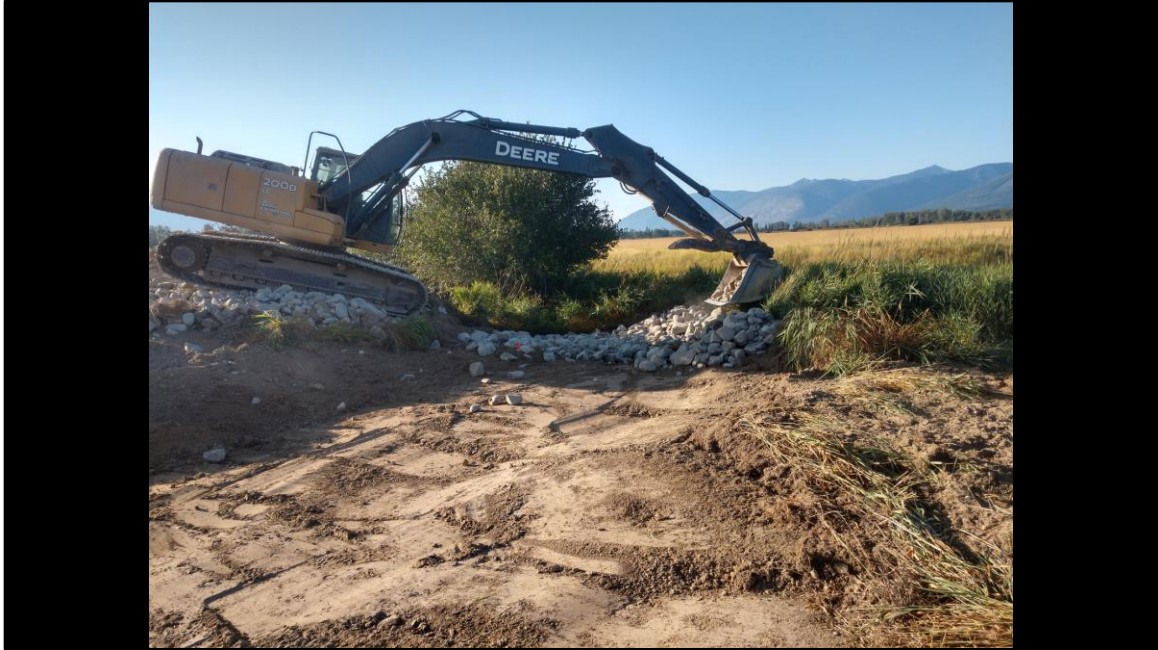
Rock is used to armor the steep slope where water flows from the restored outlet into the Goat River South. The rock is embedded into the ground to control erosion and to prevent head-cuts from forming. The current elevation of the Goat River South is much lower than it was historically, explaining why the slope between the outlet and the Goat River South was so steep.

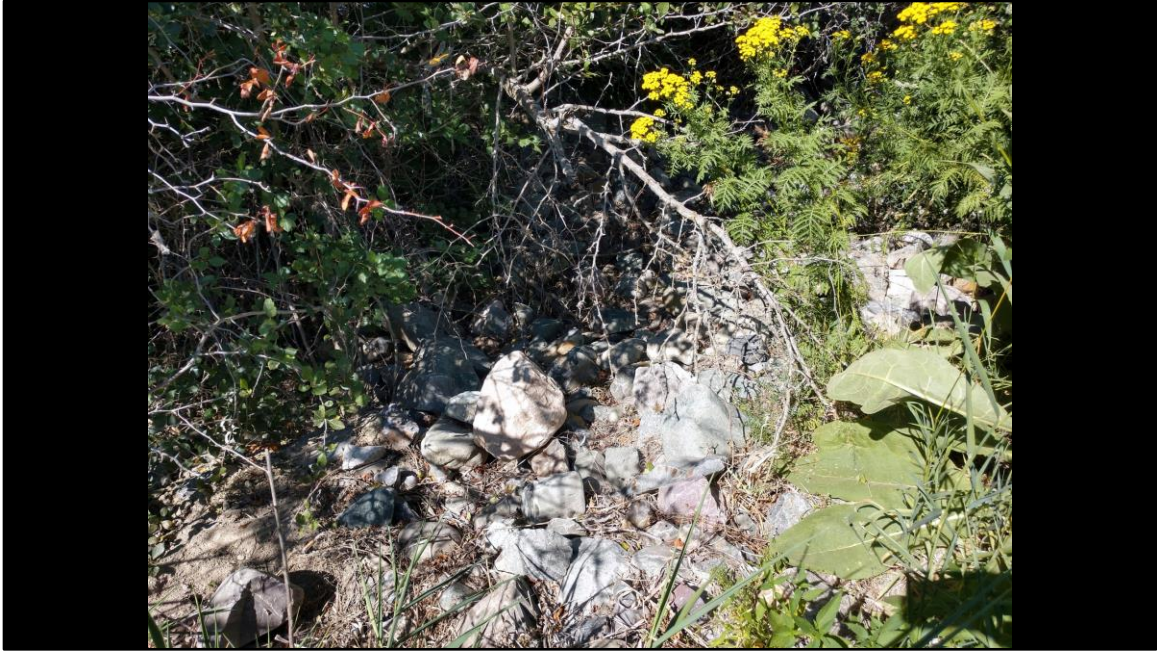
Here is how the rock-armored outlet appears one-year after construction. No erosion is occurring.

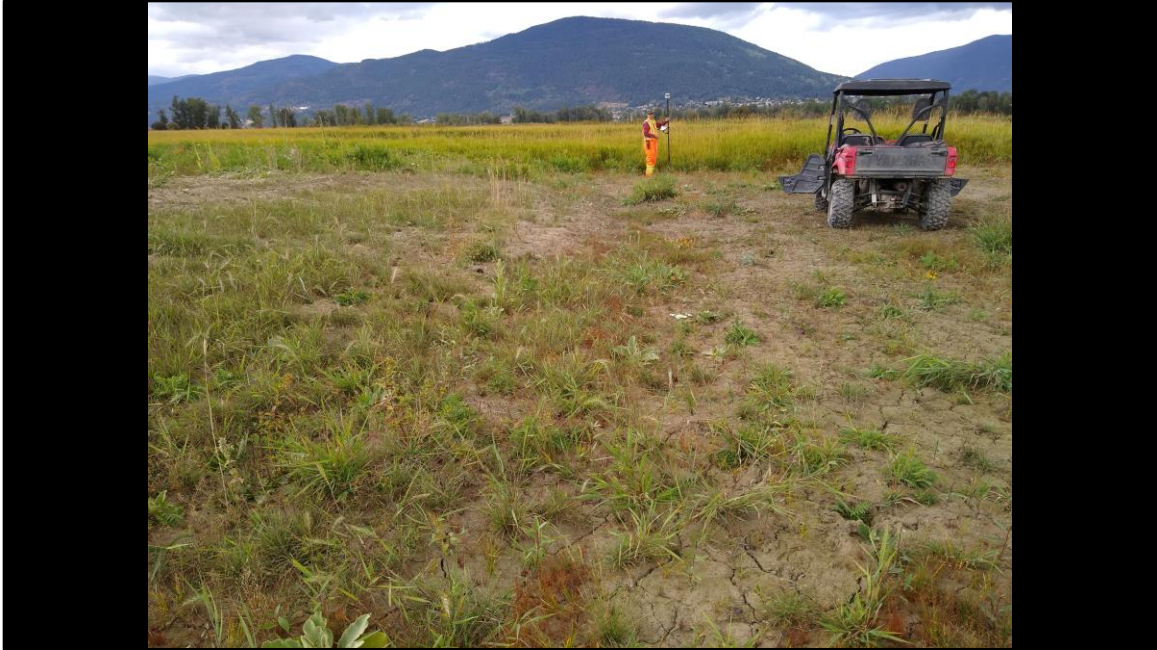
Here Norm Allard uses a Trimble GNSS Unit to check elevations in an outlet constructed the year before. The outlet area where the dam was removed is now growing a diversity of aquatic plants.

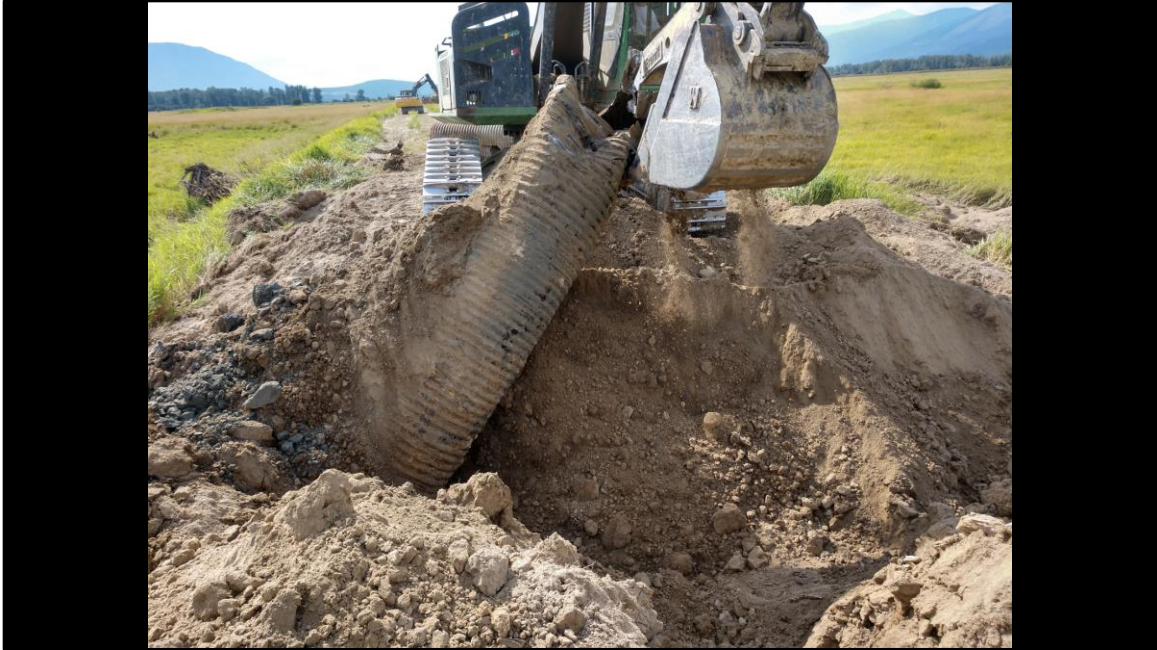
Pipes installed for the impoundment were removed as part of the restoration project. Here a drainpipe and water control structure are being removed.

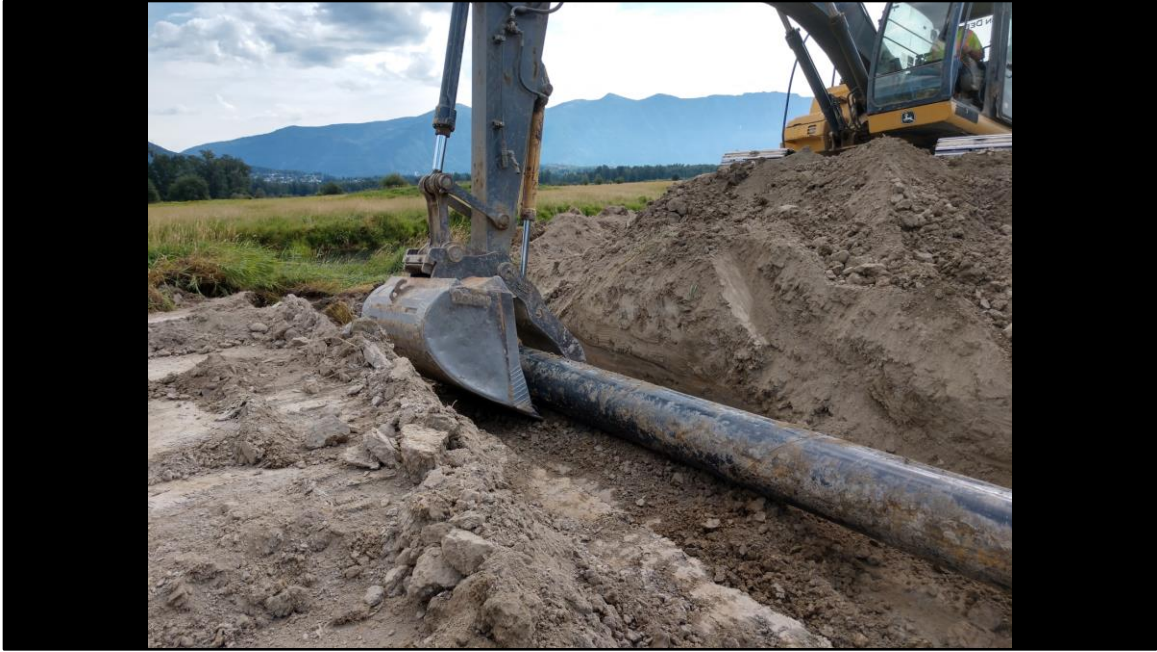
The pipe that moved water from a pump to the impoundment was also removed.

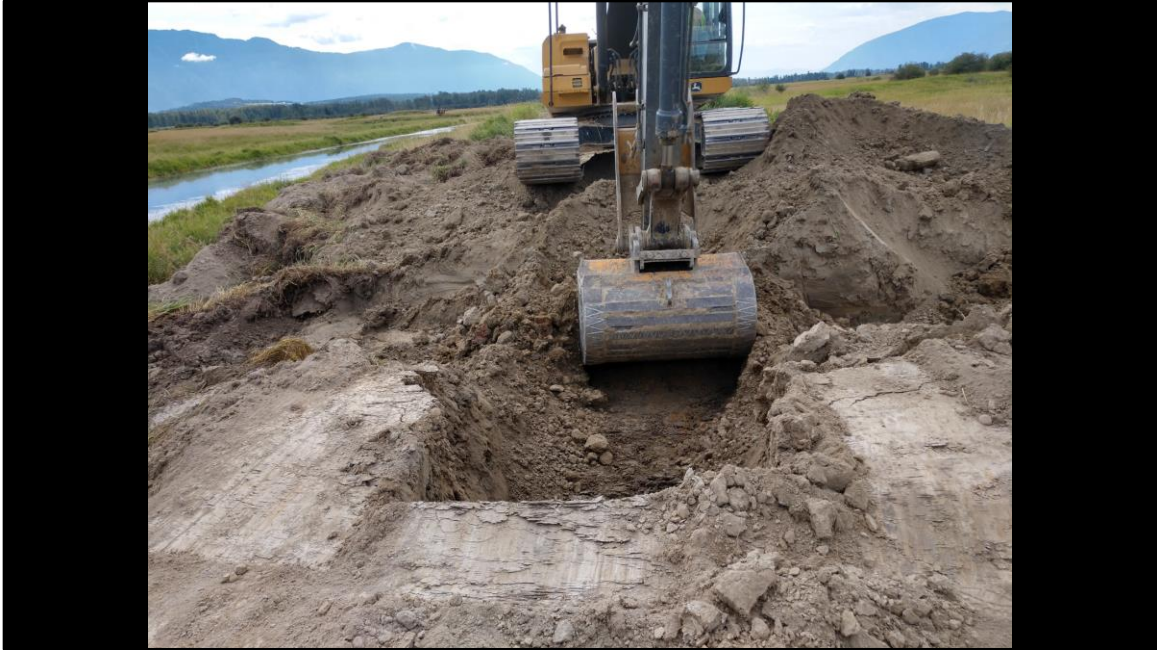
A wide and deep trench was dug perpendicular to where each pipe passed under the dam. This allowed us to locate where other pipes had been buried in the dam.

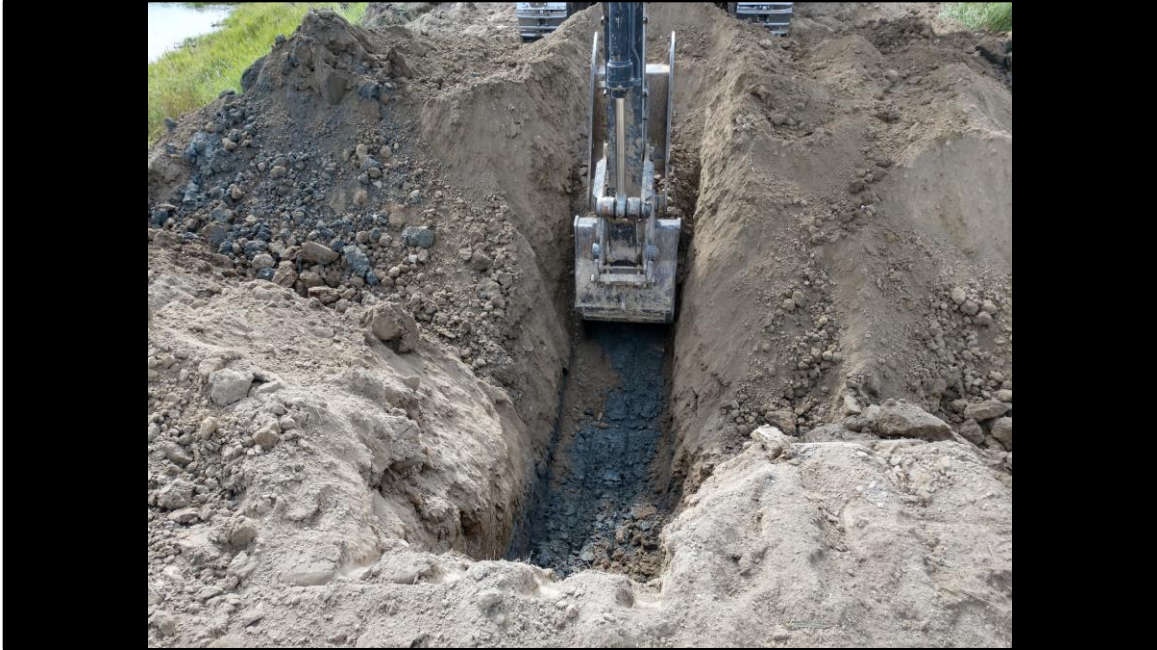
The trench was dug perpendicular to the pipes being removed, extending down through the dam into a thick layer of clay. The trench showed where the dam had been built over topsoil and sand, explaining why the dams did not hold water. Soil high in clay was placed in the trench and compacted in layers to prevent water from flowing where the pipe was removed.

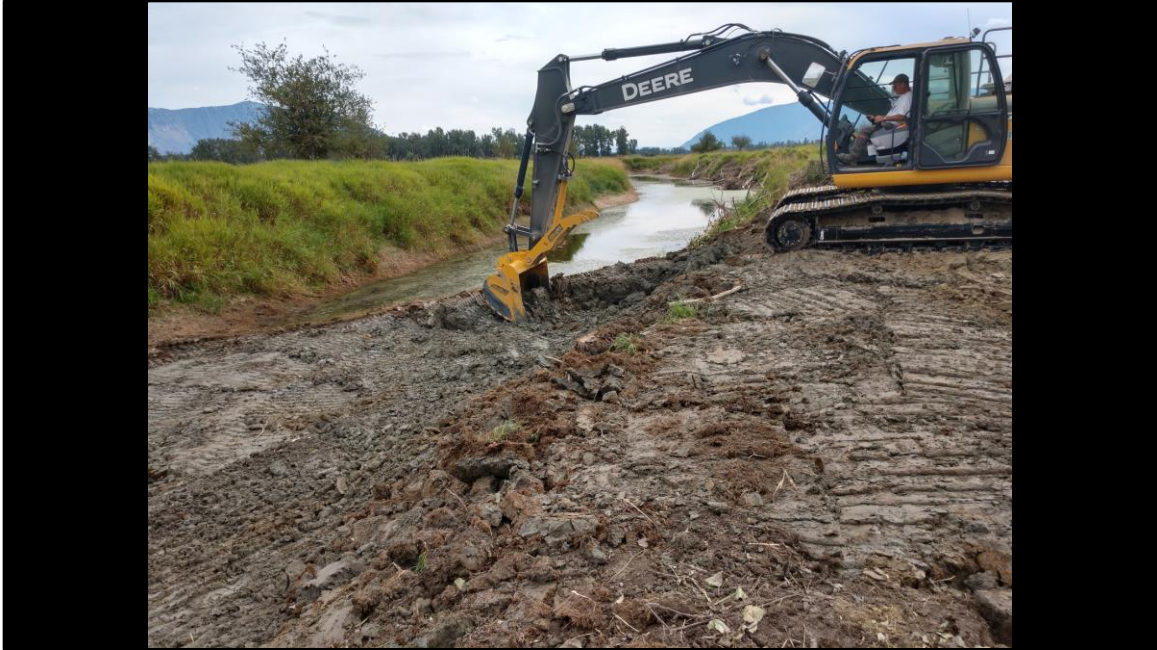
Here the soil that was used to block the natural channel of the Goat River South is being removed by using a John Deere 210G Excavator.

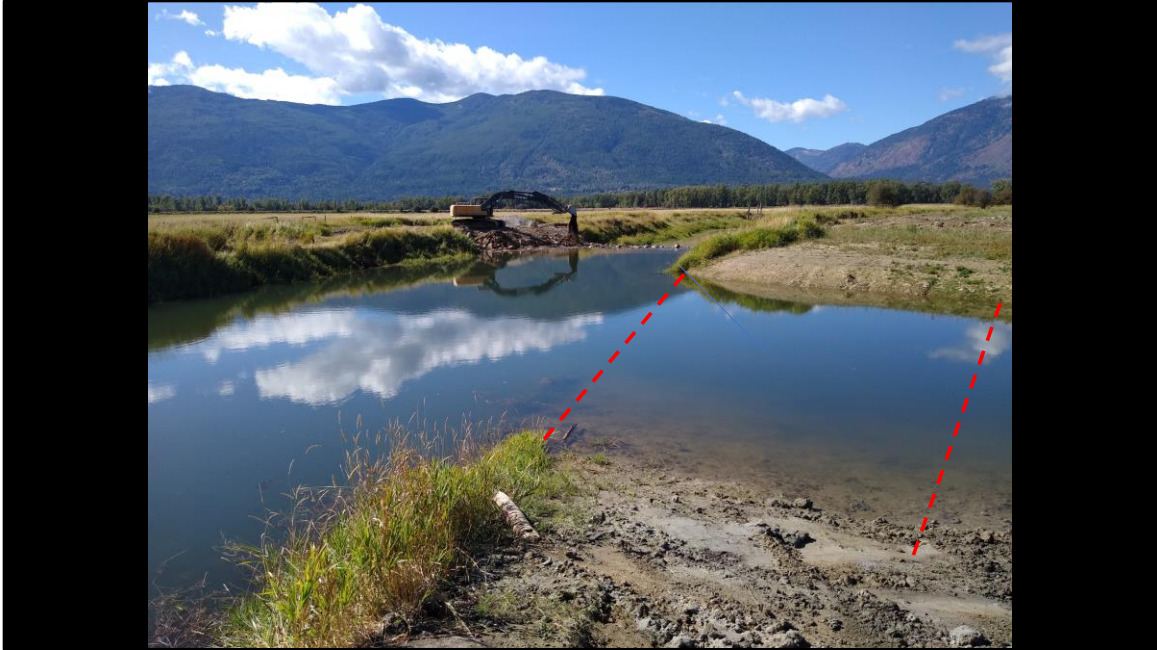
A 1.15 km loop in the Goat River South that was separated from the river was reconnected by removing 4-dams that were built to block the entrance and exit of the river loop. The dashed lines show the location of one of the dams that was removed. Here the excavator is building a riffle to transition higher water in the restored loop into the ditched section of the river that is at a lower elevation.

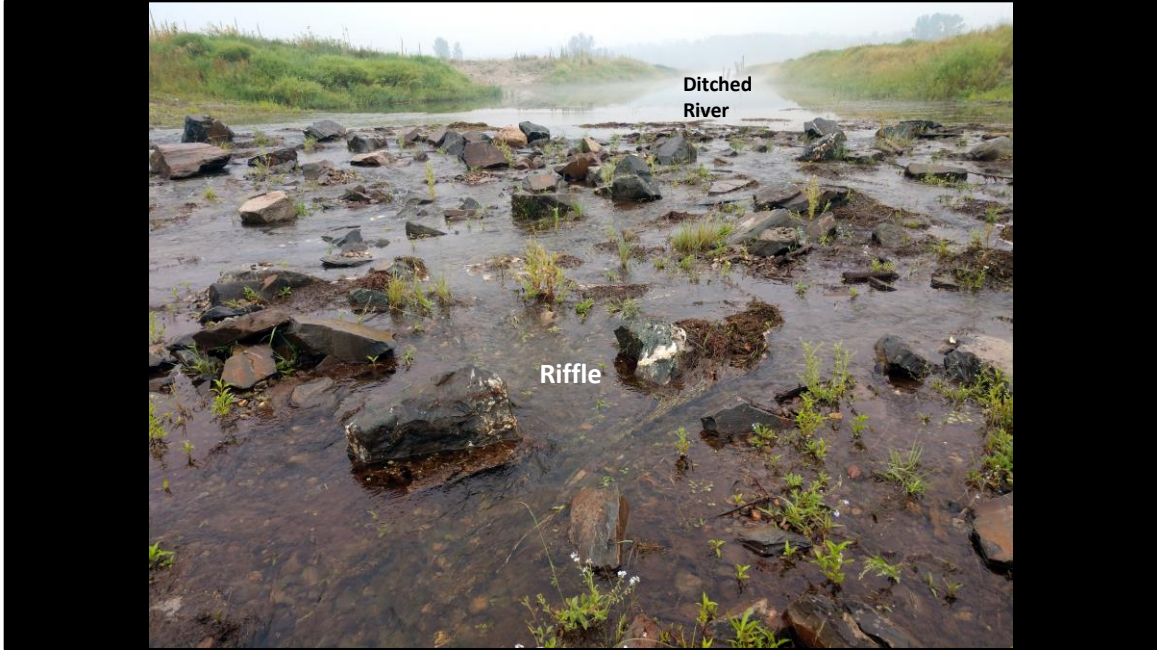
Rock was used to build two riffles in the Goat River South. The upstream riffle directed water from the ditched section into the restored loop of the river. The downstream riffle returned water from the restored loop where water the water level was higher into the dug ditch where water levels were lower.

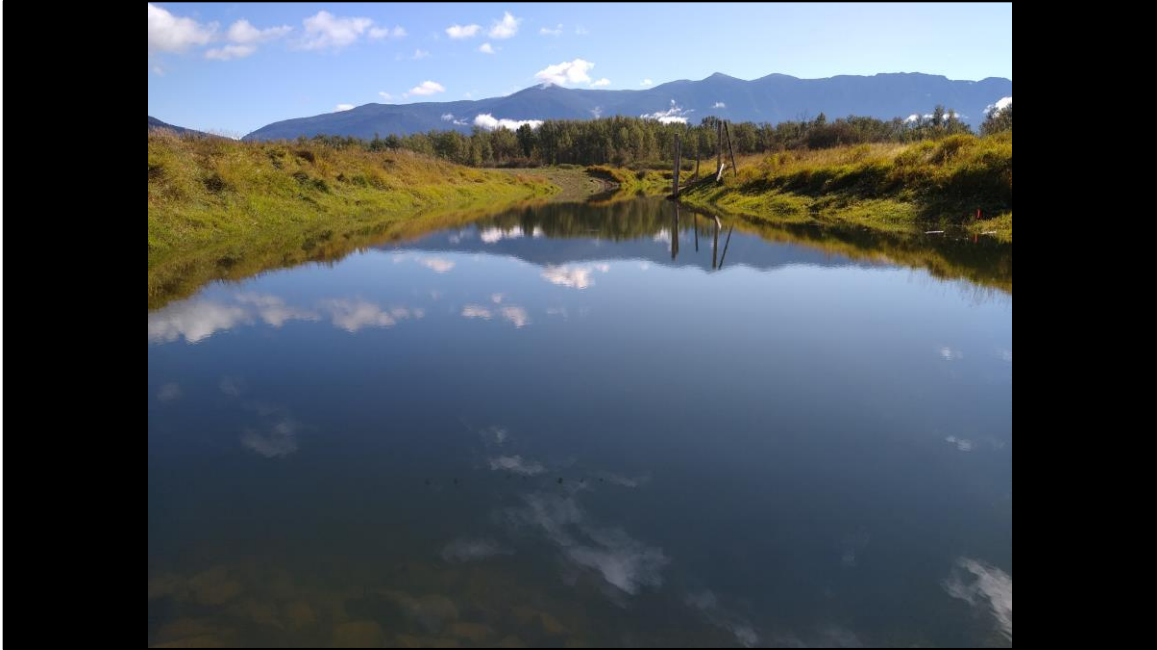
The constructed downstream riffle raised the elevation of the ditched section of river by approximately 1-meter.

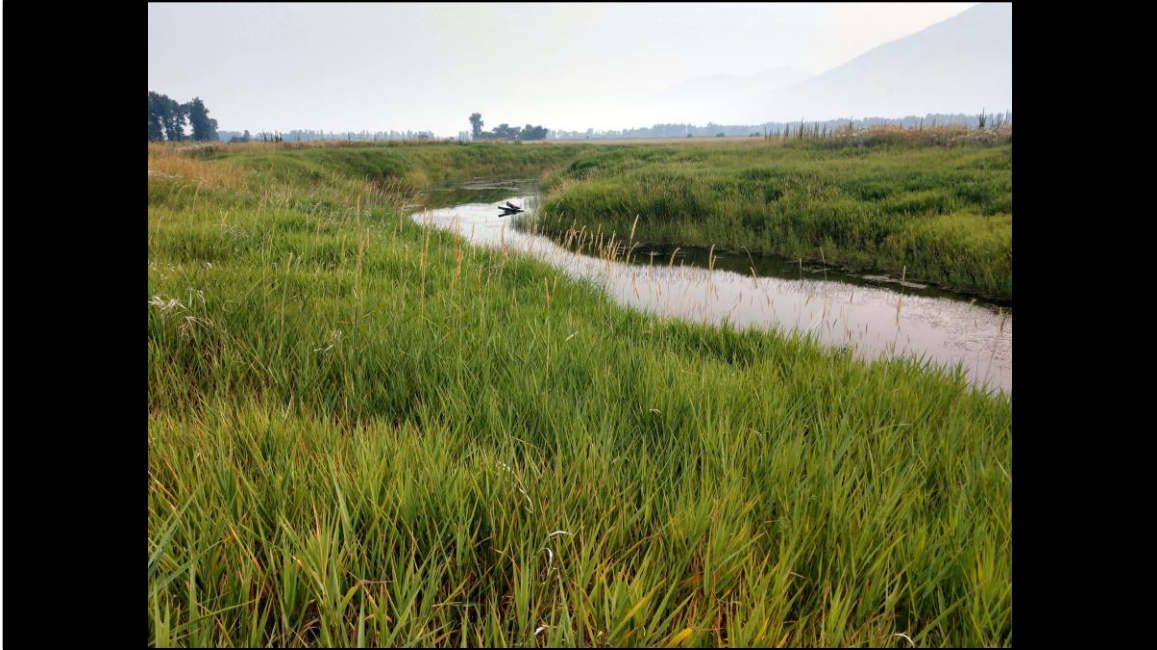
The loop in the Goat River South had been cut off to facilitate the construction of a dam for the impoundment. The cut-off loop was reconnected to the river and the original depth of water in the loop was also restored. The higher water level will help to restore groundwater elevations over the Hunting Grounds.

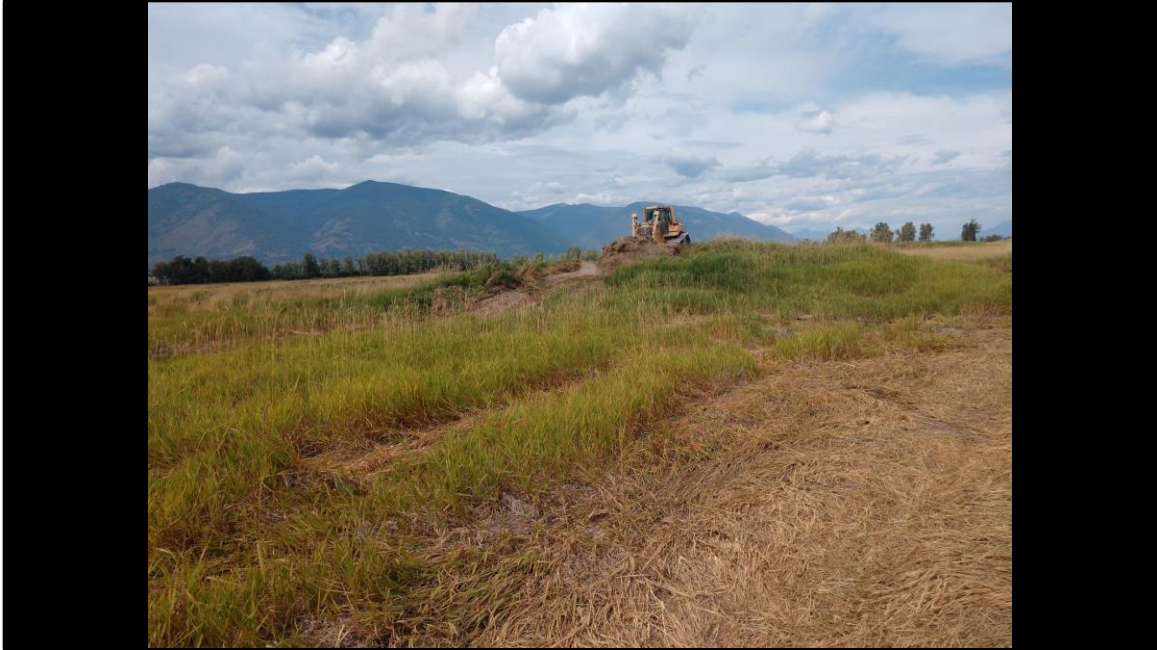
Here the dozer operator removes one of the large mounds of soil. The soil from the mound was used to fill drainage ditches and to restore the rims of the many natural wetlands that were drained.

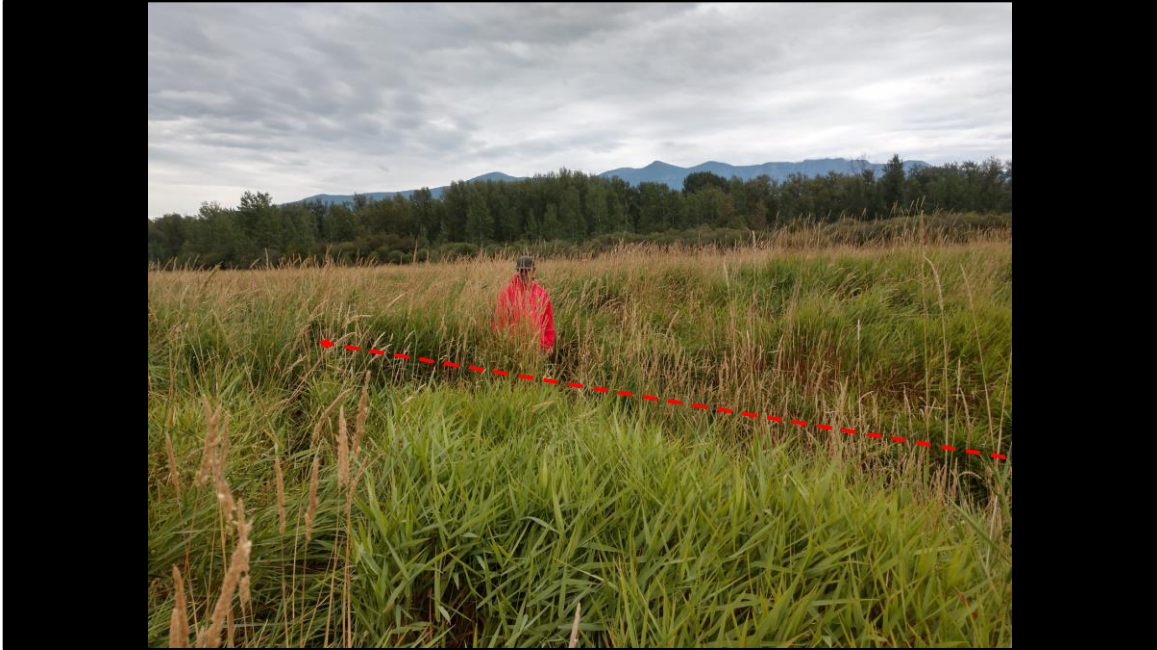
Norm Allard is standing in the bottom of a ditch dug to drain a natural wetland for construction of the impoundment. The ditch appears deepest where he is standing because it is passing thru the natural rim of the drained wetland. Notice the tall and dense reed canary grass in the drained wetland. We identified ditches that were dug to drain every natural wetland within the Hunting Grounds as part of Impoundment Construction.
