**RESTORATION OF WETLANDS AND STREAMS FROM CONSTRUCTED  
IMPOUNDMENTS**  
Thomas R. Biebighauser

This presentation focuses on how wetlands, streams, and rivers are being restored from constructed impoundments on the Yaqan Nukiy Hunting Grounds near Creston, British Columbia, Canada. The project is receiving major funding from the Columbia Basin Trust, Fish and Wildlife Compensation Program, and the Aboriginal Fund for Species at Risk. The project is a partnership program involving the Yaqan Nukiy First Nations and the British Columbia Wildlife Federation. You'll see why after constructing over 1,400 dams, Tom Biebighauser now works to remove them.

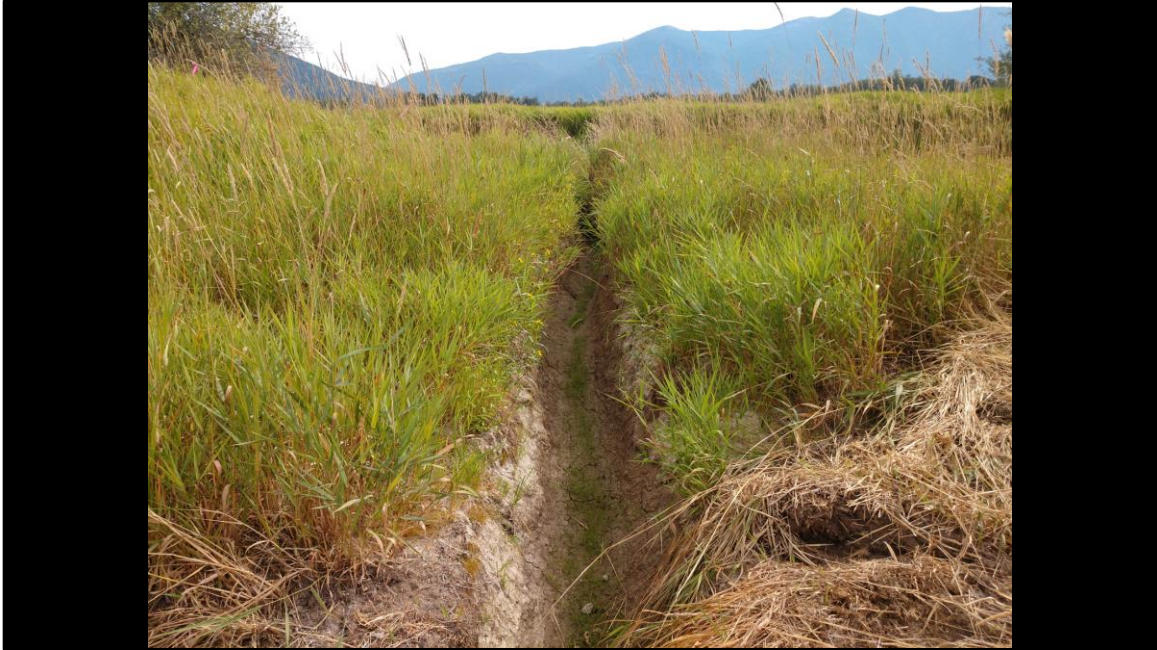
This is a ditch within a ditch. The narrow ditch was dug by a beaver in the bottom of a wide ditch dug by humans to drain a natural wetland for the impoundment. We found that beaver often dug canals along the length of human dug ditches. The deeper beaver dug channels resulted in further drying of wetlands drained by humans.

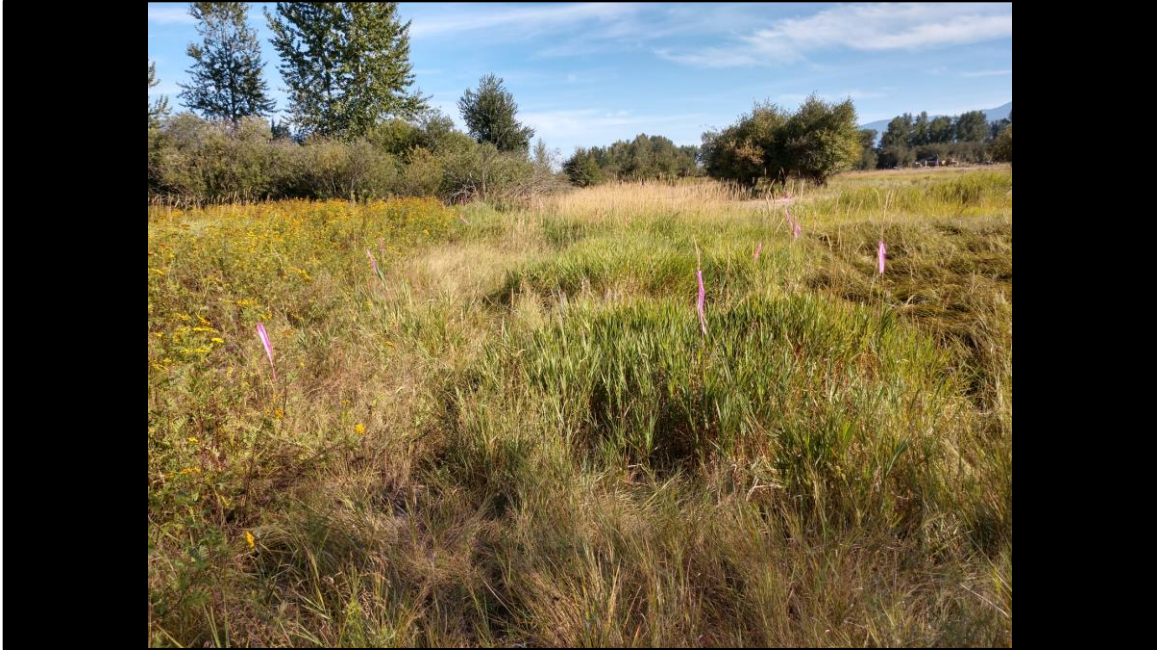
Colored plastic ribbons were used to show heavy equipment operators the center location of ditches to be filled.

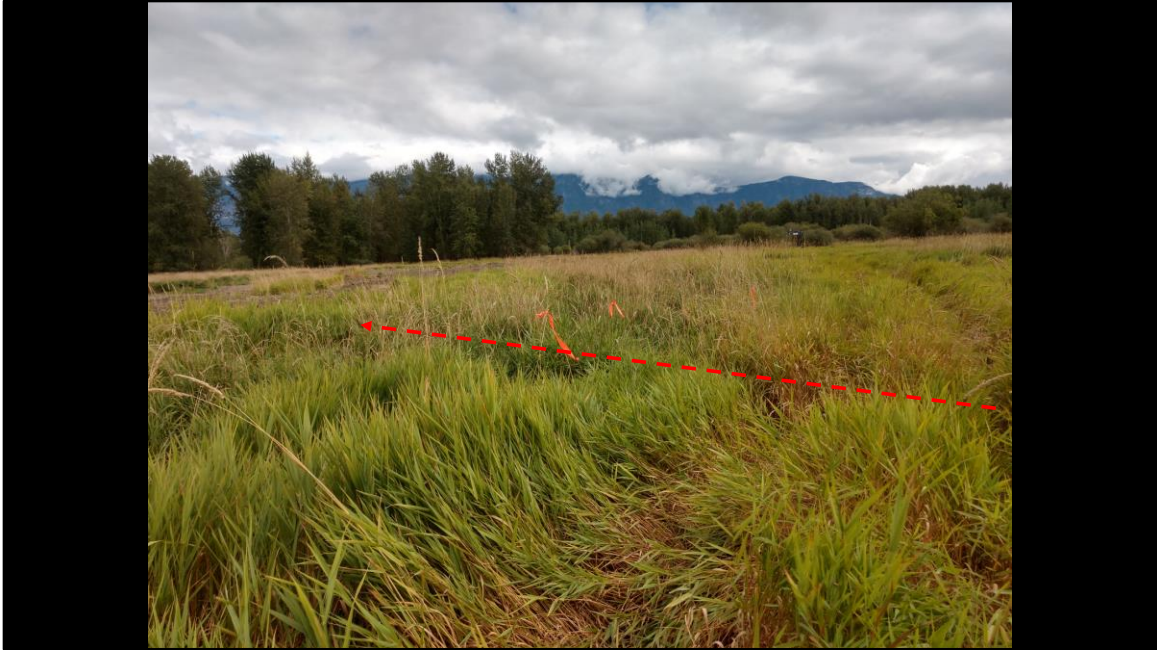
The orange plastic flags show the excavator operator where to build a groundwater dam in order to disable the ditch shown by the dashed line..

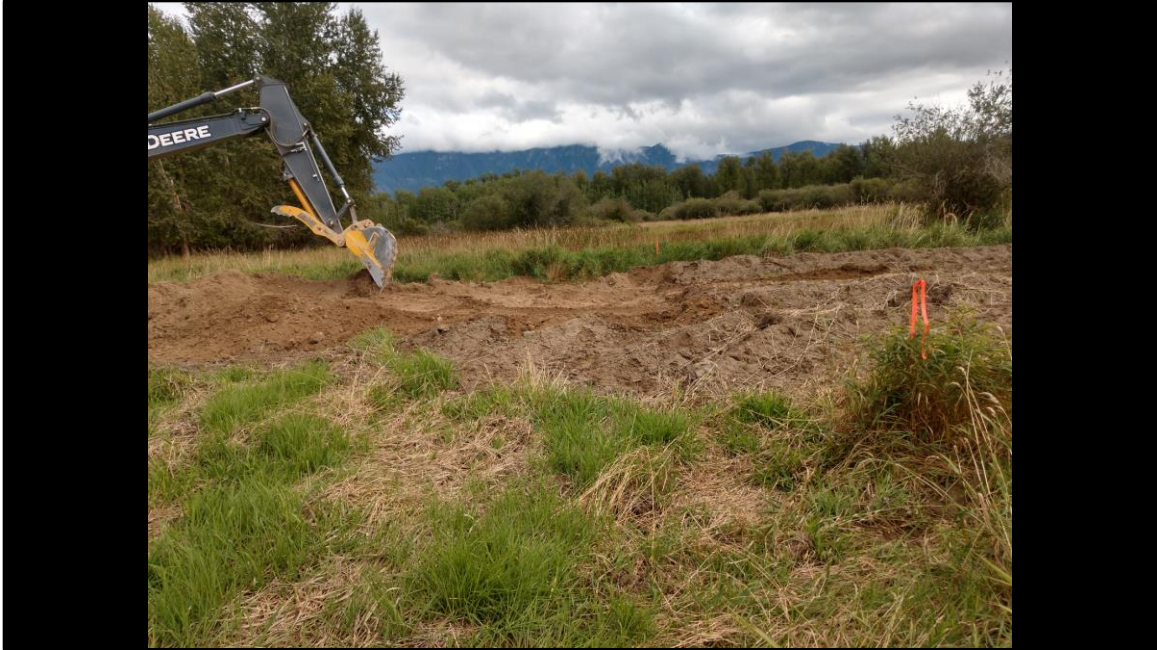
Here the excavator operator begins the restoration of a drained wetland by removing vegetation and topsoil from a ditch to be filled.

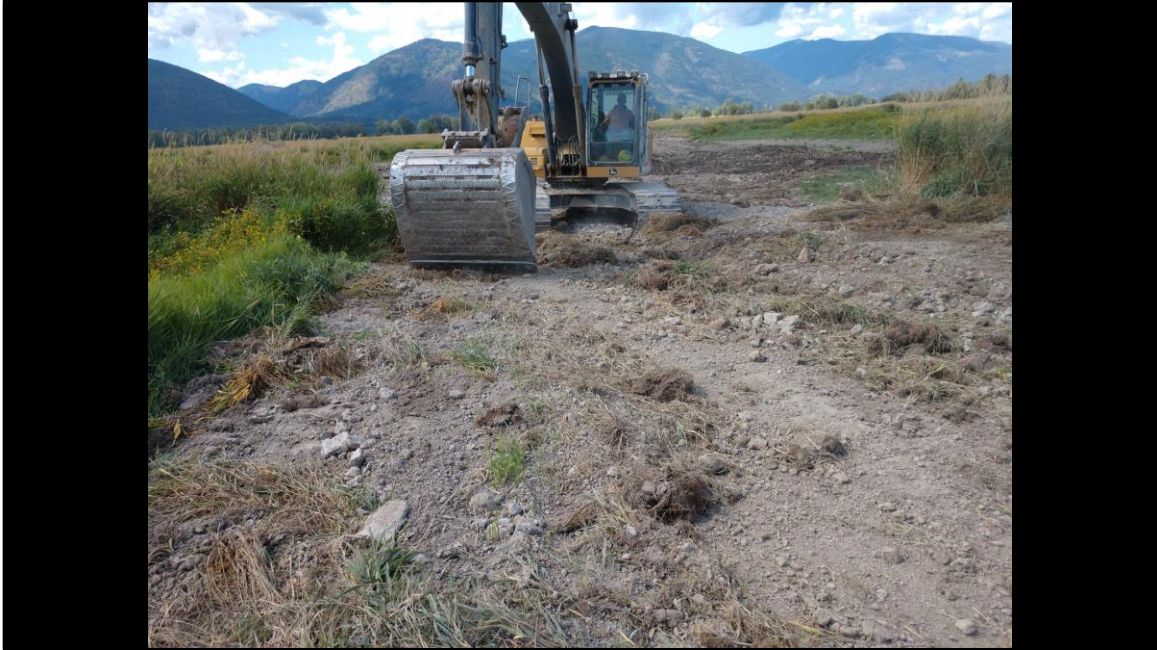
Plants and topsoil are removed from an area approximately 10-meters either side of the center of the ditch.

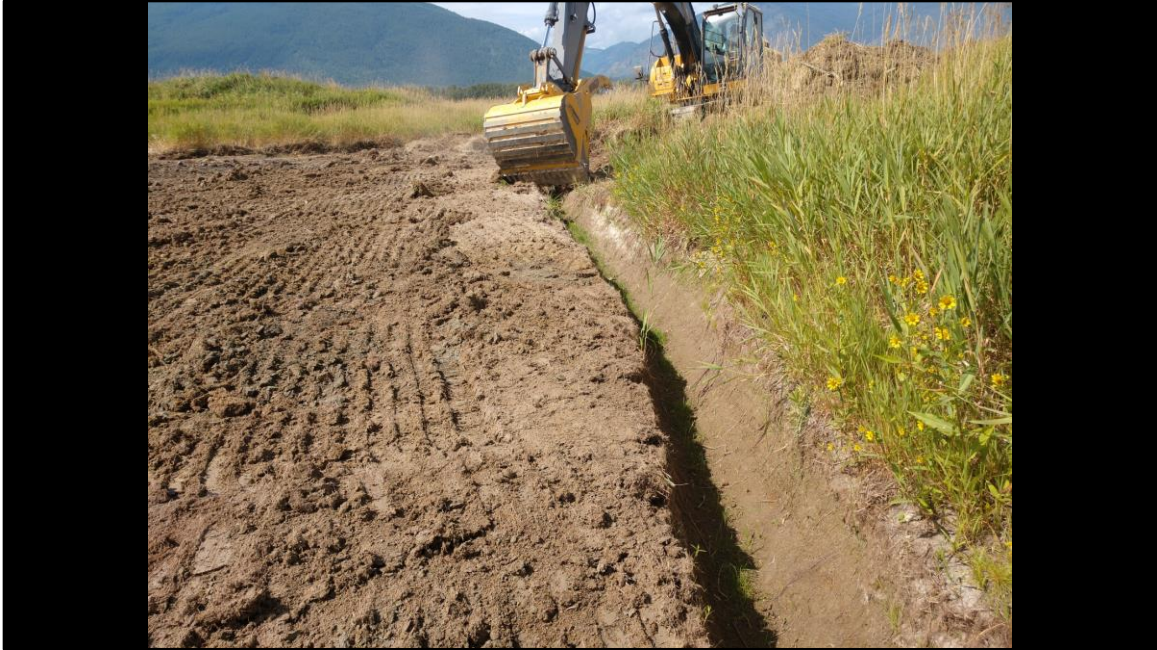
The excavator has removed the reed canary grass and topsoil from one side of the ditch to be filled. This is two-ditches in one. The narrow beaver-dug canal is in the center of a much wider ditch dug by humans.

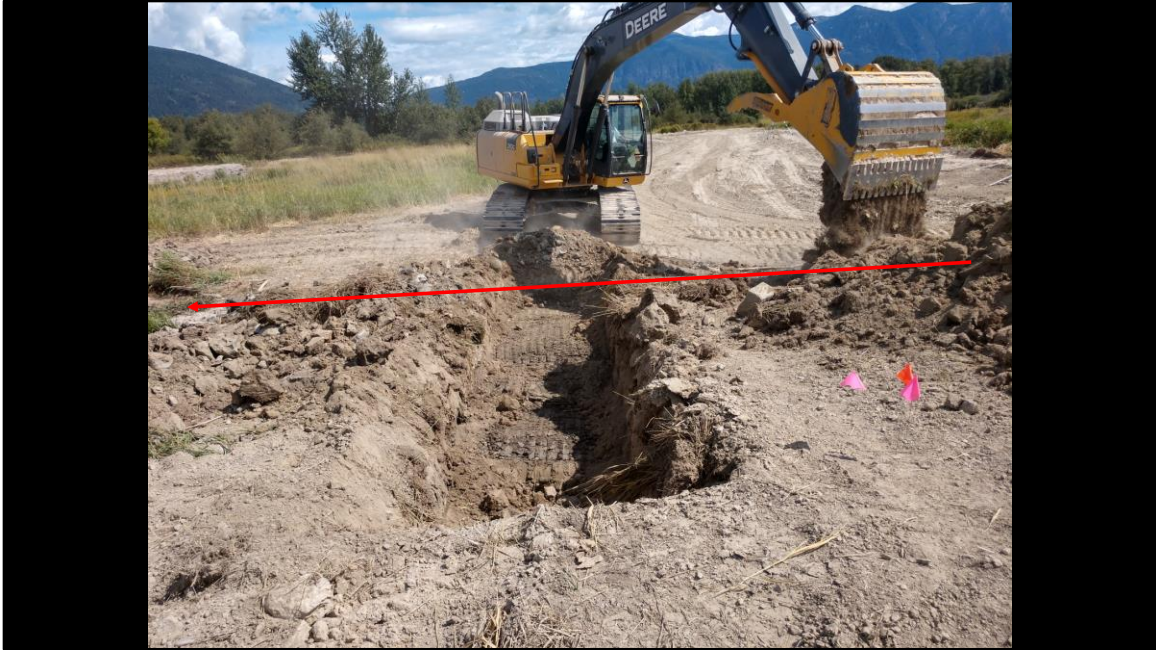
The next step in restoring the wetland involves building a groundwater dam at right angles across the ditch. The ditch is shown by the red arrow. The purpose of the groundwater dam is to control the flow of water in soil beneath the ditch, and the flow of water in the filled ditch. The groundwater dam is built where the natural rim or dam of the historic wetland was located.

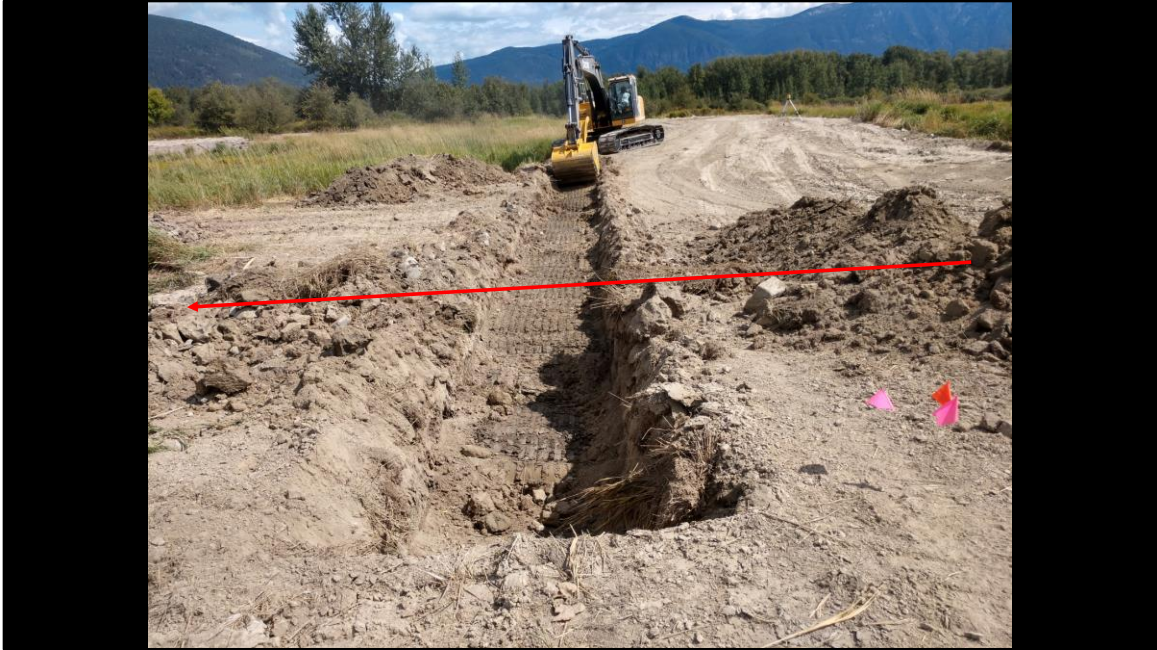
The pink wire flags show the operator where to begin and end digging the trench for the groundwater dam. The trench is dug deep into a dense layer of clay. Note the roots that were severed by digging the core trench.

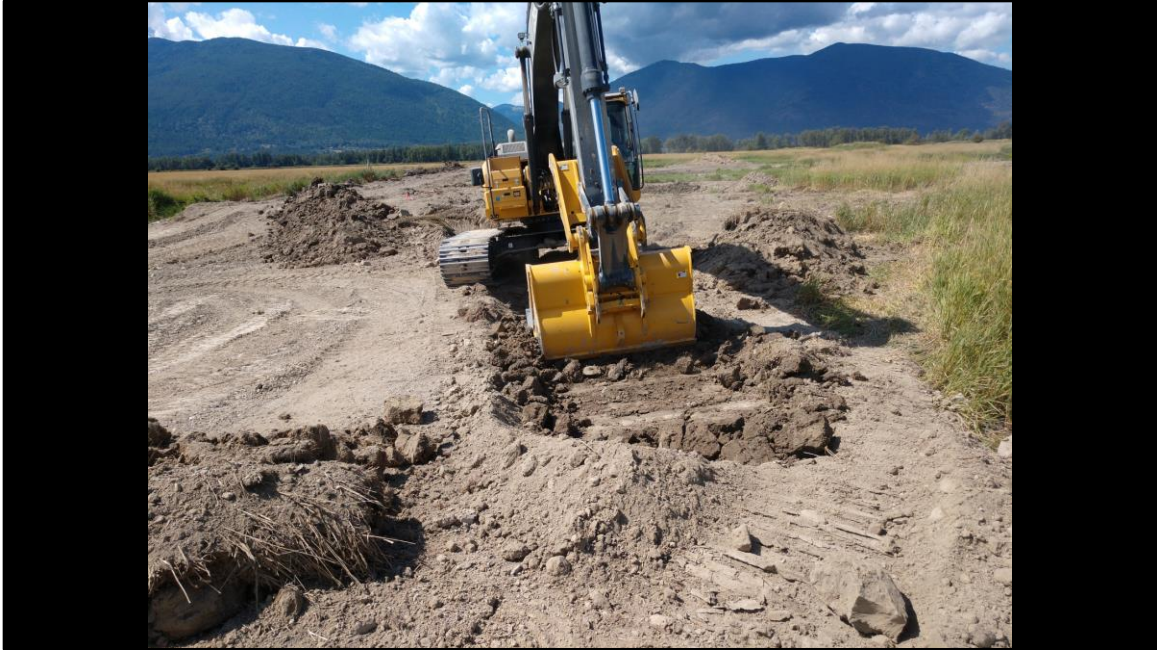
Soil that is high in clay is placed in the core trench in 15cm thick layers, with each layer being compacted using the bucket on the excavator.

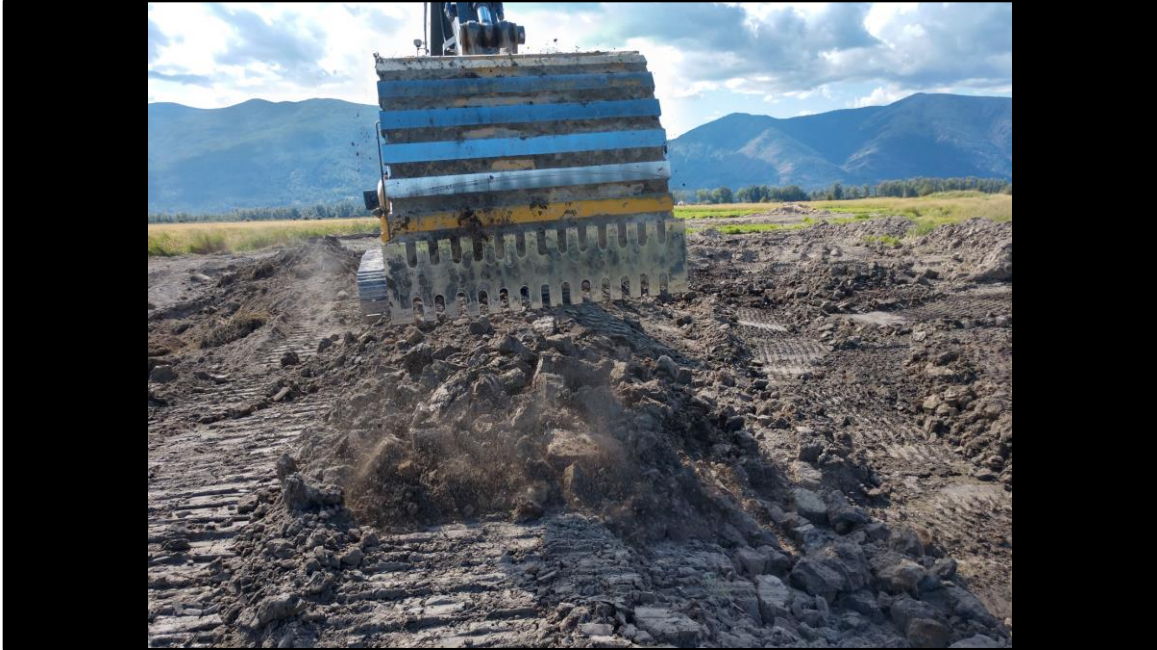
It takes time to fill the core trench with clay, and to compact each layer of clay. The clay used to fill the trench is obtained from the basin of the wetland being restored.

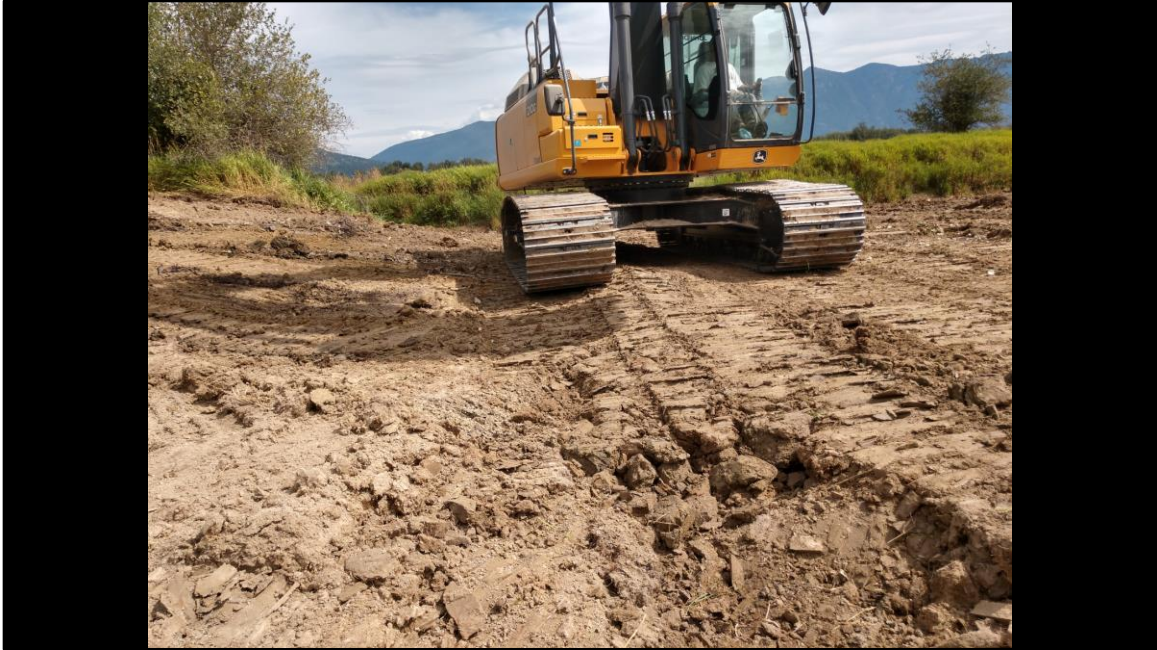
Here the excavator operator uses the weight of the machine to compact the upper layers of clay placed in the trench.

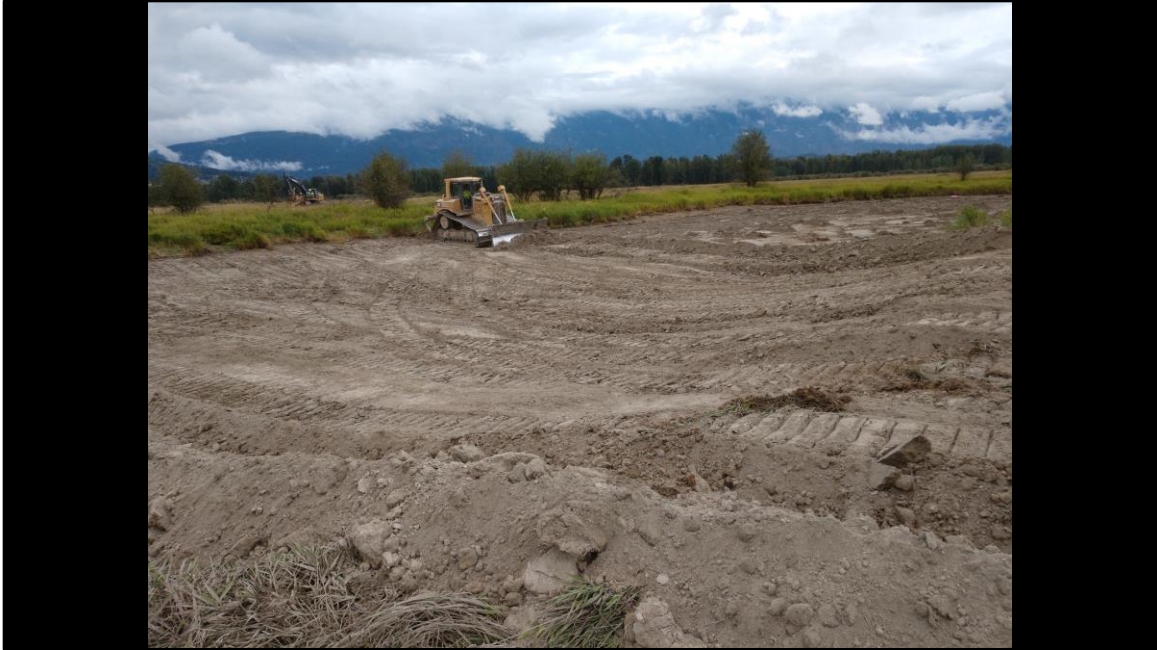
The dozer is used to move soil high in clay towards the excavator. The dozer also shapes a naturally appearing basin and rim for the wetland while supplying the excavator with the soil needed to fill the ditch. It is very important that one excavates basins if you want water to remain after floodwaters recede. This is because the elevation of the inlet is only 20cm higher than the outlet. When floodwaters recede a layer of water only 20cm deep will remain unless there are depressions on the floodplain.

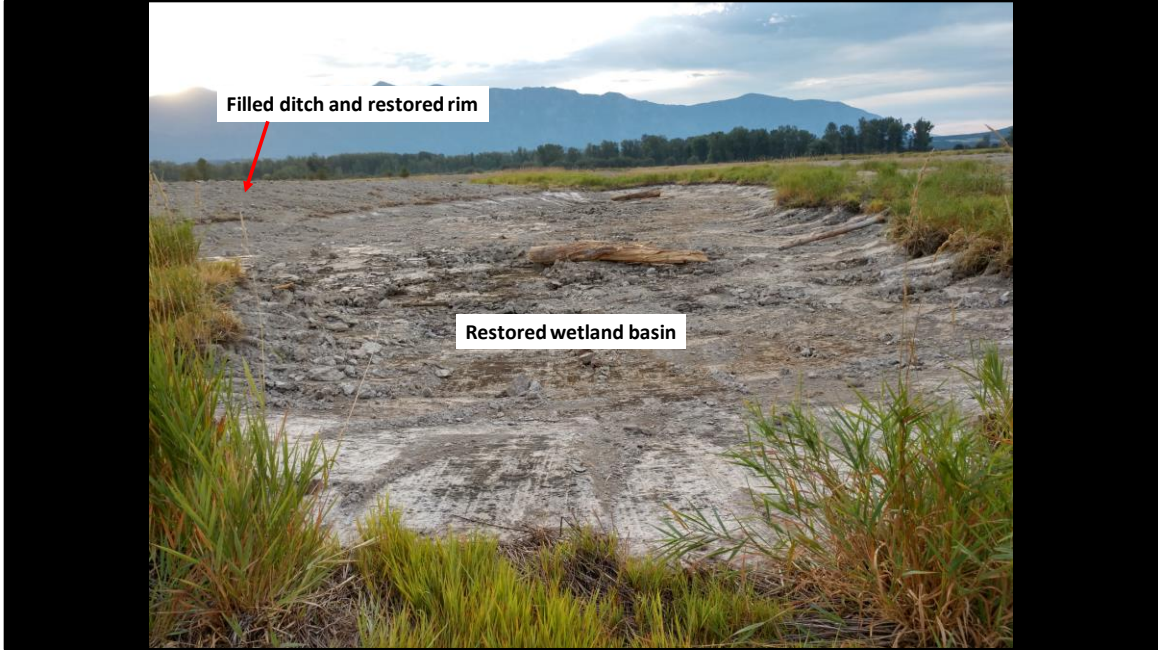
The ditch has been filled and the natural rim surrounding the wetland basin has been restored.

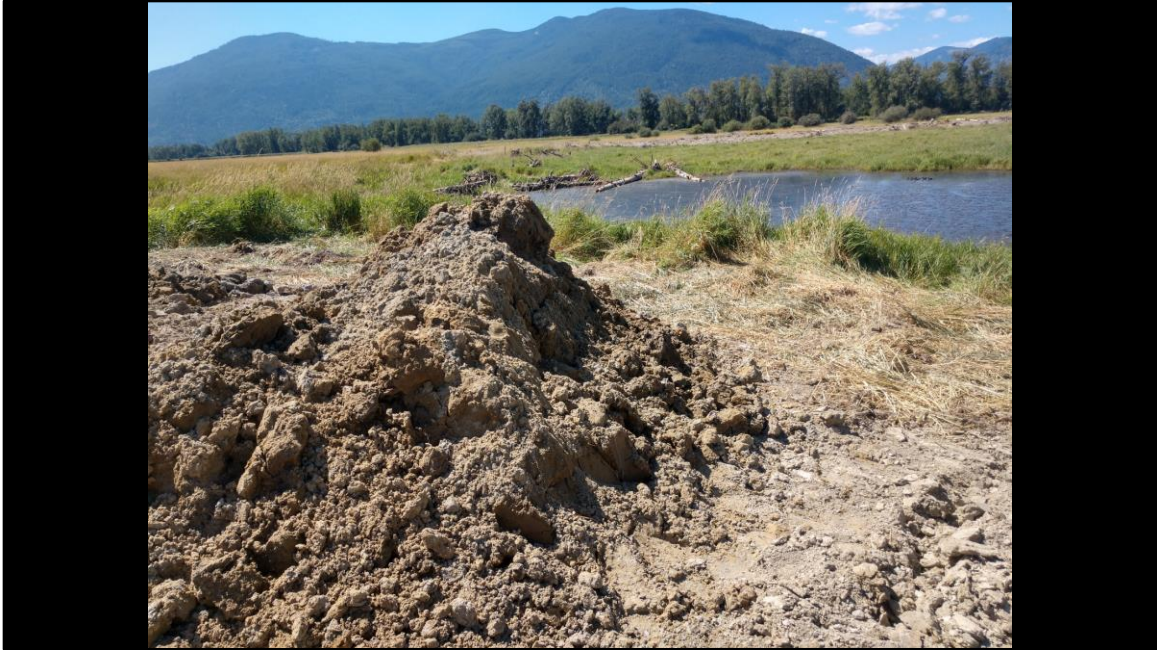
Sandy-loam texture soil removed during wetland restoration was shaped into above ground islands and ridges in well-drained and sunlit locations to provide the Western painted turtle with nesting sites. Note the logs placed in the background to provide turtles with basking sites.

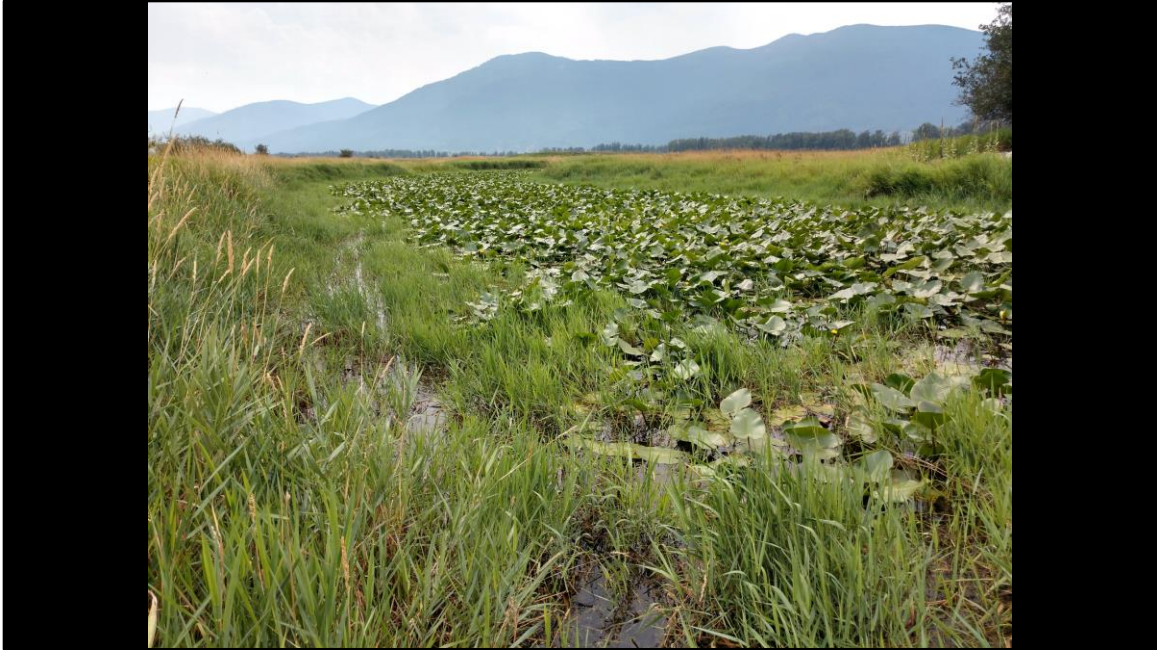
Restored wetland basins were shaped with pits, mounds, and ridges to provide conditions for the establishment of a diversity of plants. The pits and mounds in the basins varied up to 2-meters in elevation. Excavator bucket marks were hidden, and loose soil was spread in the wetland basins. Cattails or reed canary grass are not able to dominate a wetland built using these techniques.

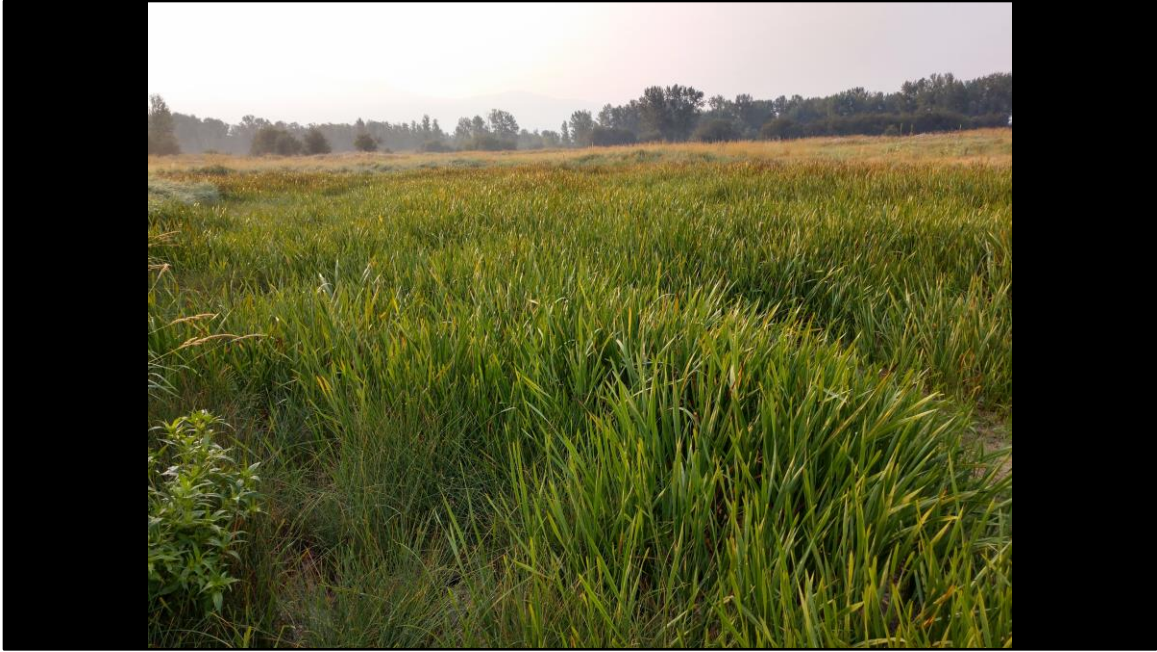
The restored wetlands are quite diverse. This restored wetland is growing burreed, rushes, and willow.

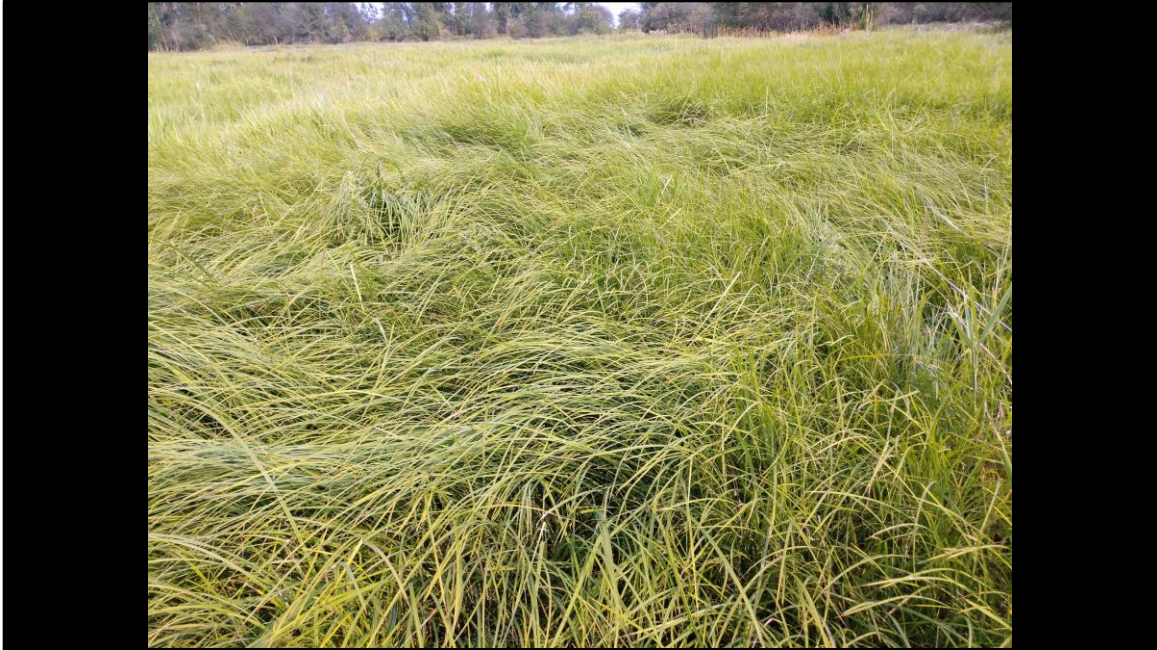
Sedge dominates this restored wet-meadow wetland on the Hunting Grounds. Sedges are important food for elk in the fall and winter.

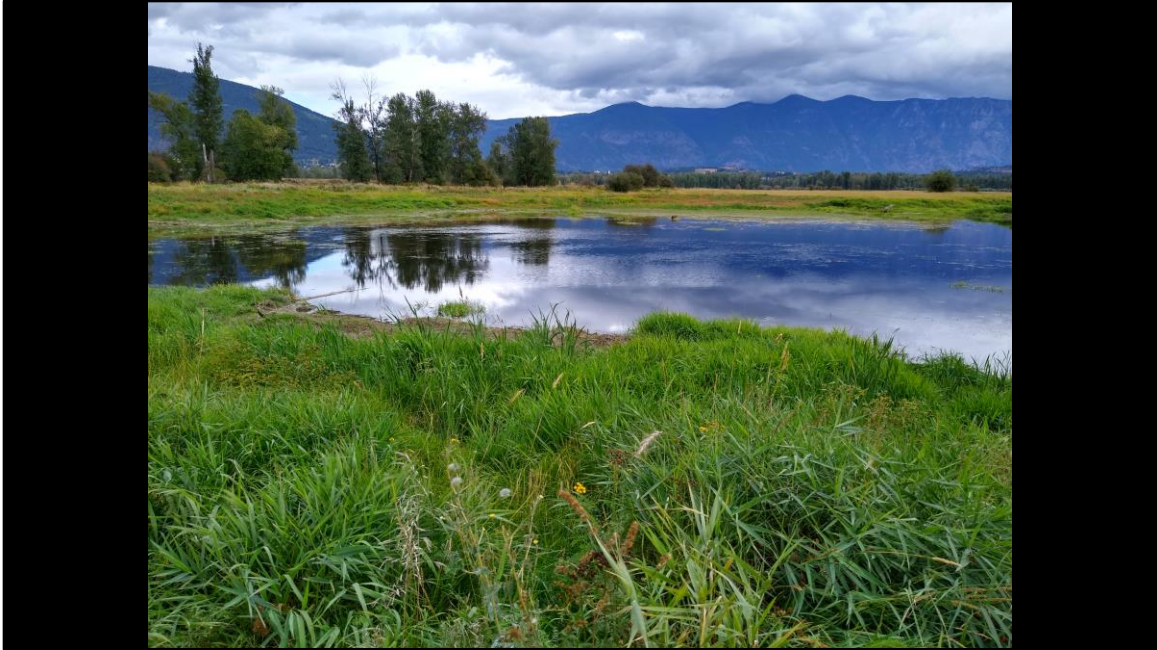
Here is one of many wetlands restored on the Hunting Grounds one-year after construction. This site was dominated by a large mound of soil and by a dense growth of reed canary grass. The wetland filled when the Kootenay and Goat Rivers flooded the Hunting Grounds in the Spring of 2020. Restored wetlands that were hydrologically connected with floodwaters contained water throughout the severe drought experienced in 2021 while wetlands not inundated by floodwaters dried.

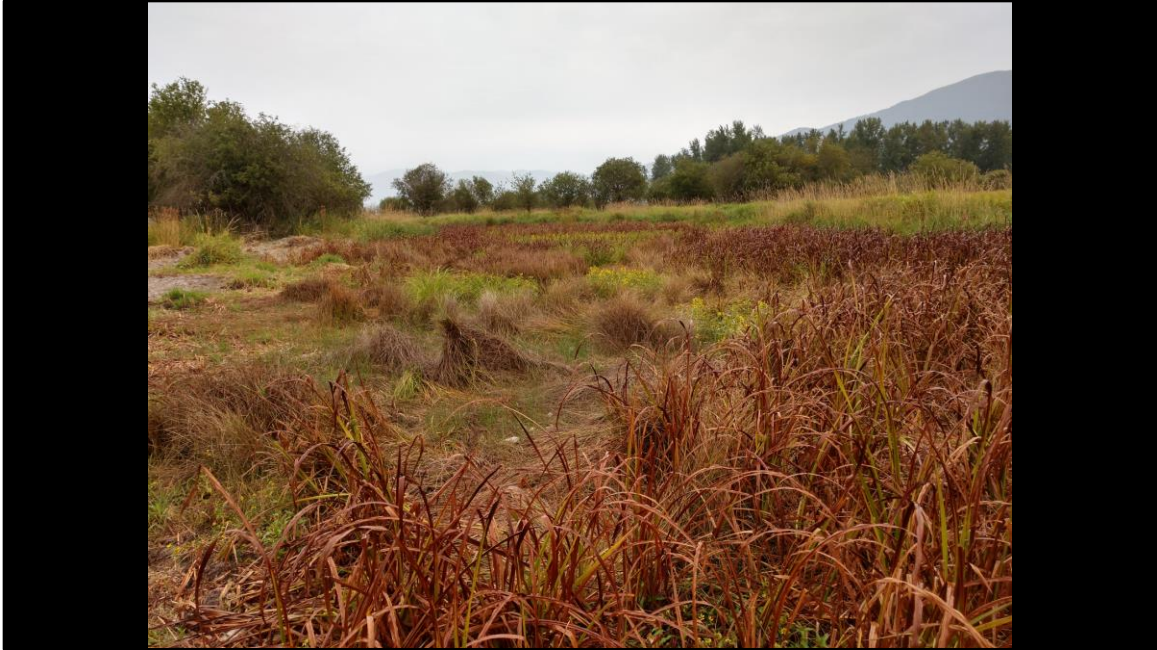
The Hunting Grounds project restored natural ephemeral streams that had been cut-off from rivers and impacted by the construction of impoundment dams.

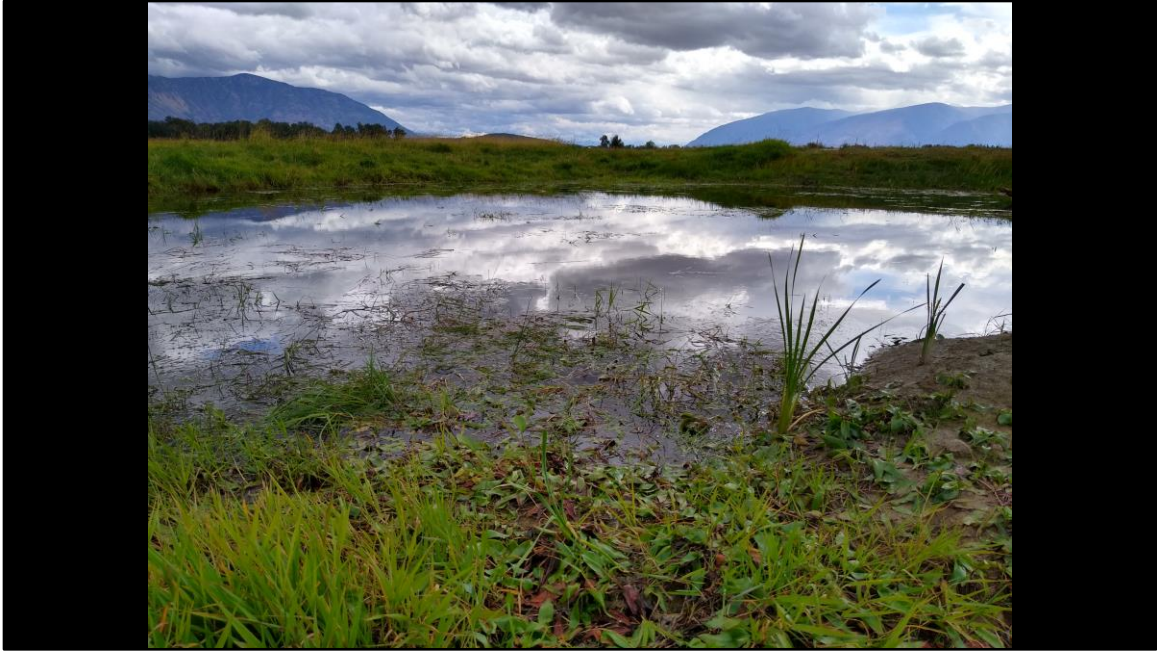
This photo taken by Norm Allard shows the Hunting Grounds on June 6, 2022 reconnected with floodwaters from the Goat River, Goat River South, and the Kootenay River.

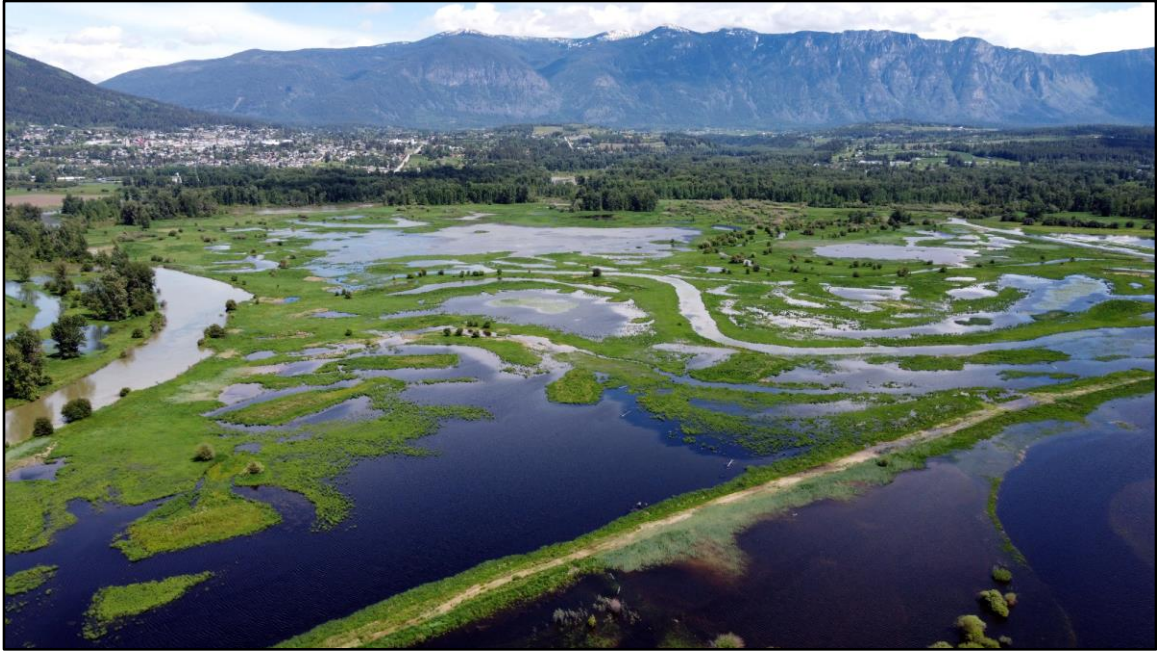
This aerial photo shows the Hunting Grounds prior to restoration in 2015.

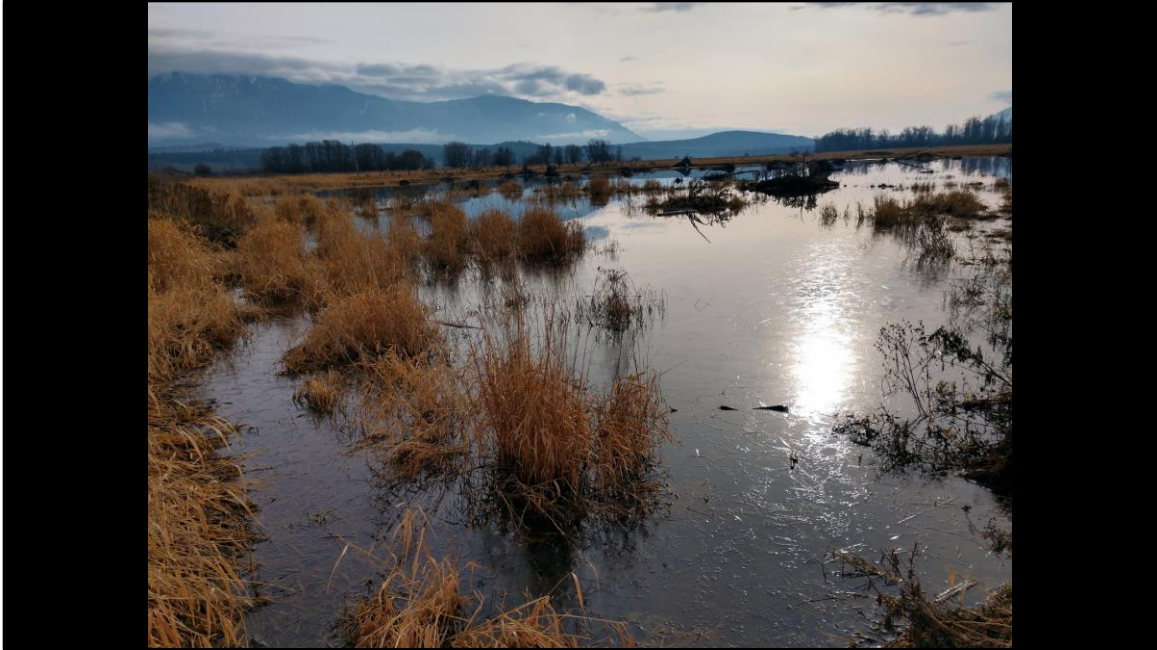
This photo shows the Hunting Grounds reconnected with floodwaters in 2021.
